Energy Performance Analyses  
of a Santa Clara County Facility  
by CEE243 Student Groups

**CIFE Technical Report #TR204  
December 2011**

# Energy Performance Analyses of a Santa Clara County facility by CEE243 student groups

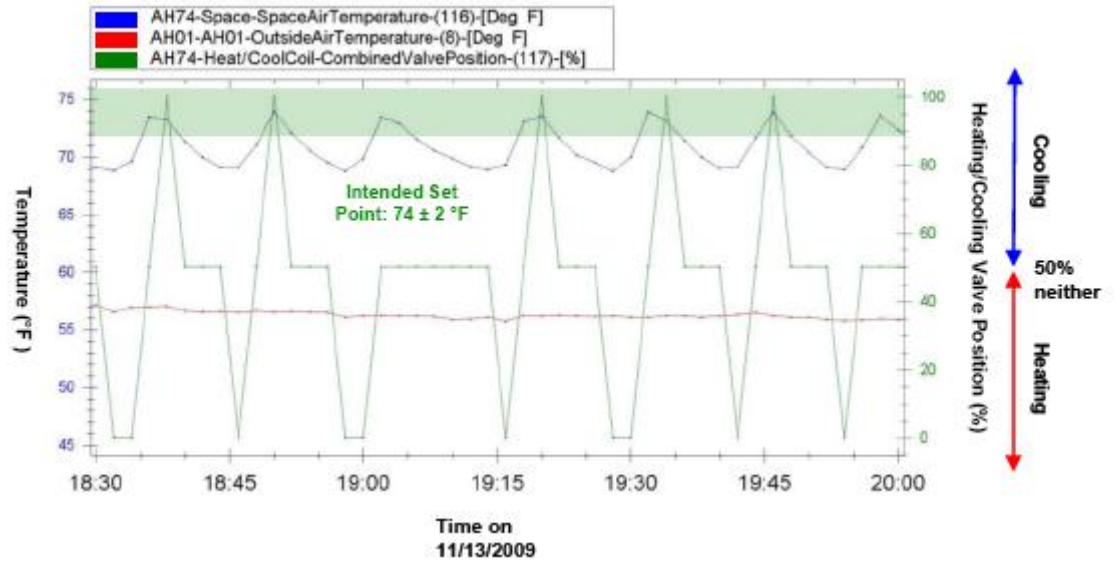
<b>Functional Intent</b>	<ul style="list-style-type: none"> <li>• Core and lobby maintained at 74±2°F.</li> <li>• Damper position should be 100% open for 100% air replacement.</li> </ul>
<b>Functional Areas</b>	<p>Lobby</p> <ul style="list-style-type: none"> <li>• Relatively constant space air temperature with varying OAT</li> </ul> <p>Core</p> <ul style="list-style-type: none"> <li>• Slight upward trend in space temperature with OAT consistent with cooling-only functional intent</li> <li>• Cooling appears to operate predominately during summer</li> </ul>
<b>Problem Areas</b>	<p>Lobby</p> <ul style="list-style-type: none"> <li>• Space temperature varies between 69°F and 78°F, exceeding set point range.</li> <li>• Cooling control set to full open when OAT is between 52°F 80°F with no cooling between 80°F and 90°F OAT.</li> <li>• Heating control set to open during some days in the summer and for range of OAT up to 82°F.</li> <li>• On the evening of August 25, 2009, control valve alternated between 100% open heating and 0% activity in response to a drop in space air temperature from 72°F to 69°F. While in line with functional intent, perhaps dead band should be widened to reduce need for summer heating.</li> <li>• On August 26, 2009, hottest OAT occurs (96°F) and only 10 minutes of cooling required to maintain tolerance levels. However, heating was called for in the evening.</li> <li>• Period of October and November 2009 required more frequent cooling than summer months. On November 13, 2009, system quickly alternated between heating and cooling.</li> </ul>

Figure 1: AH74 lobby space air temperature, heating/cooling valve position, and OAT on November 13, 2009, showing heating and cooling cycles

- On March 23, 2010, excessive cooling (possibly due to abnormal space usage) causes a brief usage of heating.

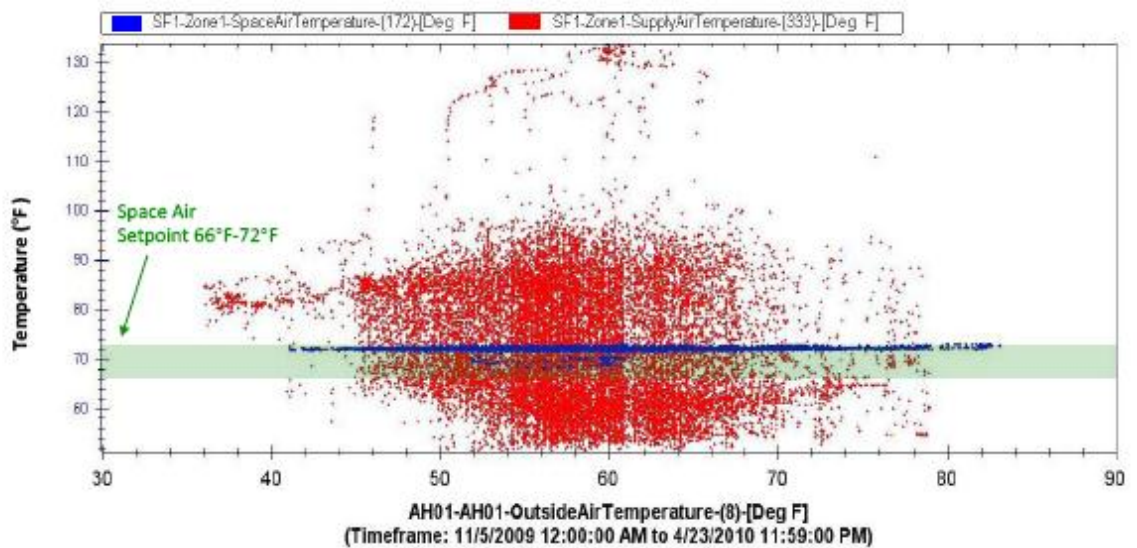
- Supply air temperatures for zones 1 through 4 fluctuate radically from about 50°F to 130°F for almost all OATs. The difference between supply and space air temperature is +60°F and -20°F for a given OAT, while the space air temperature remains very constant.
- Cooling and heating are occurring almost simultaneously resulting in a clear indication of energy waste.
- Heating is occurring during warmer spring months and cooling is occurring during cooler winter months.

Figure 2: Supply air temperature for Zone 1 of SF1 as OAT varies from November 4, 2009 through April 22, 2010. Note the extreme fluctuation in supply air temperature and lack of correlation to OAT, while space air temperature is extremely constant

- Install redundant sensors to check supply temperature for each zone.
- Take spot measurements at diffusers.
- Investigate and determine cause of the variation in space air temperature in mid-December. Consult with facility manager and check data for other building subsystems. Determine why space air temperature was allowed to fluctuate within the appropriate set point range during this period, but remains constant at 72°F during all other times.

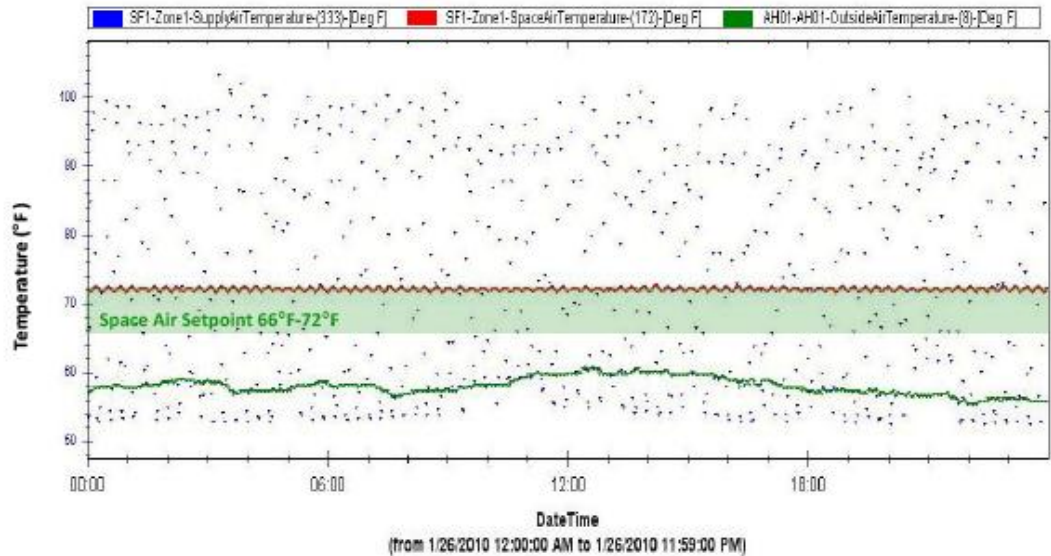
Figure 3: An illustrative example of space 1 on January 26, 2010, showing the near simultaneous temperature fluctuation of supply air temperature as OAT and space air temperature remain fairly constant

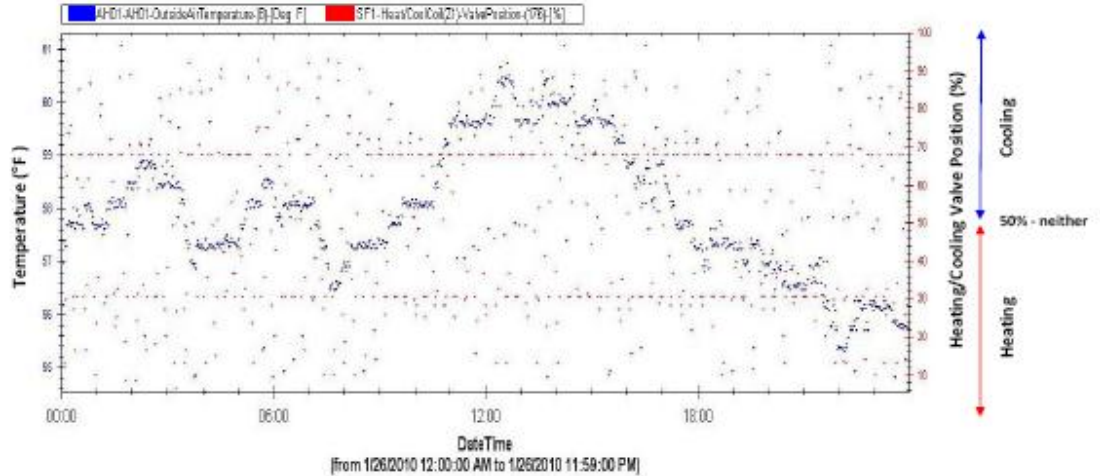
Figure 4: An illustrative example of space 1 valve position on January 26, 2010 (0% being full heating, 50% being neither heating nor cooling, and 100% being full cooling), showing the near simultaneous heating and cooling. Also note that cooling is occurring on a winter day when the OAT is less than 60 °F

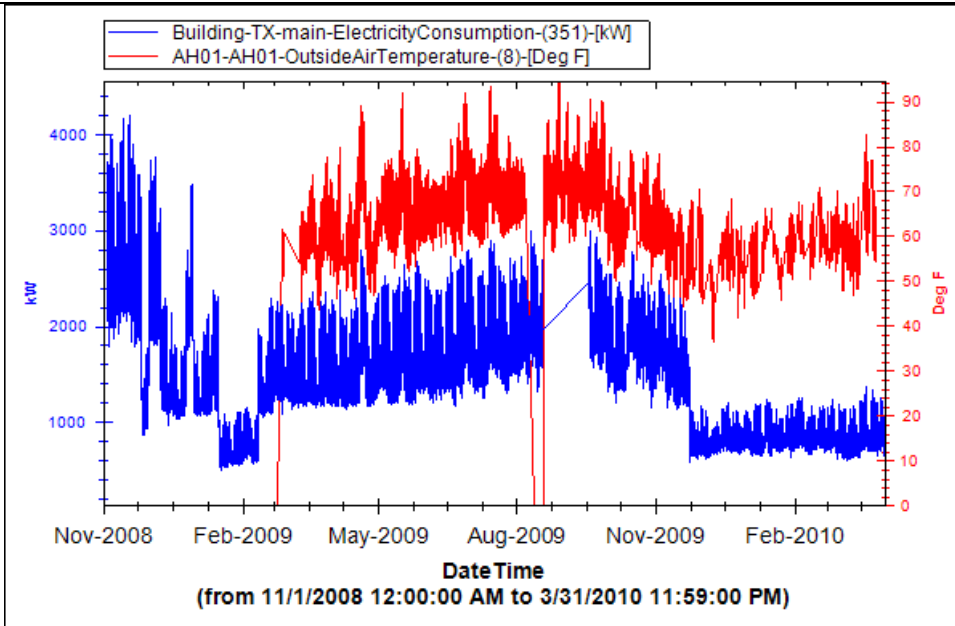
Figure 7: Whole Building Hourly Electricity Consumption

<b>Problem Areas</b>	<ul style="list-style-type: none"> <li>• During the second half of August 2009 and the first half of September 2009, the electricity data was unavailable.</li> <li>• There is a significant drop in measured electricity consumption between 1/16/2009 and 2/10/2009. A similar drop occurs from 11/23/2009 through 3/31/2009. Electricity is expected to decrease during time periods, but the drops are sharp. Perhaps large pieces of electric equipment, such as chillers, are turned off during these time periods. If so, there may be major energy conservation opportunities in these pieces of equipment when they are in operation, especially on either side of the scheduled outages.</li> </ul>

- Since this meter measured several facilities, it is difficult to determine what portion is actually associated this facility.
- Submetered data was available, but it is unknown which pieces of equipment are on each submeter. Electricity consumption on the submeters was relatively small and fairly constant throughout the year. There were evident daily patterns in the submeters, but their meanings were not intuitive. For example, meter TX-38 would oftentimes peak in the early morning.

<b>Recommendations</b>	<ul style="list-style-type: none"> <li>• Install a separate meter to measure the electricity consumption just in this facility.</li> <li>• Confirm whether major pieces of equipment are being shut down during the winter season. If so, it appears that these units have major energy conservation potential while in operation.</li> <li>• Determine the specific systems on the submeters for additional analysis. It would be useful to submeter specific areas or systems, such as the chillers, lights, and fans.</li> </ul>
------------------------	---
