**Third Five-Year Review Report  
Sanitary Landfill Co. Superfund Site  
(a.k.a. Cardington Road Landfill Site)  
Montgomery County, Ohio**

**U.S. Environmental Protection Agency  
Region 5  
Chicago, Illinois**

**Sanitary Landfill Co.  
(a.k.a. Cardington Road Landfill)  
Montgomery County, Ohio  
Third Five-Year Review**

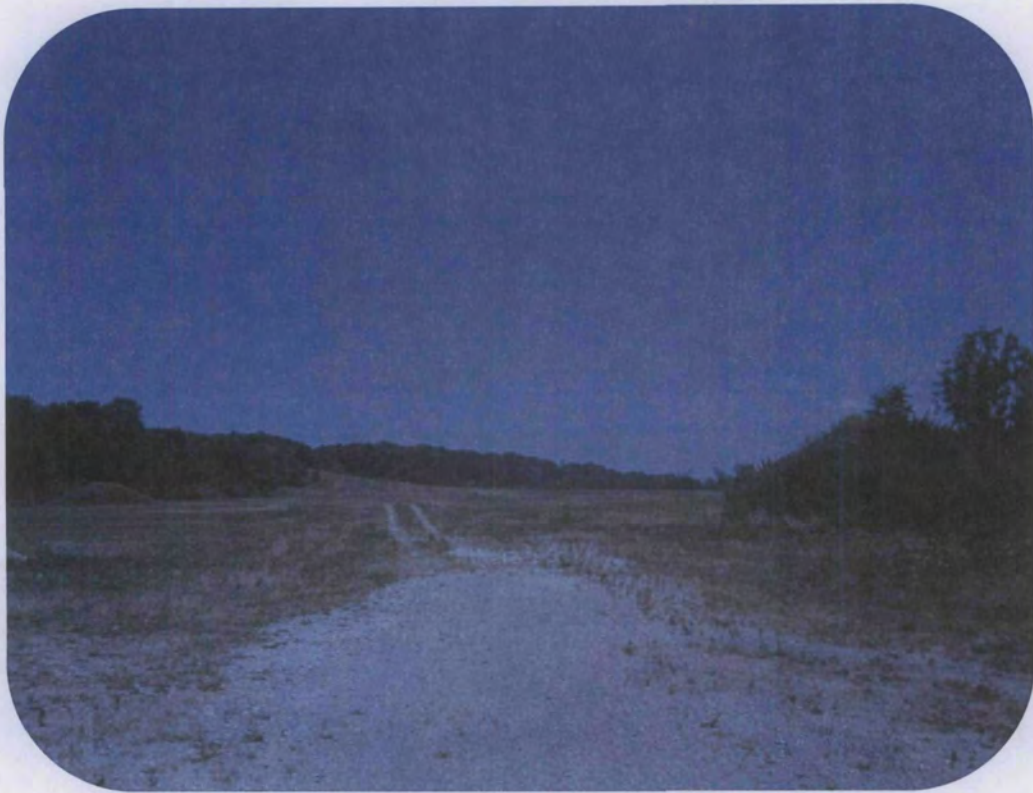
**Photo 1:** On site, looking north towards MP-6D.

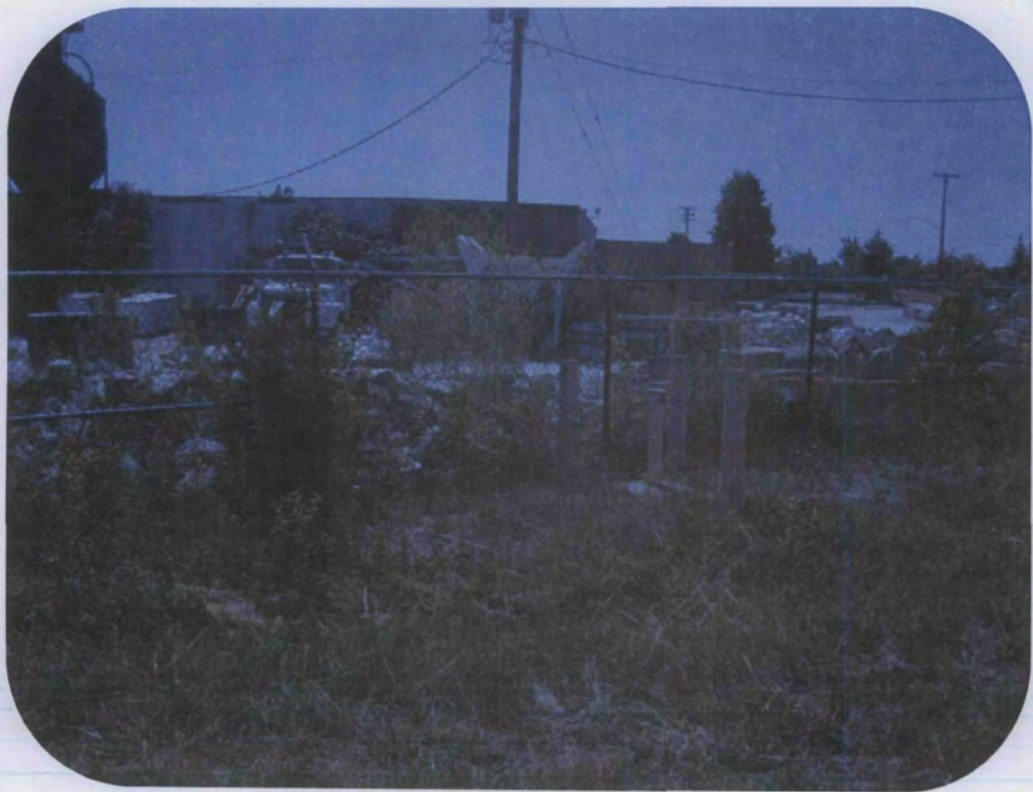
**Photo 2:** On site, looking east with MP-3 along fence.

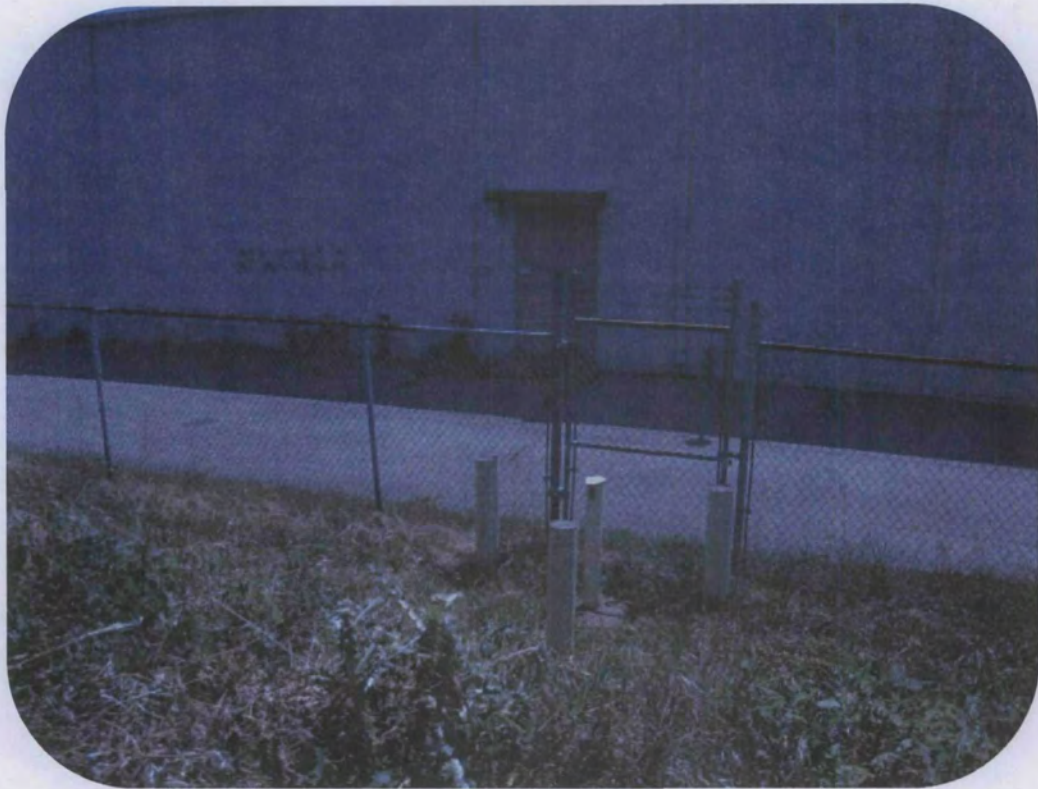
**Photo 3:** On site, looking east to MP-2 along fence.

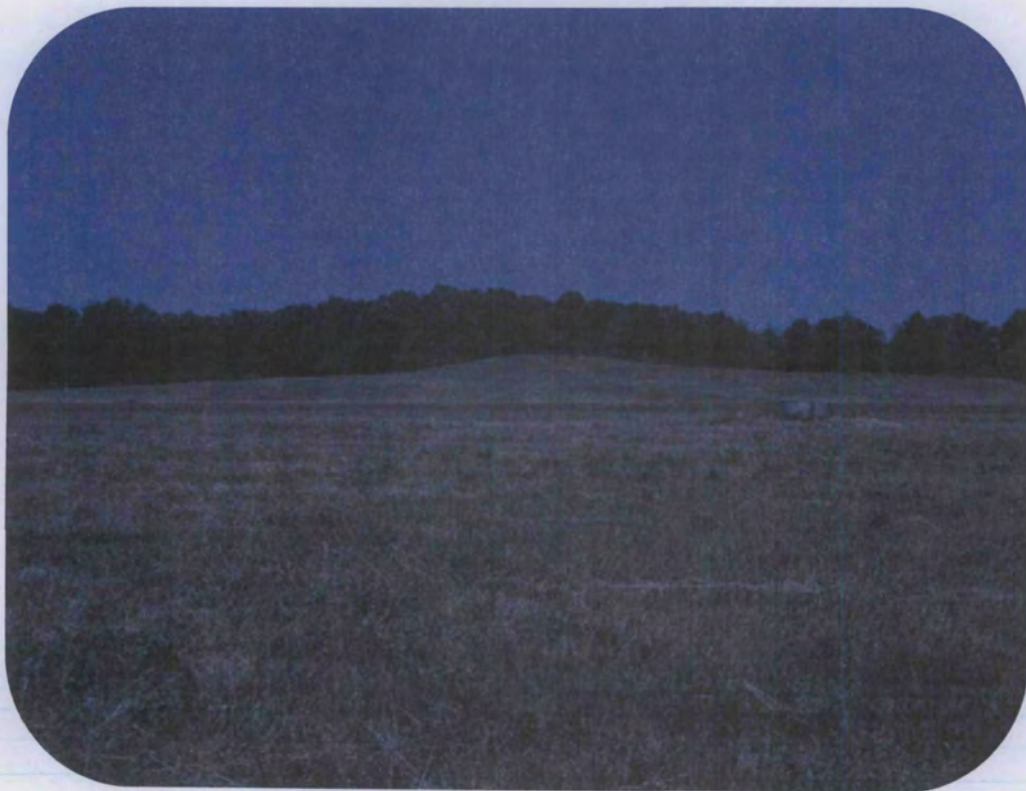
**Photo 4:** On site, looking east on to landfill cover with G-14 on horizon.

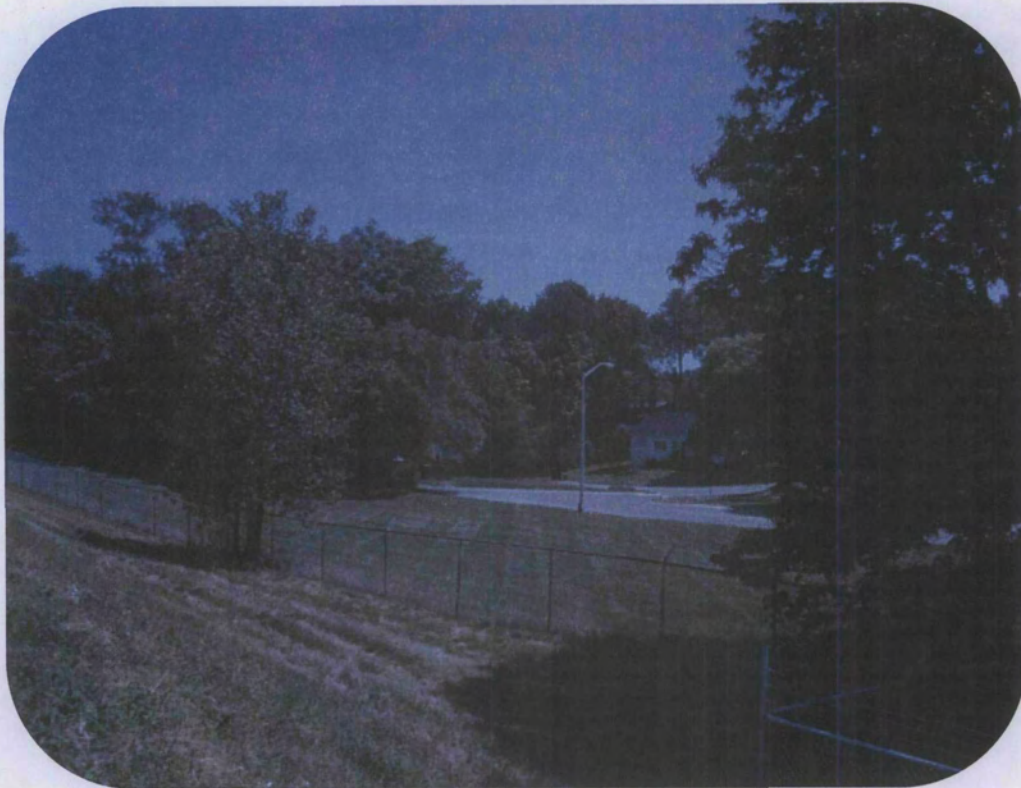
**Photo 5:** On site, looking northeast with residence in background. There is a CGI located in the garage.

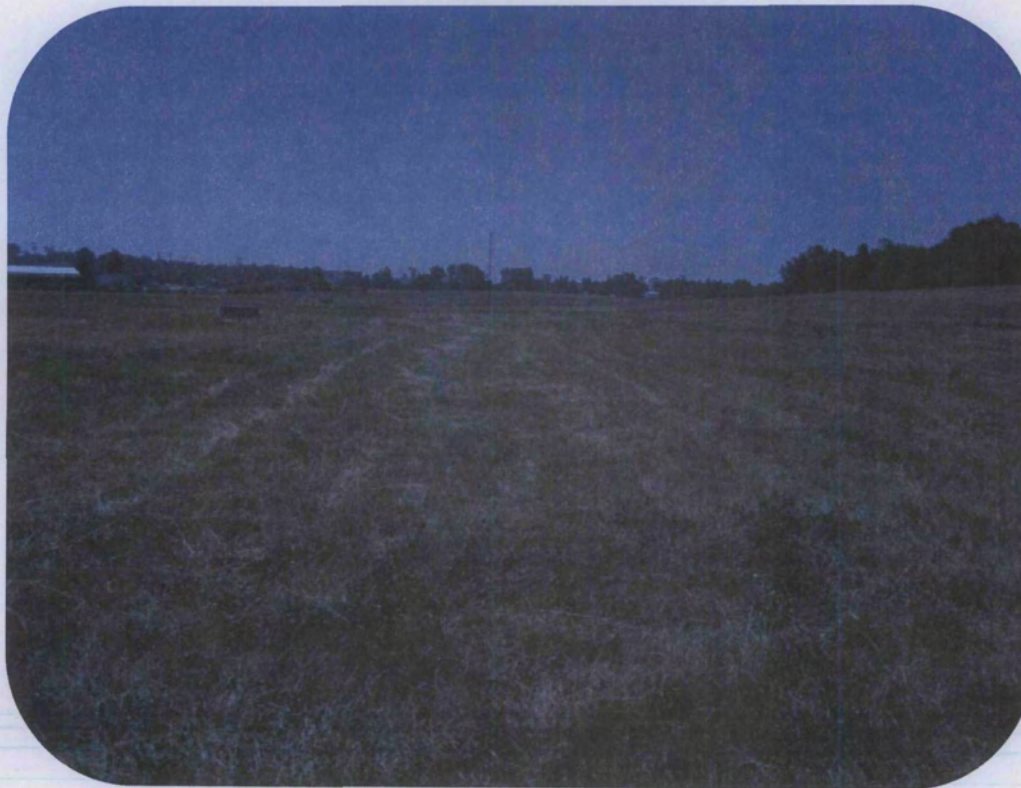
Overall, the inspection found the Site to be in very good condition. No rivulets were observed on or near the landfill and the soil cover appeared to be well maintained. The landfill flare, well casings and condensate tanks are well maintained and in good condition. O&M personnel indicate that there have been no problems with trespassing at the Site.

**Photo 6:** On site, looking south onto well established and maintained landfill cover.

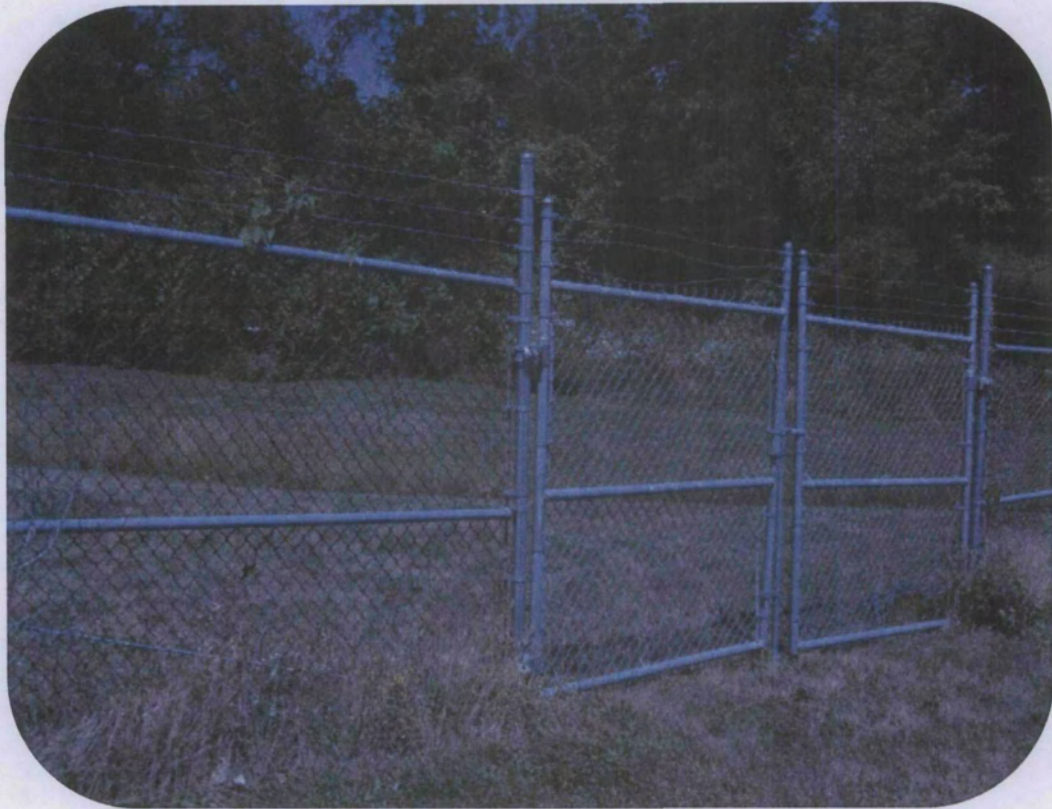
**Photo 7:** On site, looking west – access fence to Calvary Cemetery Property as well as MW 3R, MW 3I, and MW 3A, MW 4I

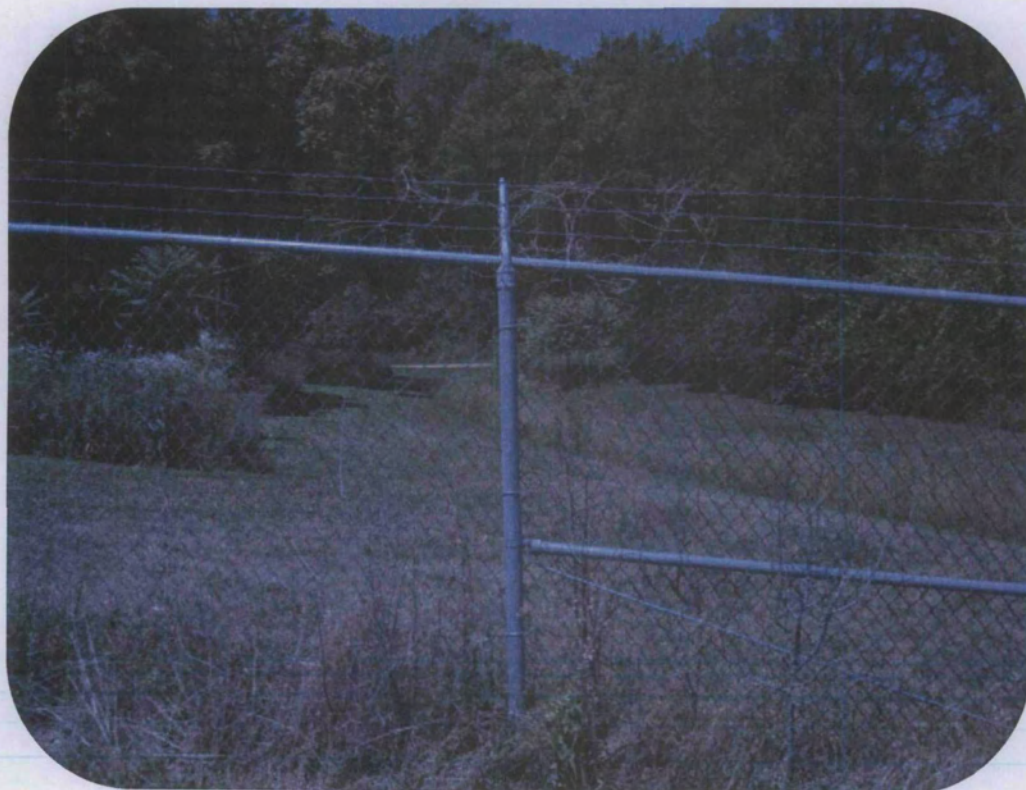
**Photo 8:** On site, looking west towards MW 8I, MW 8M, And MW 8A

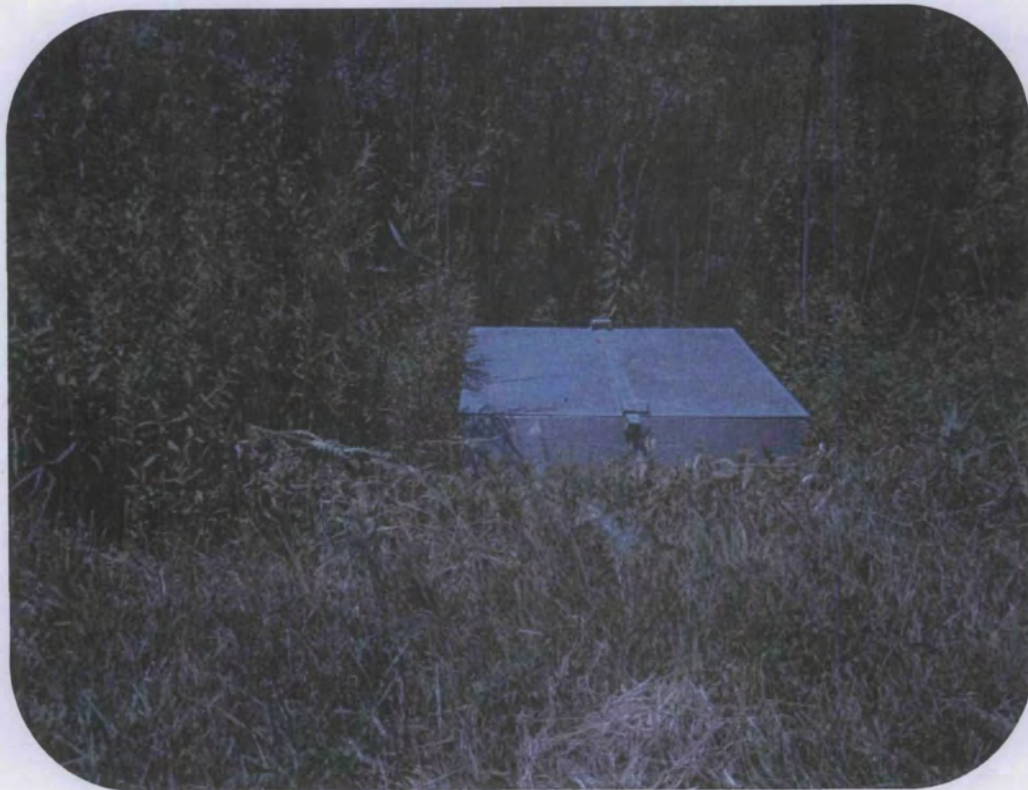
**Photo 9:** Condensate sump along western edge of fence.

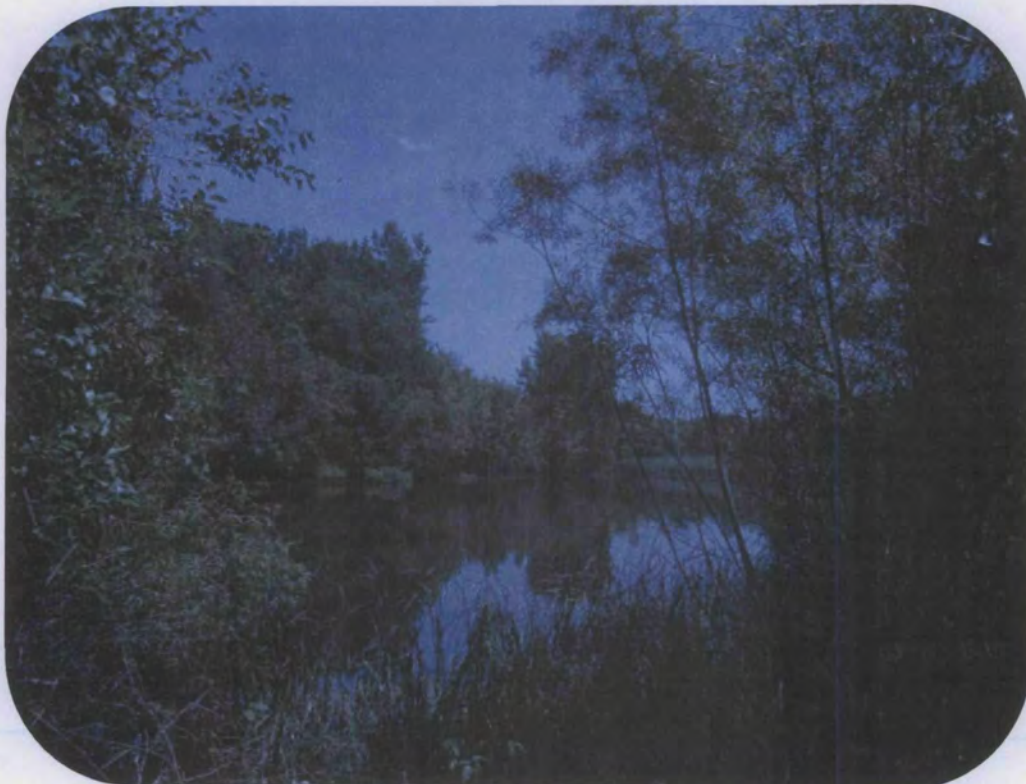
**Photo 10:** Off site, looking north towards pond located near the southwest corner of the landfill.

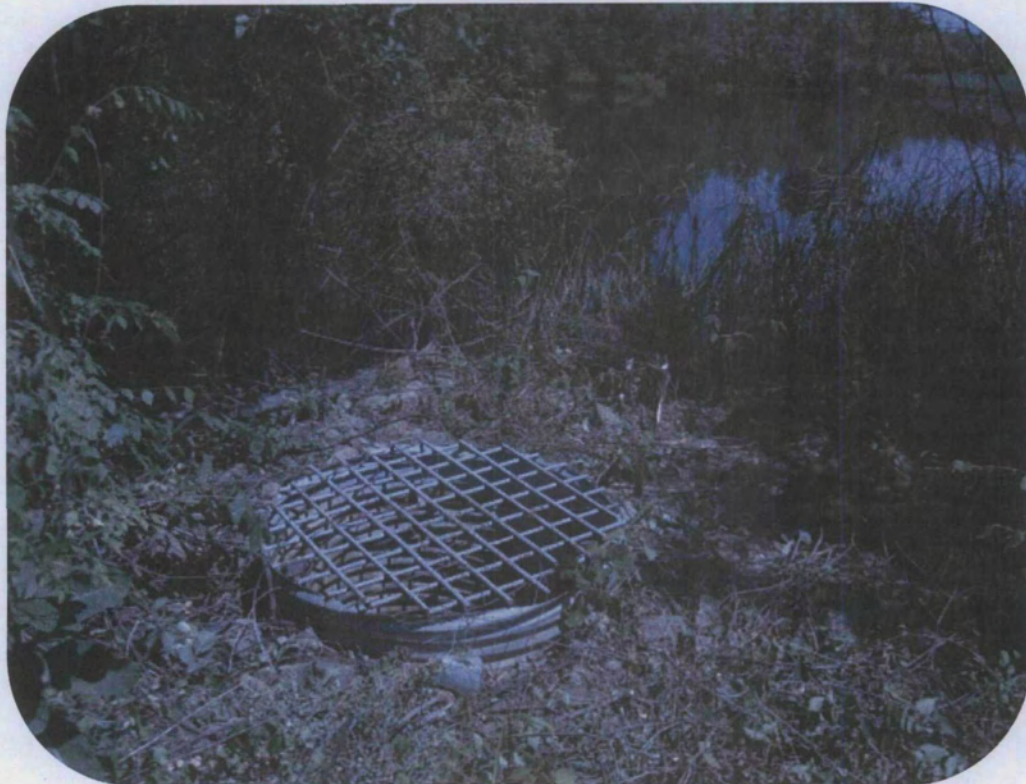
**Photo 11:** Off site, looking north at the sediment basin near the pond in Photo 10 along the southwest corner of the landfill.

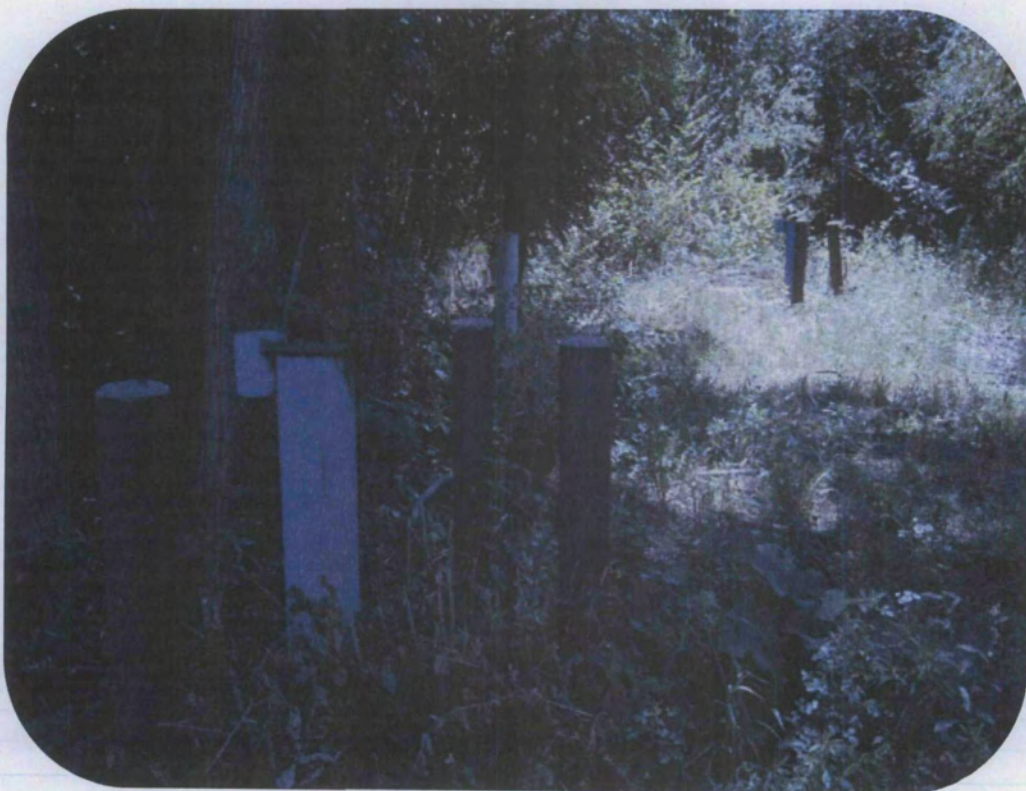
**Photo 12:** Off site, looking south towards MW 6I, MW 6M, and MW 6A.

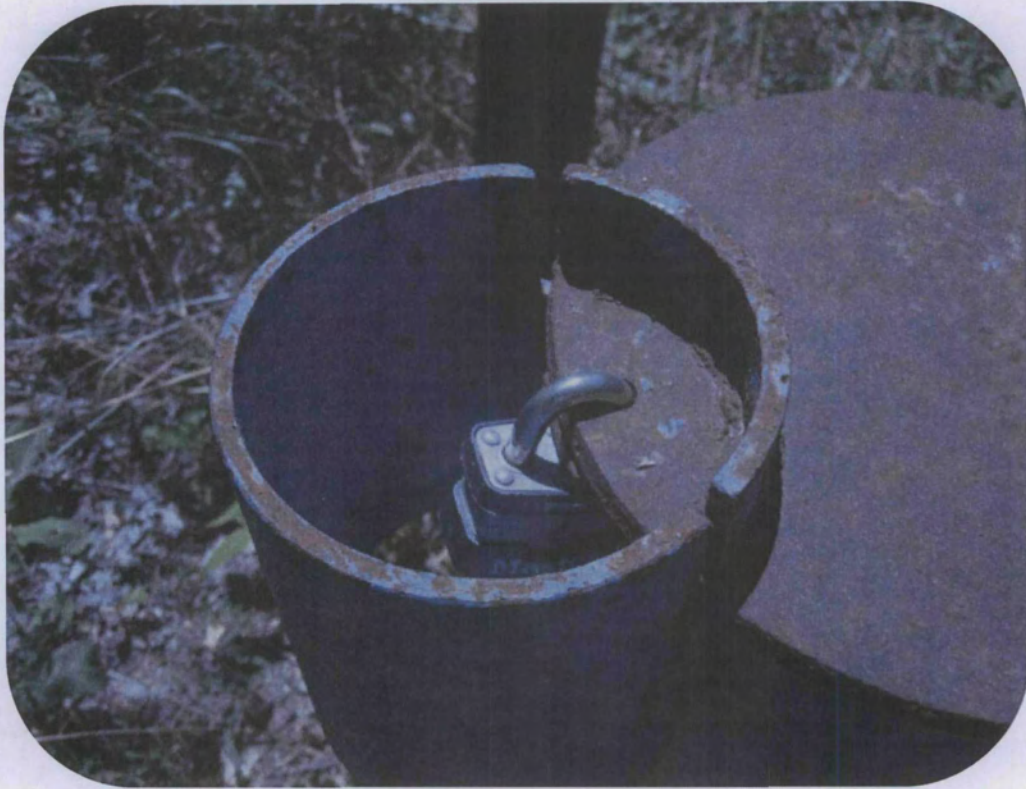
**Photo 13:** Lock with guard on MW 6M.

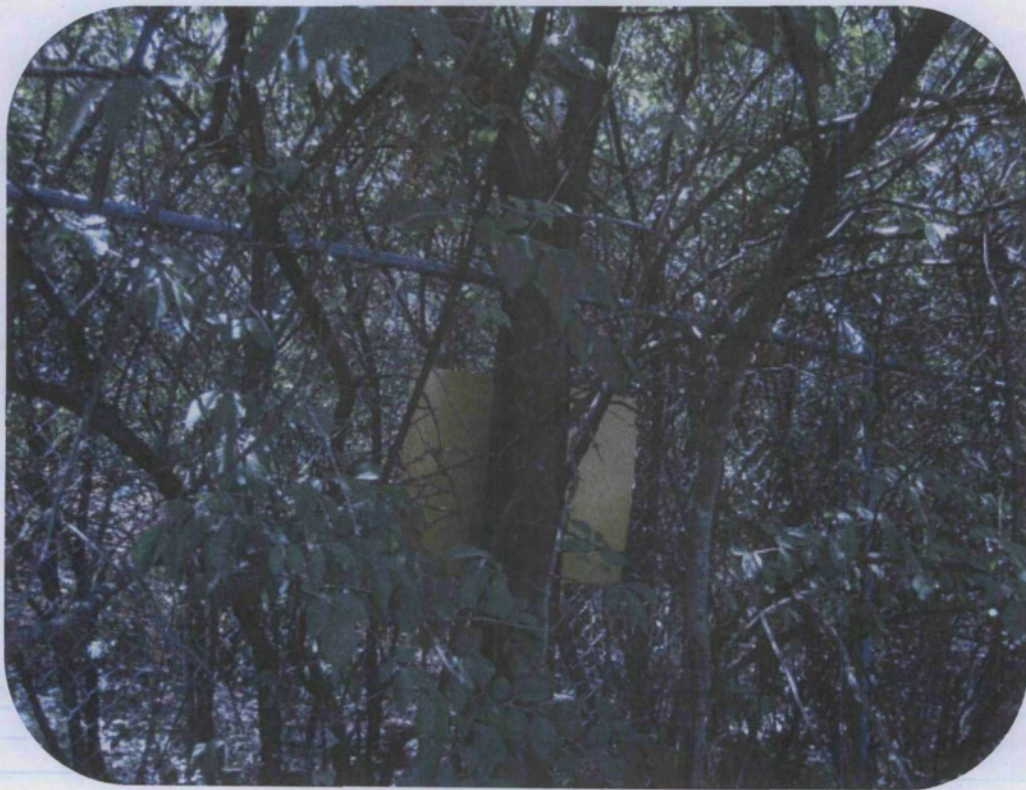
It was noted that the visibility of some site signage is blocked by overgrowth of vegetation along Cardington Road. O&M personnel indicated that this will be addressed as part of normal O&M activities for the Site.

**Photo 14:** On site - back of sign posted along fence, not visible from off-site due to heavy vegetation

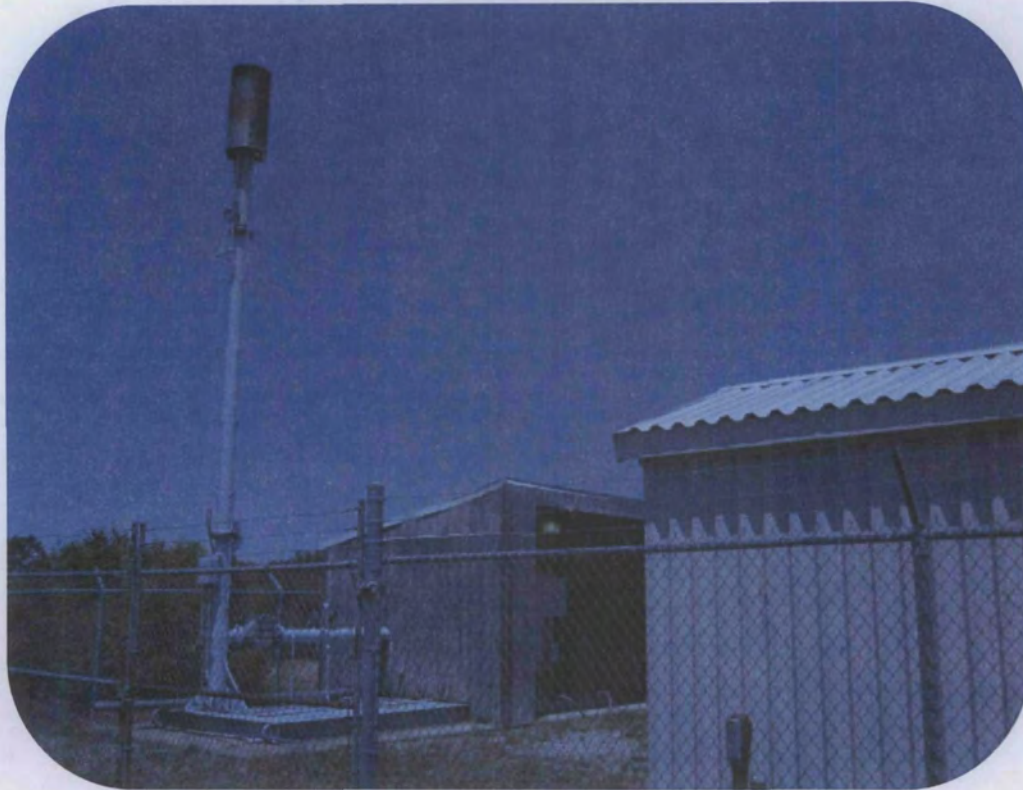
**Photo 15:** On site, landfill gas candlestick flare, landfill gas system structure, and associated storage structure.

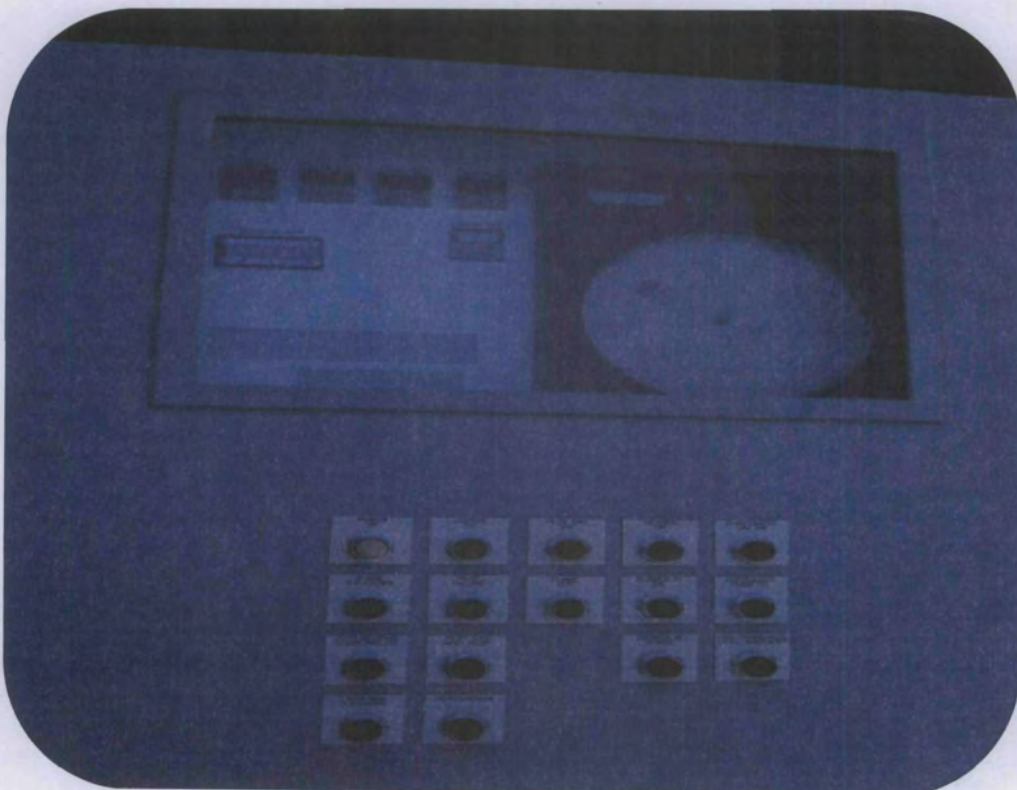
**Photo 16:** Electronic monitoring panel of landfill gas system.

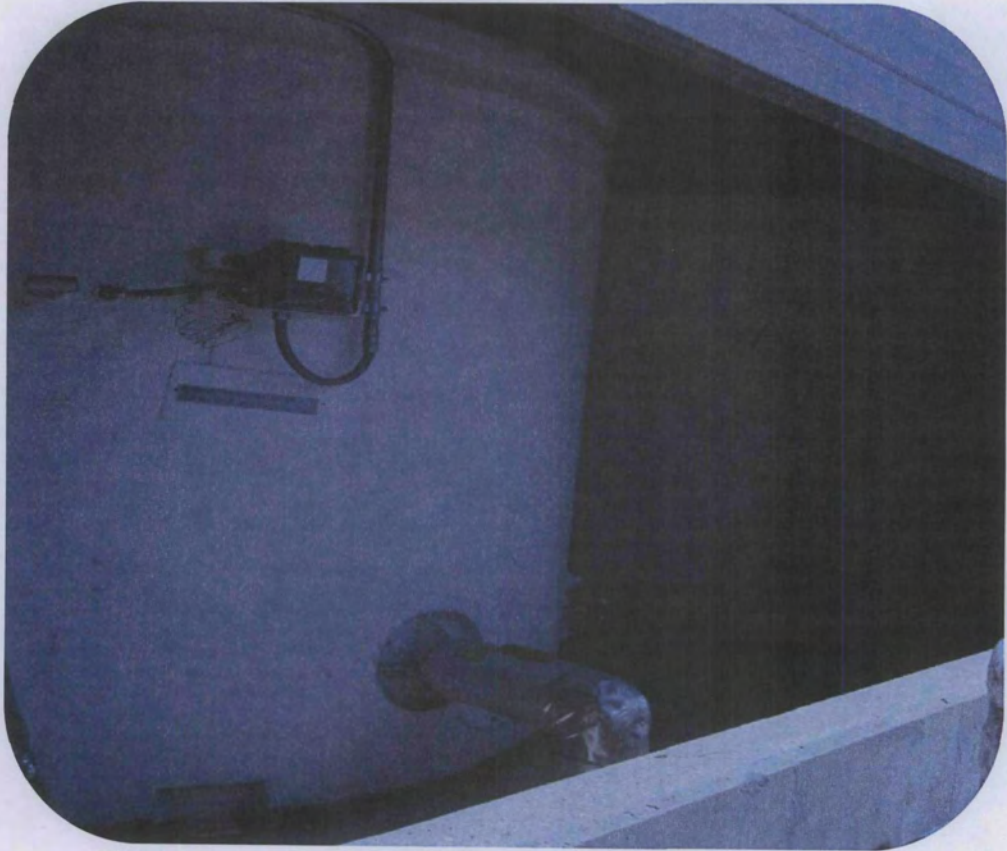
**Photo 17:** Condensate storage tanks contained within structure on site.
