# Stanford Balustrade Restoration

2006-2007

# Background

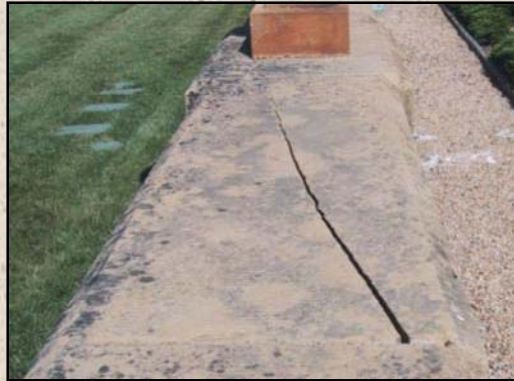
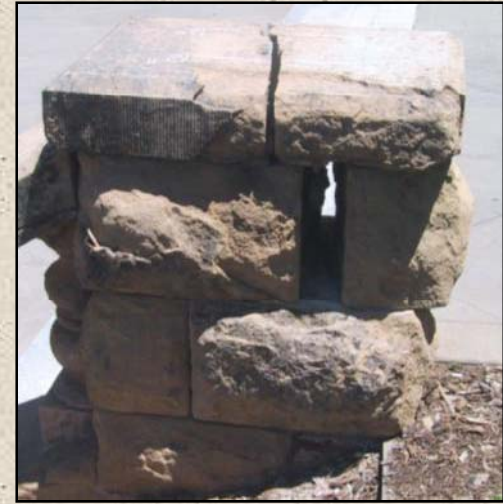
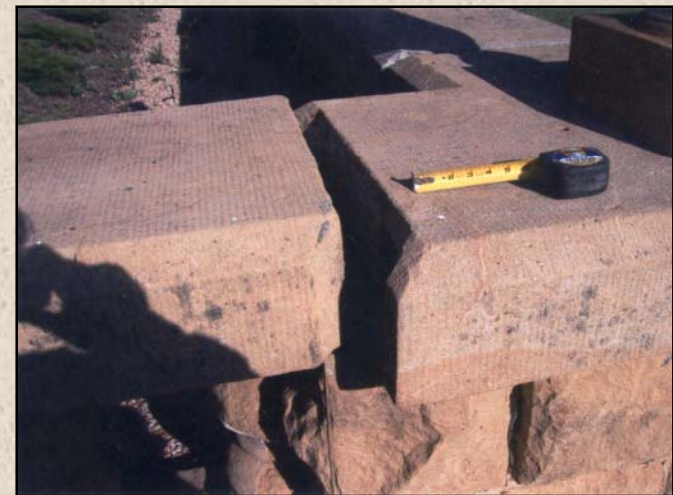
- Hardening
- Fissuring
- Spalling
- Surface Flaking
- Surface Discoloration
- Fracturing and Displacement

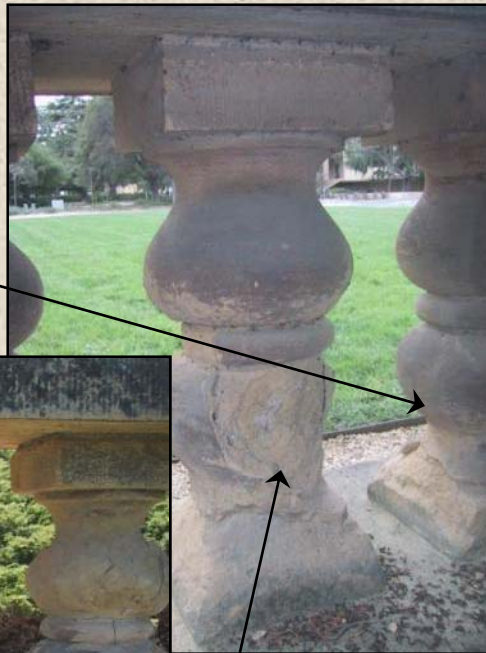
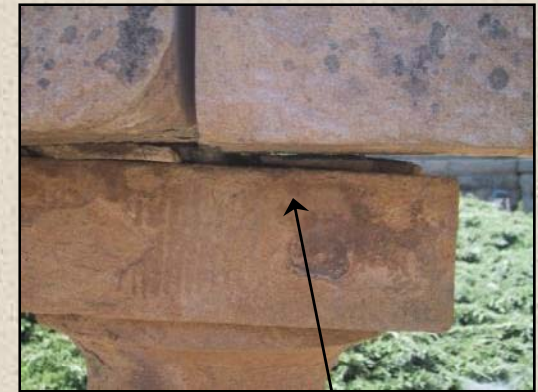
- Balusters

Hardening

Fissuring

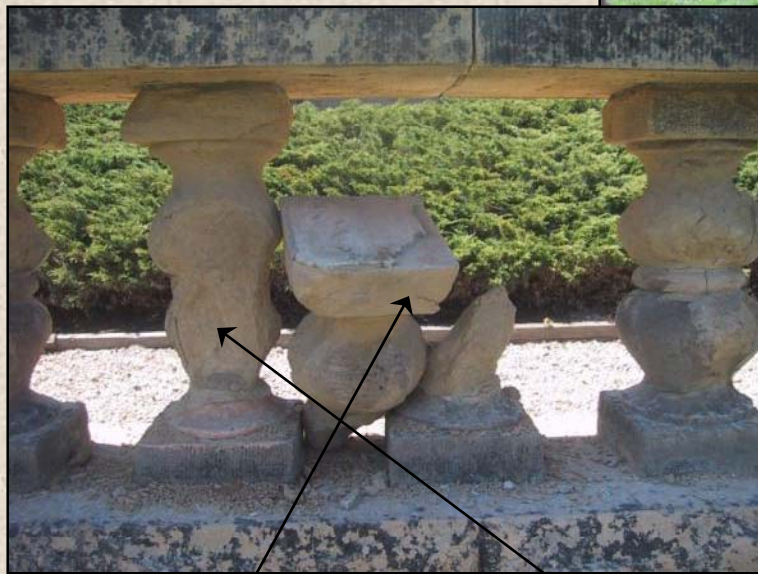
Displacement

Collapse

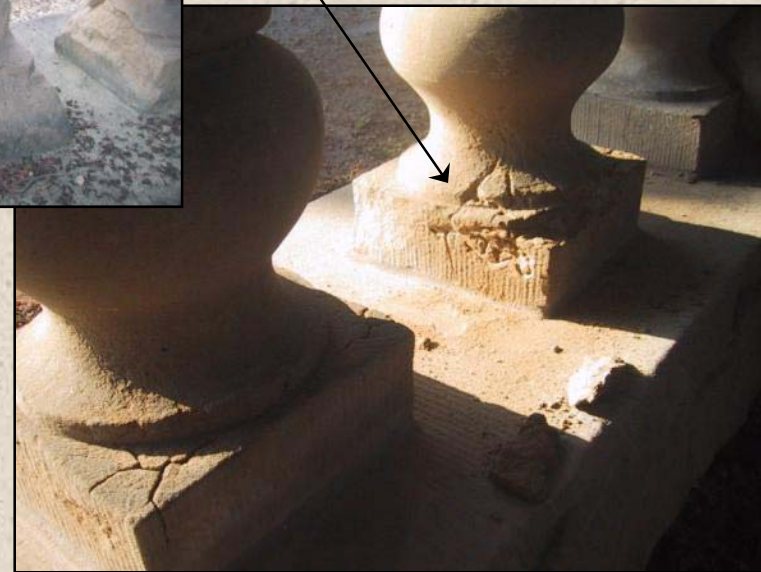
Spalling

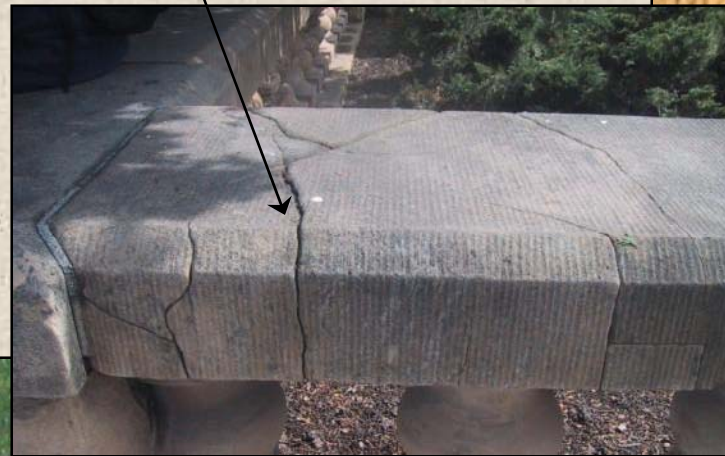
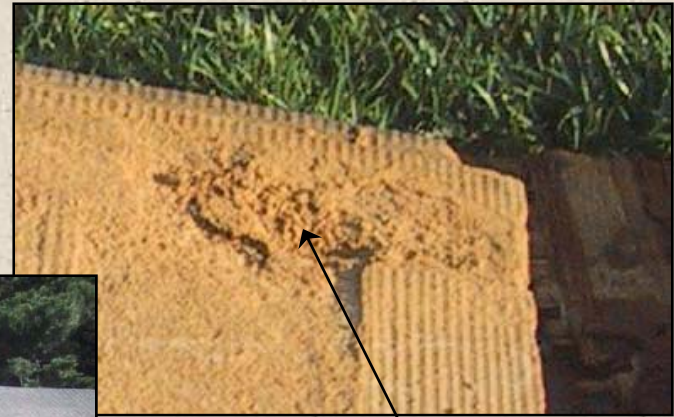
- Top stones

Fissuring

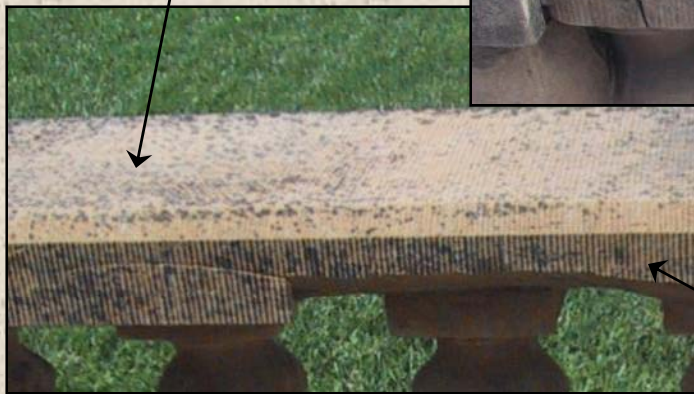
Surface Flaking

Hardening

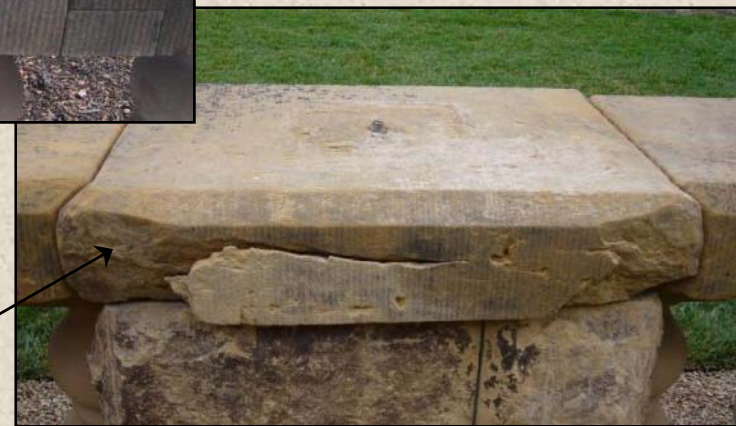
Spalling

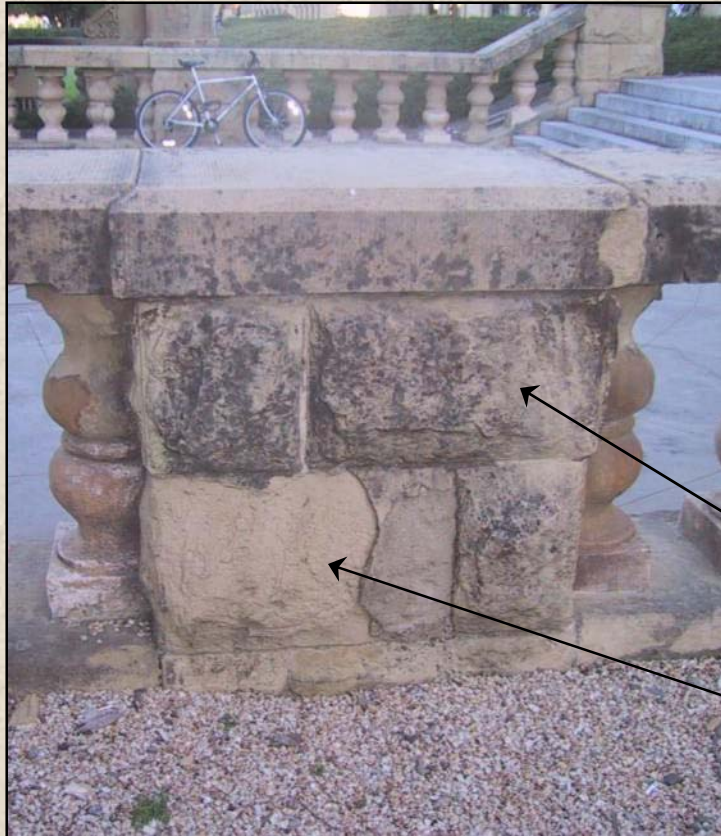
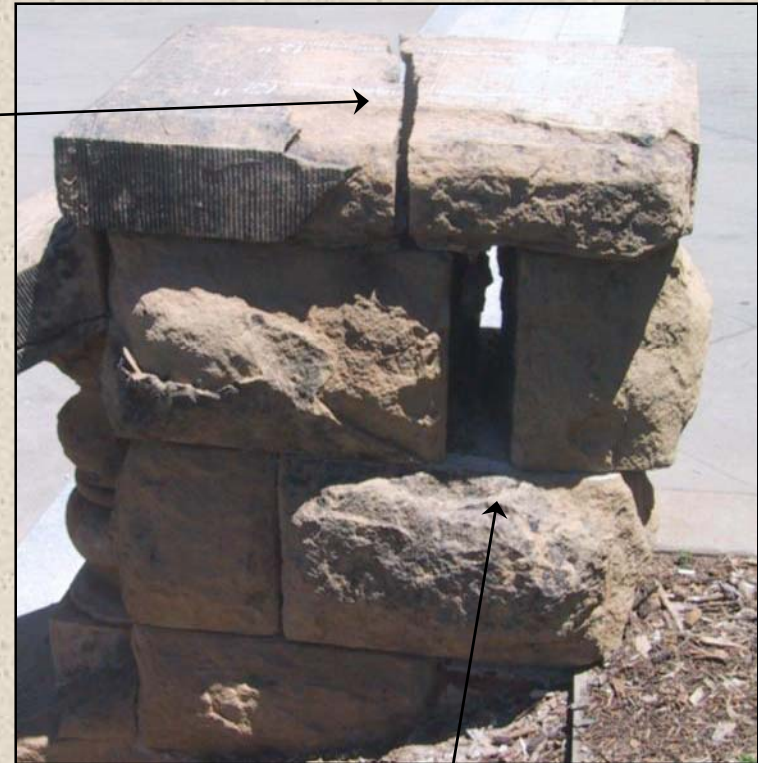
- Walls

Fracturing

Hardening

Spalling

Displacement

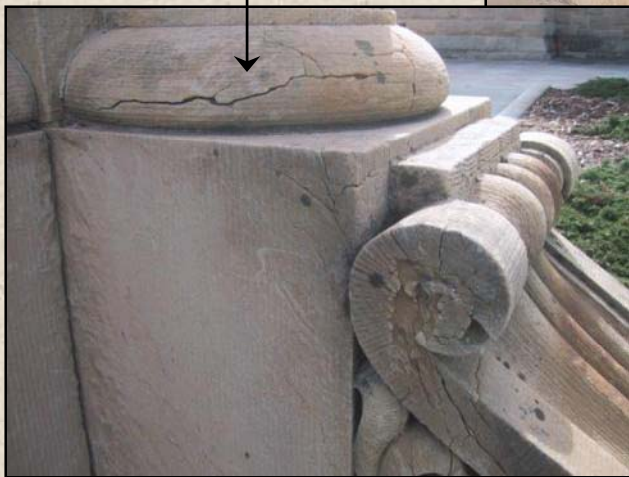
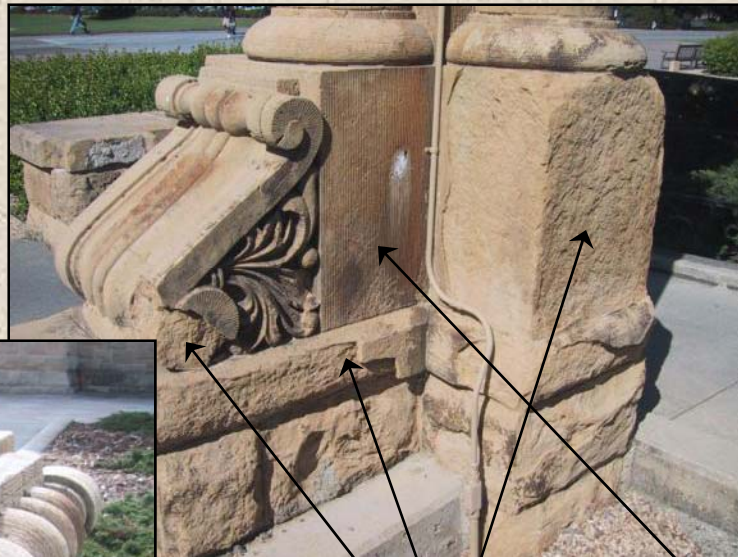
Fissuring

Spalling

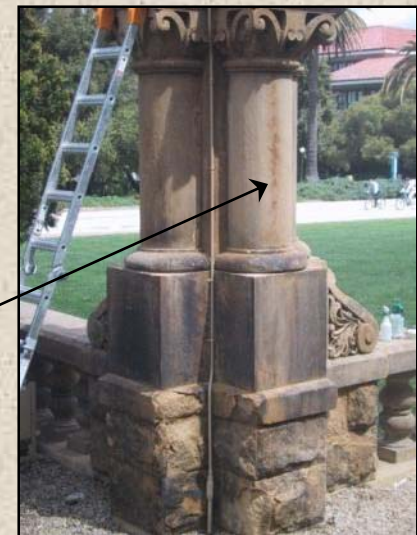
Ferrous Stains

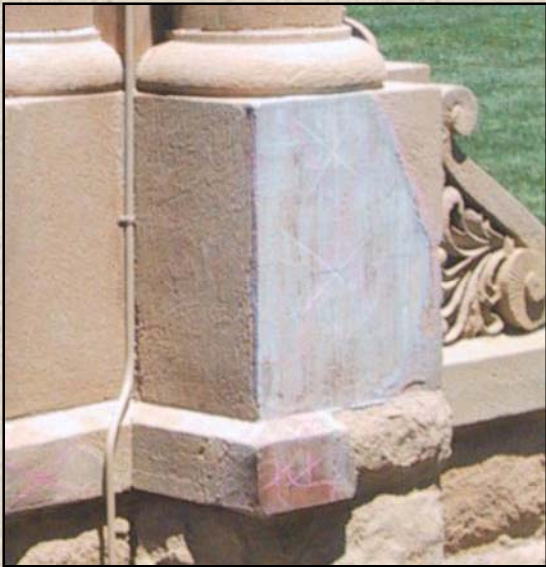
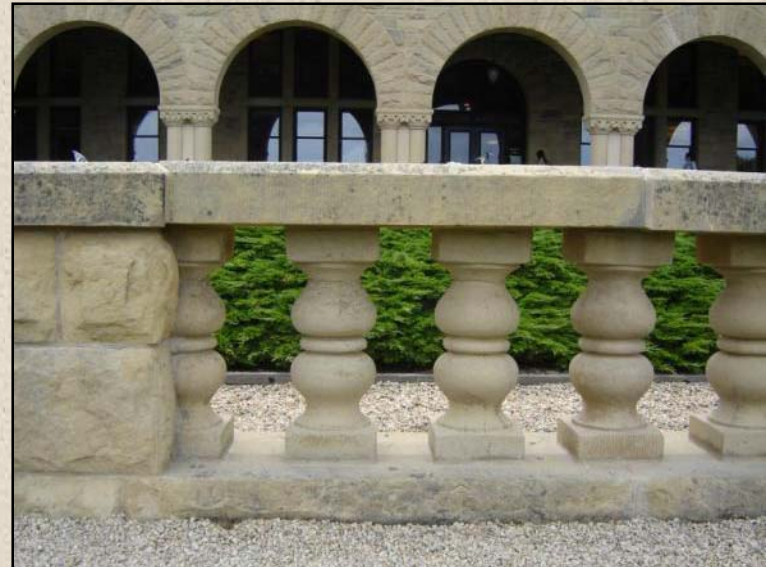
- Concrete patches
- Precast replacement balusters
- Redesigned irrigation and drainage

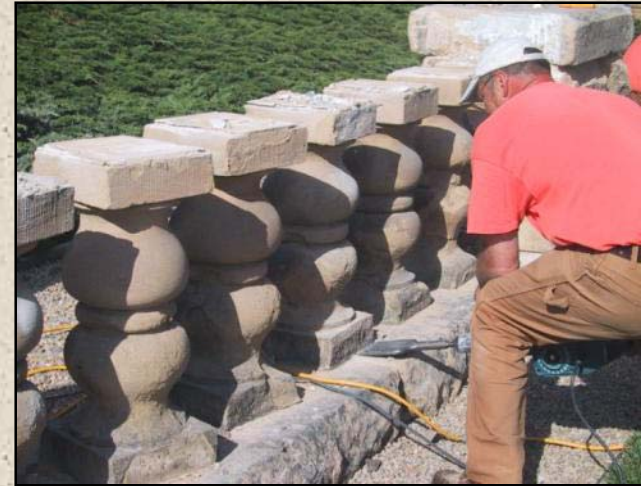
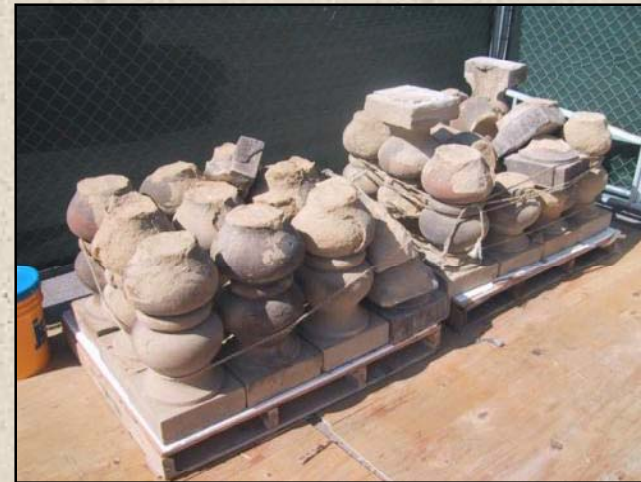
3. Balusters were first loosened (top) and then removed. Upon removal, the extent of decay became apparent, as the bottoms of nearly all the balusters fell off (bottom).
