APPENDIX A
Project Plans

ARB MAJOR REVIEW:

429 UNIVERSITY AVENUE PALO ALTO, CA

REVISION 3B : 11.03.14

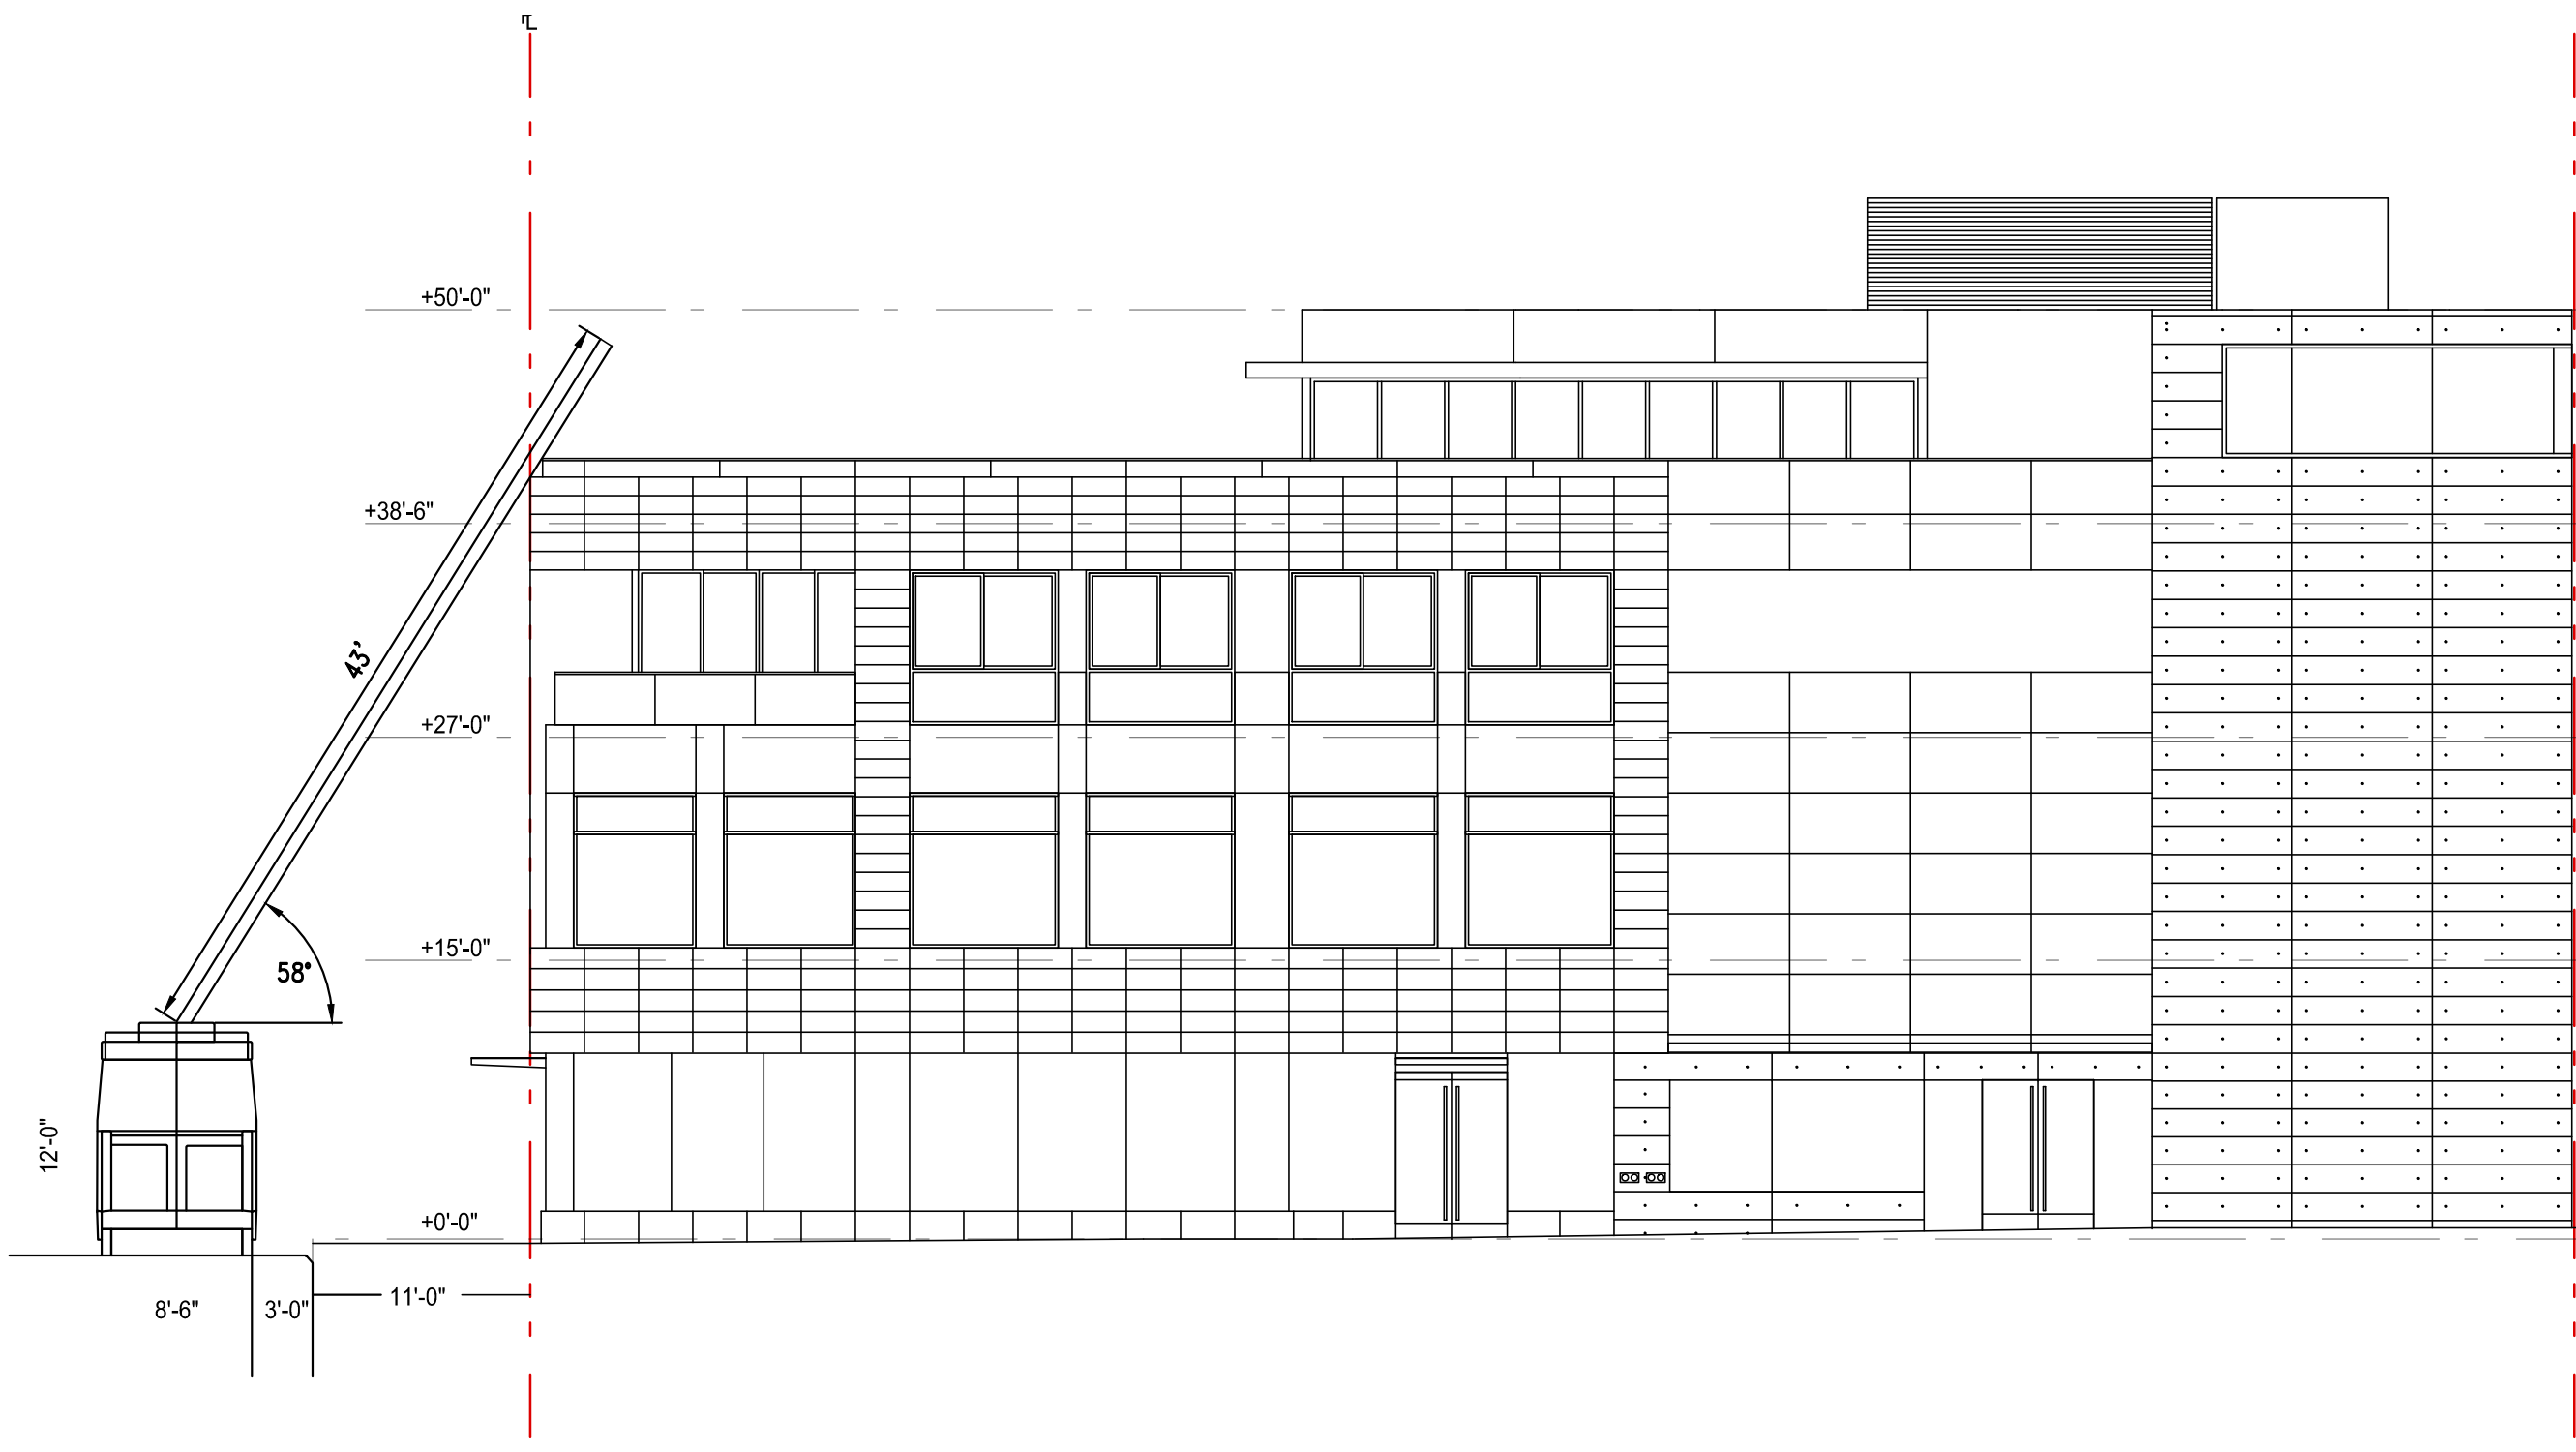
FIRE EXHIBIT: SCALE 1"=10'

CPAFD TRUCK DIMENSIONS

Width	: 8.50 ft
Track	: 8.00 ft
Lock to Lock Time	: 6.0 sec
Steering Angle	: 30.5 ft

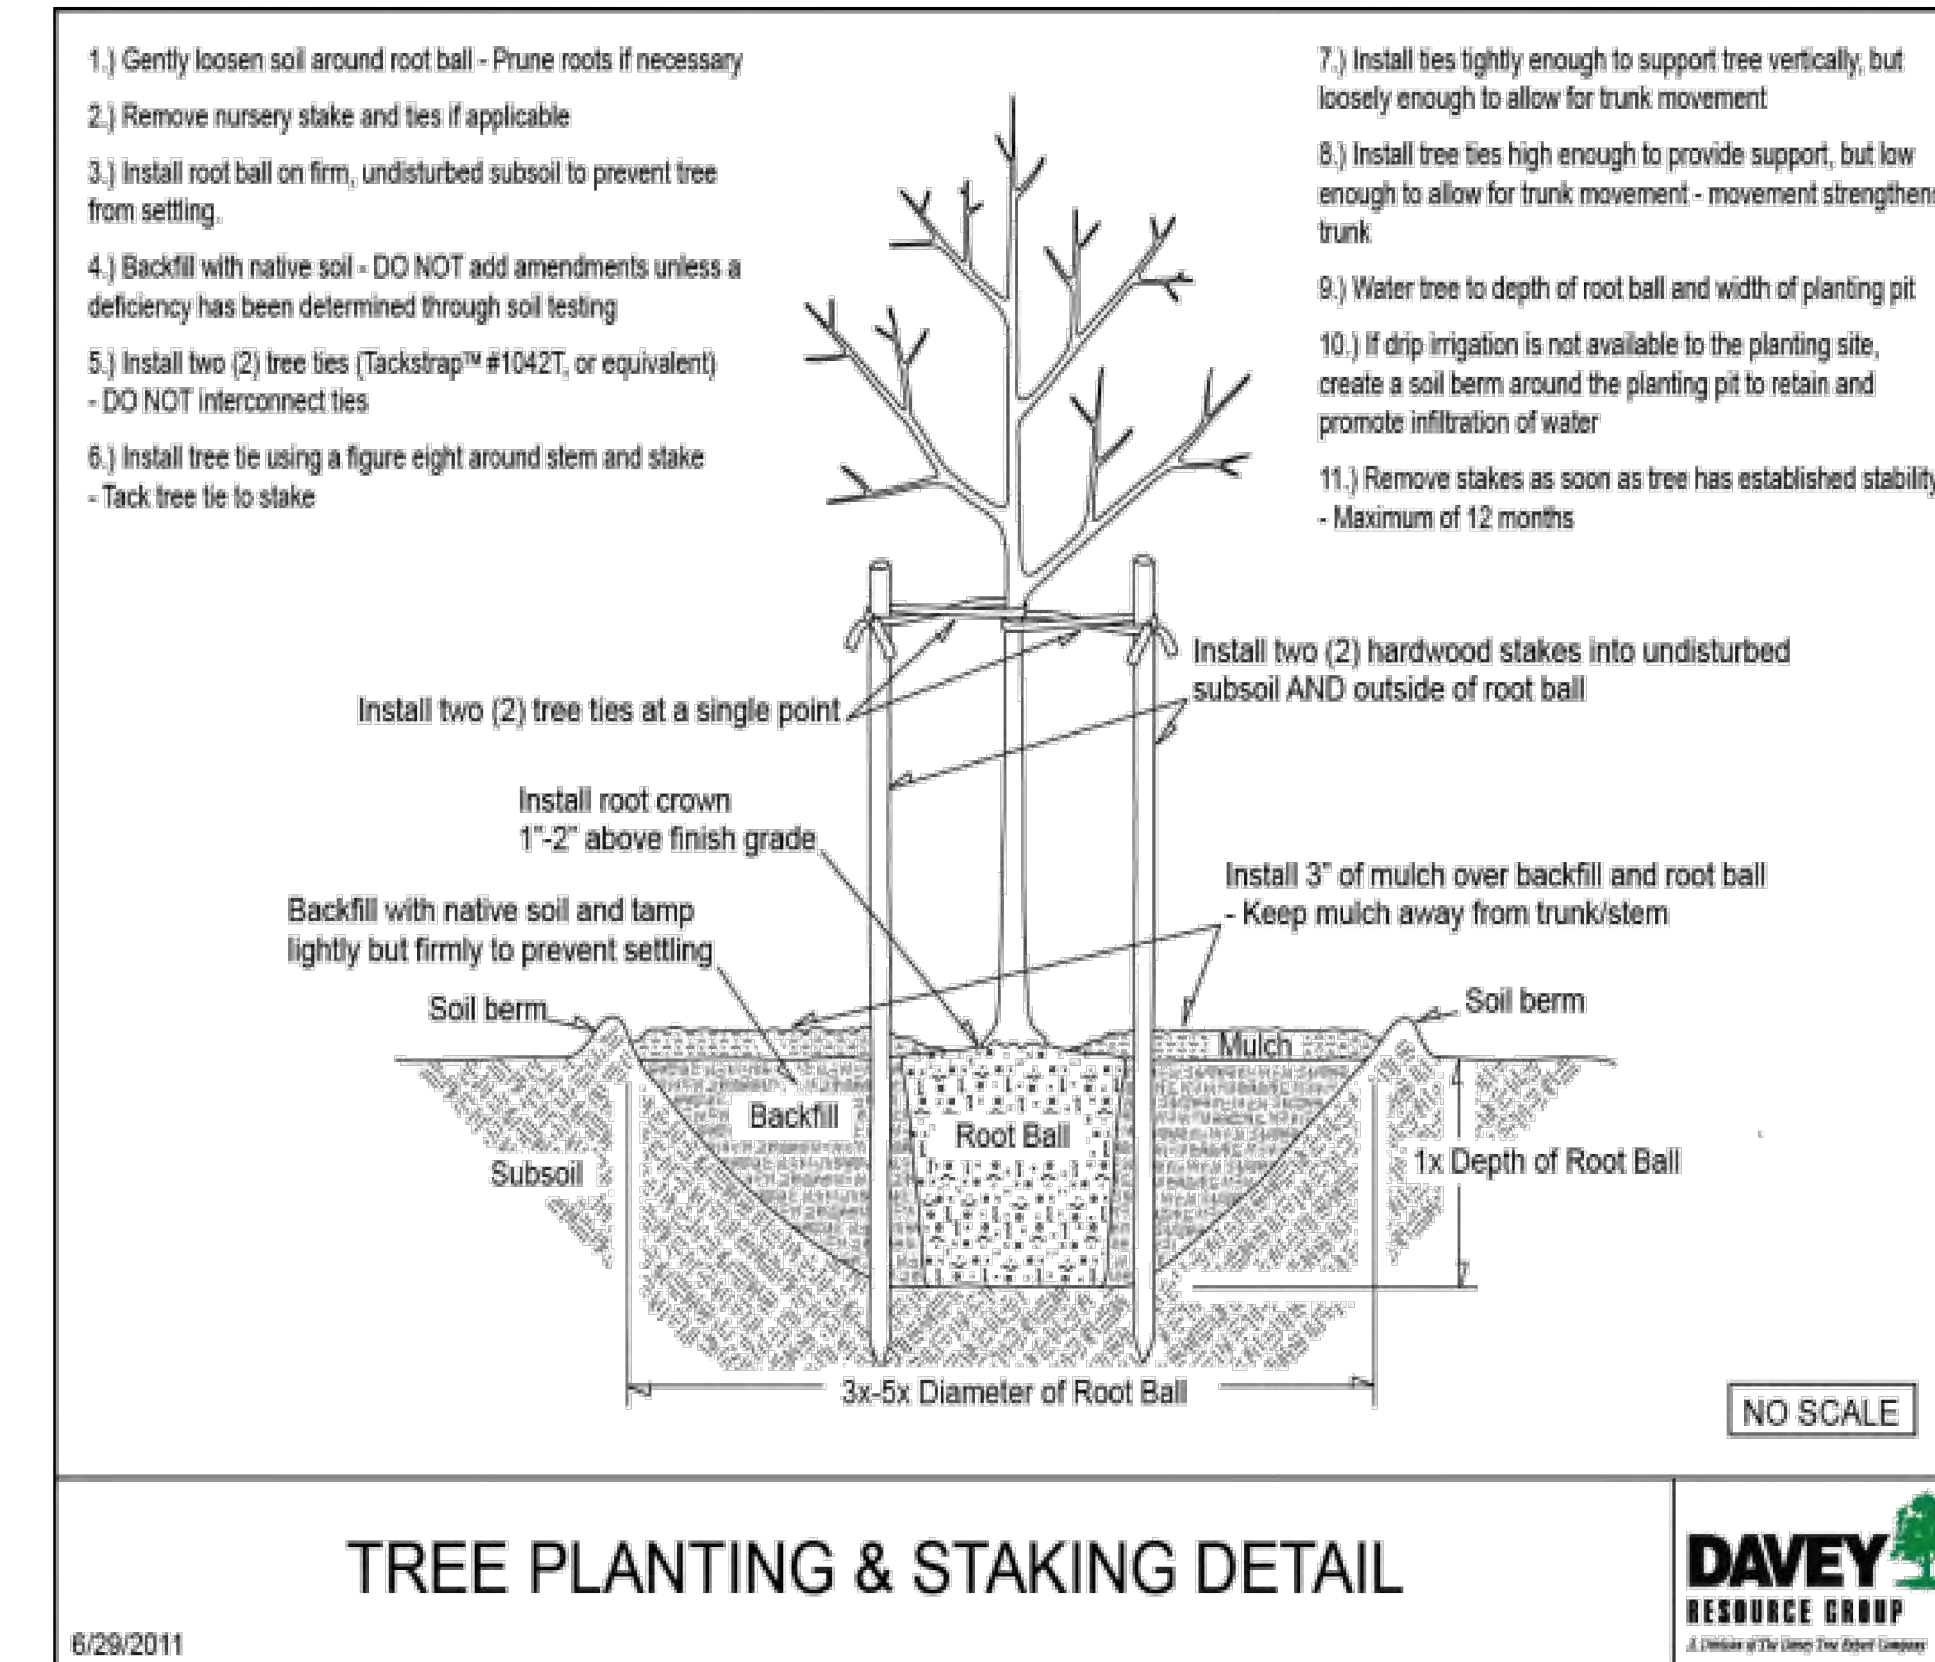
Figure 1: Proper tree planting is critical to establishment

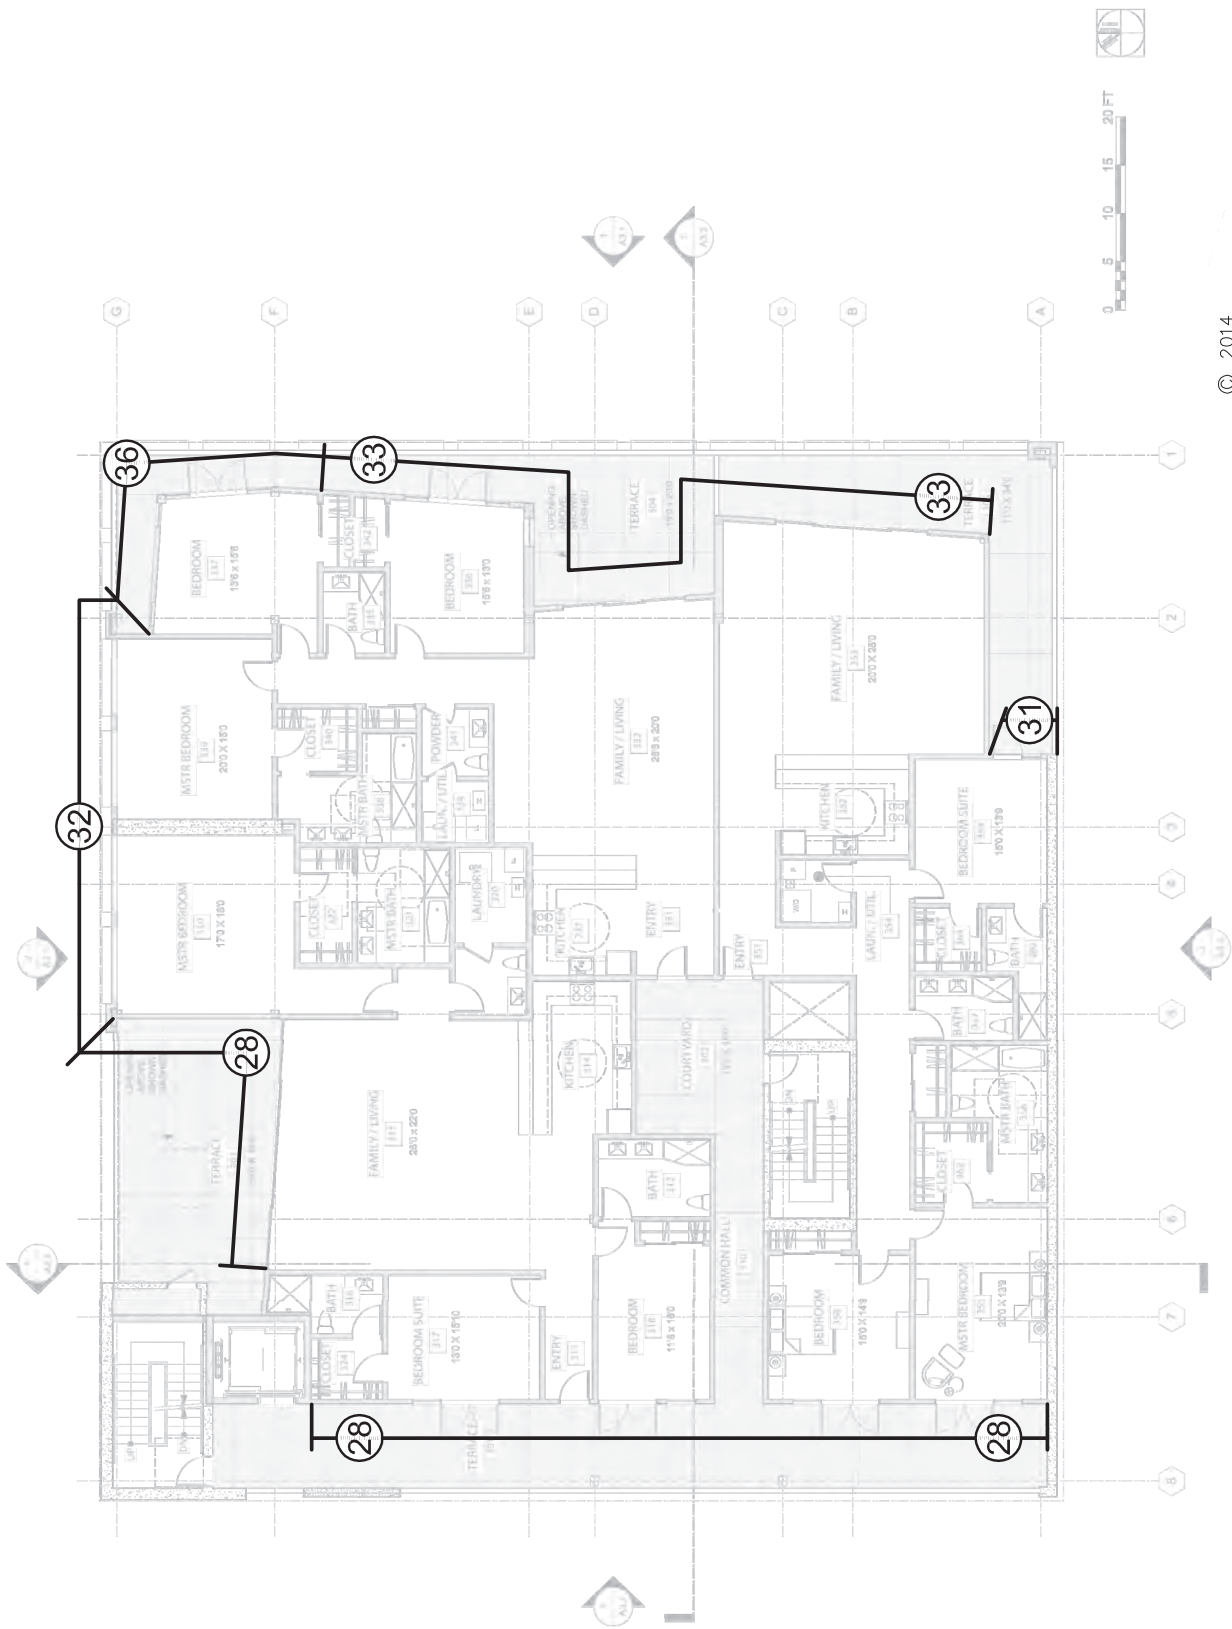
**429 UNIVERSITY AVENUE: MINIMUM RECOMMENDED
 STC RATINGS FOR WINDOWS AND EXTERIOR DOORS
 TO MEET DNL CRITERION (FLOOR 3)**
