Research Questions

Location and Test-Bed Site Layout

Objectives

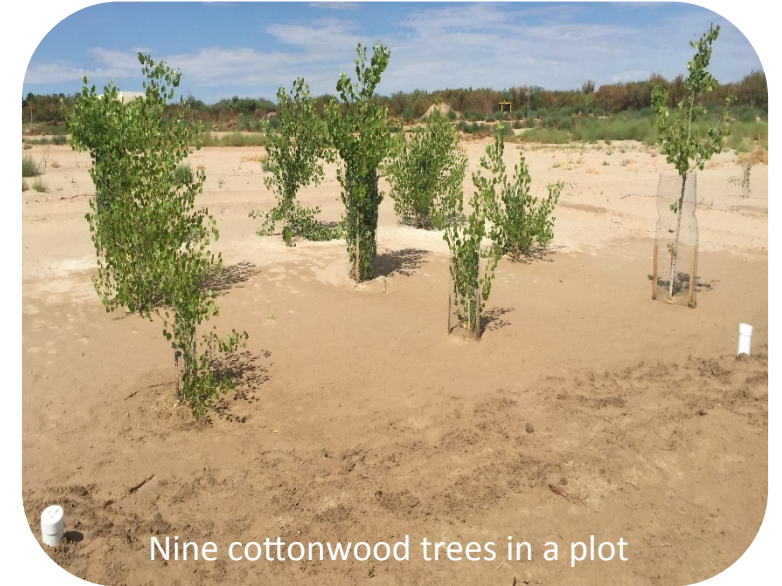
Methodology - Continue

- Collect soil samples to determine the soil type, sodium adsorption ratio, and other soil chemical properties in each test plot
- Install drainage pipes to collect leachate samples after irrigation
- Measure depth to groundwater
- Conduct health assessment of cottonwood trees in the experimental plots on a weekly basis to determine growth and survivability
- Measure water quality of irrigation and the leachate in the drainage pipes

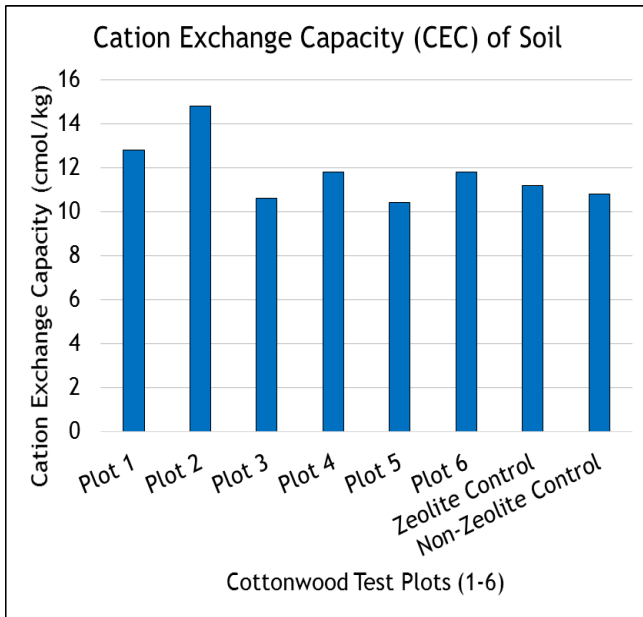
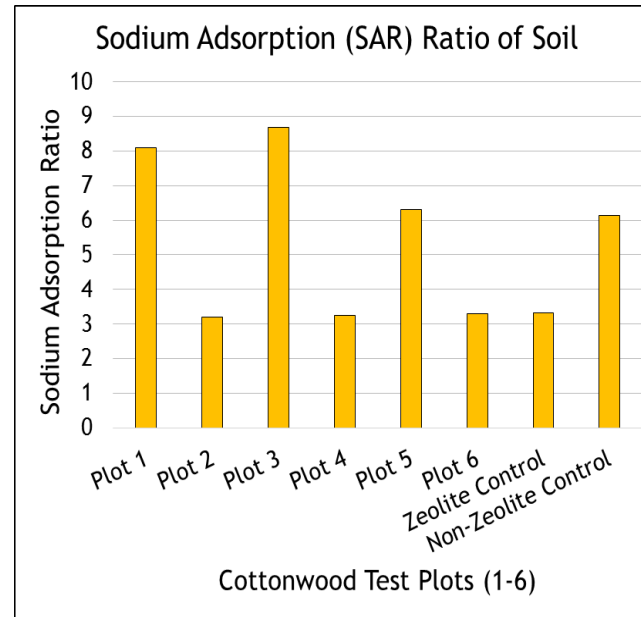
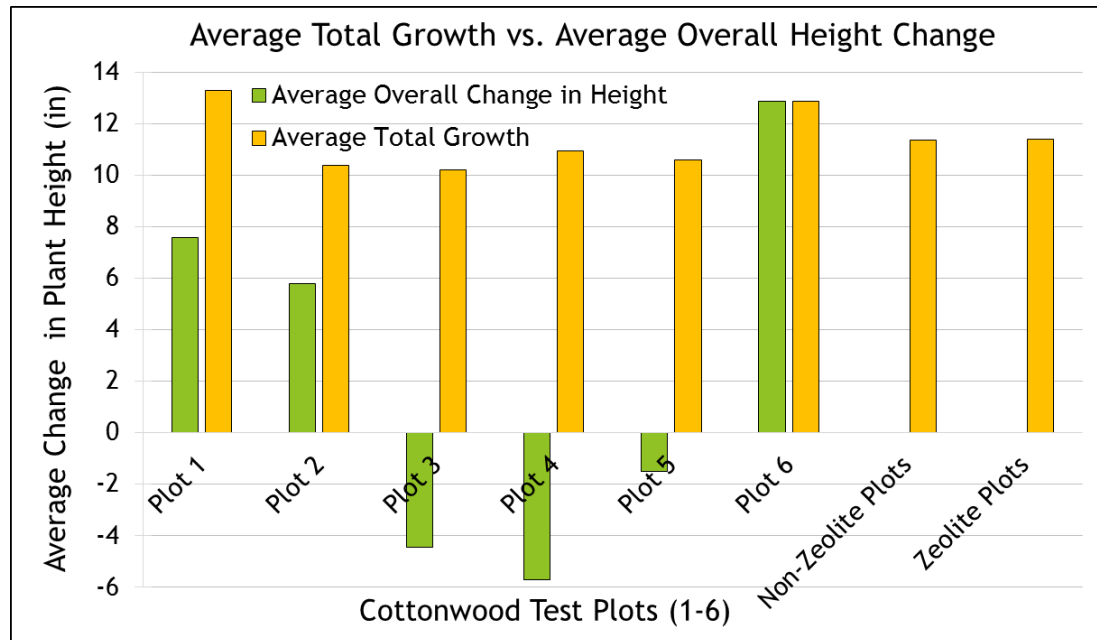
Preliminary Results

Data from plant assessments showed 100% survival rate of cottonwoods in all plots. Damage caused by beavers resulted in a negative average overall change in plant height for plots 3 through 5. Despite this, the average total growth of cottonwoods per plot were similar.

The cation exchange capacity (CEC) of soil saturated paste (soil: distilled water slurry of 1:1) ranged from 10.4 to 14.8 cmol/kg which is typical for sandy and silt loam soils. The sodium adsorption ratio (SAR) for the plots ranged from 3.19 to 8.68. The sodium adsorption ratio (SAR) for the plots were below 13. At a SAR of 13 or above plants can be negatively affected.
