RESTORATION OF RIPARIAN VEGETATION USING GEO-ENGINEERING MATERIAL

Stephanie Almeida¹, Aldo R. Pinon-Villarreal², A. Salim Bawazir² and Nirmala Khandan²
¹ Civil Engineering Department, University of Texas at El Paso
² Civil Engineering Department, New Mexico State University

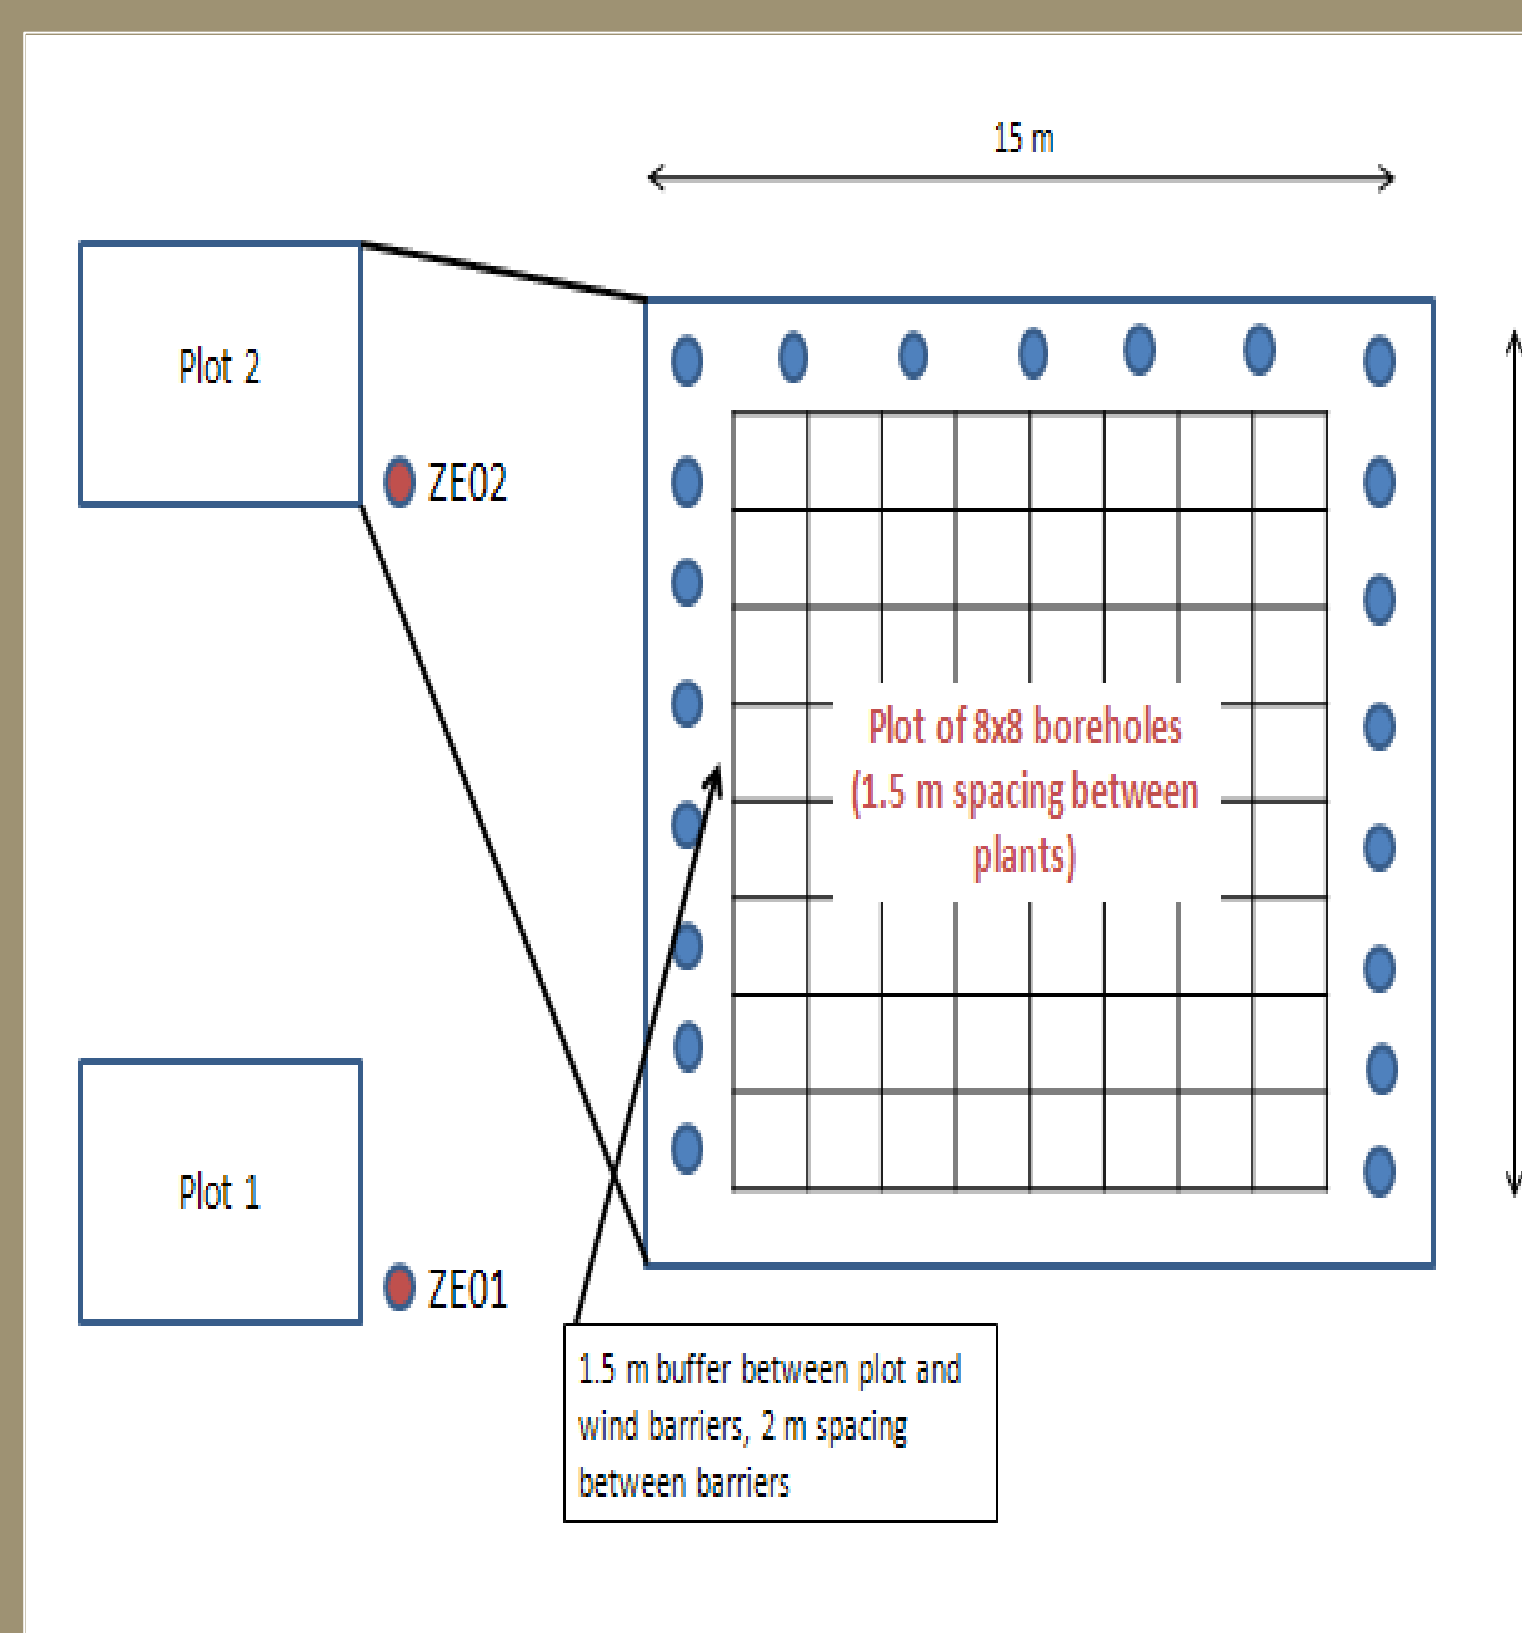
Figure 1. Relative location (not to scale) of the two plots, plant arrangement and groundwater piezometers in the restoration area at the Caballo Test Bed.

The study was located at Caballo test bed site (33° 3'59.64"N, 107°17'13.20"W, Elevation 1288 m a.s.l.). Test bed is located in the riparian zone in the Rio Grande basin between Elephant Butte Reservoir in the north and Caballo Reservoir in the south. Saltcedar growing at the site was removed by US Bureau of Reclamation in 2008 using heavy plowing machinery in an effort to control and manage the spread of Saltcedar in this riparian region. In January of 2012 a total of 104 of CZ boreholes were drilled and installed in two plots at Caballo Test Bed site, NM by a research team from New Mexico State University, Civil Engineering Dept. In March, selected native riparian plants were transplanted in the CZ cores, and control individuals were transplanted in unamended riparian soil (RS). During June and July of 2012, vegetation survival and growth, groundwater levels, water and soil chemistry, soil moisture, and climate data were collected and analyzed to evaluate overall success of the restoration. Figure 1 shows a diagram of the relative location of the two plots and groundwater piezometers within the restoration area as well as the experiment set up. Figure 2 shows a map of New Mexico indicating with arrows were the sites are located and a picture of the north plot (Plot 2). Figure 3 shows the plant arrangement inside the experimental plots. Four plants were selected to be used for restoration in the experimental plots. These plants were Saltgrass (*Distichlis spicata*), Giant sacaton (*Sporobolus wrightii*), Fourwing saltbush (*Atriplex Canescens*), and Emory's baccharis (*Baccharis emoryi*) and are shown in Figures 4 through 7. Figure 8 shows Plot 1 and the weather station located in the plot. The groundwater levels at two piezometers were taken periodically along with groundwater quality analyses during June and July of 2012.

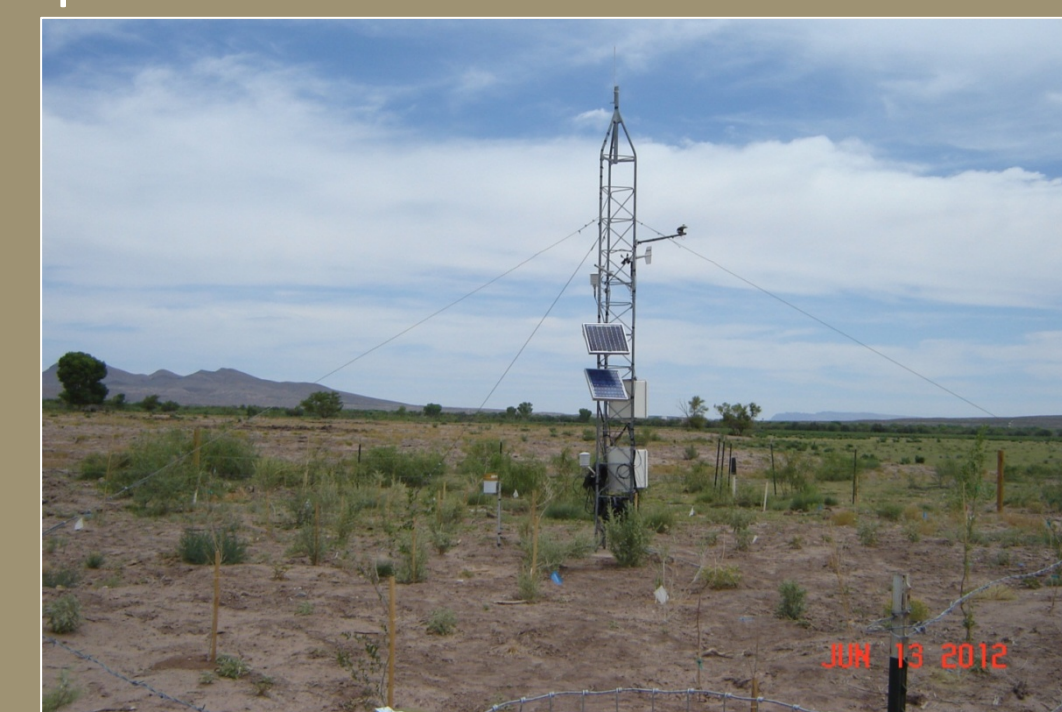
Figure 8. Weather station located in Zeolite-Saltgrass Plot 1

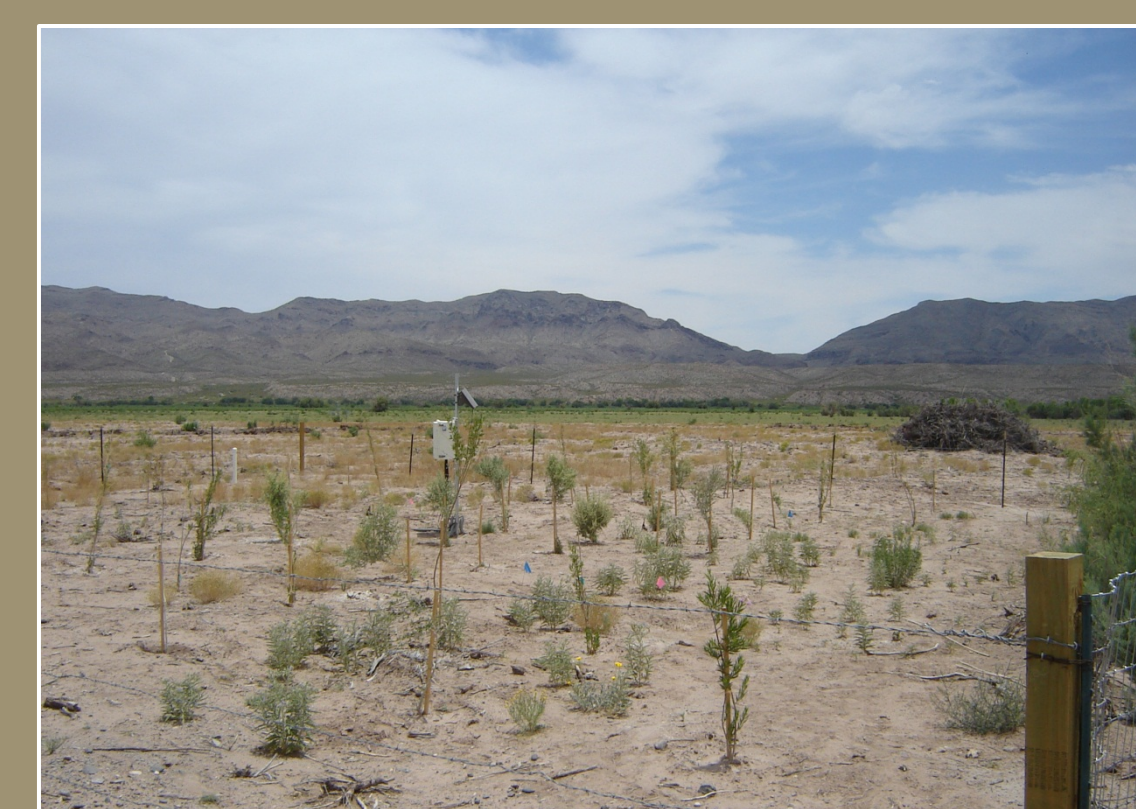
Figure 2. Picture of Plot 2 and a map of New Mexico indicating with arrows the location of the restoration site

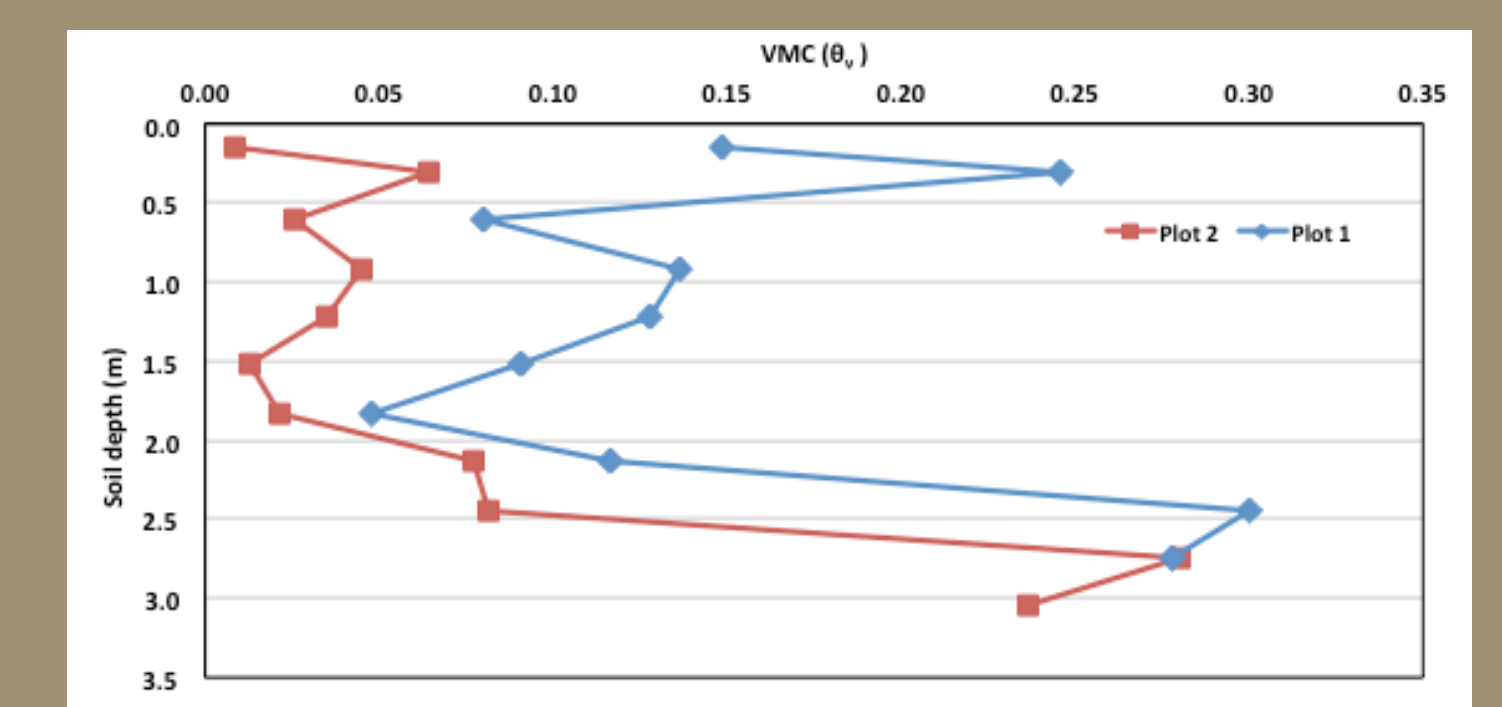
Figure 11. Relationship between soil depth and volumetric moisture content for Plots 1 and 2

- Following preliminary are conclusions from this study:
- In Plot 1, 37.5 % of plants survived in CZ and 50 % survived in RS.
 - In Plot 2, 66 % survived in CZ and 59 % survived in RS
 - The CZ cores at Plot 1 disconnected from groundwater due to drought. This may have caused the plants not to survive.
