# EPA CHEMICAL ACCIDENT INVESTIGATION REPORT

**Accra Pac Group, Inc.  
North Plant  
Elkhart, Indiana**

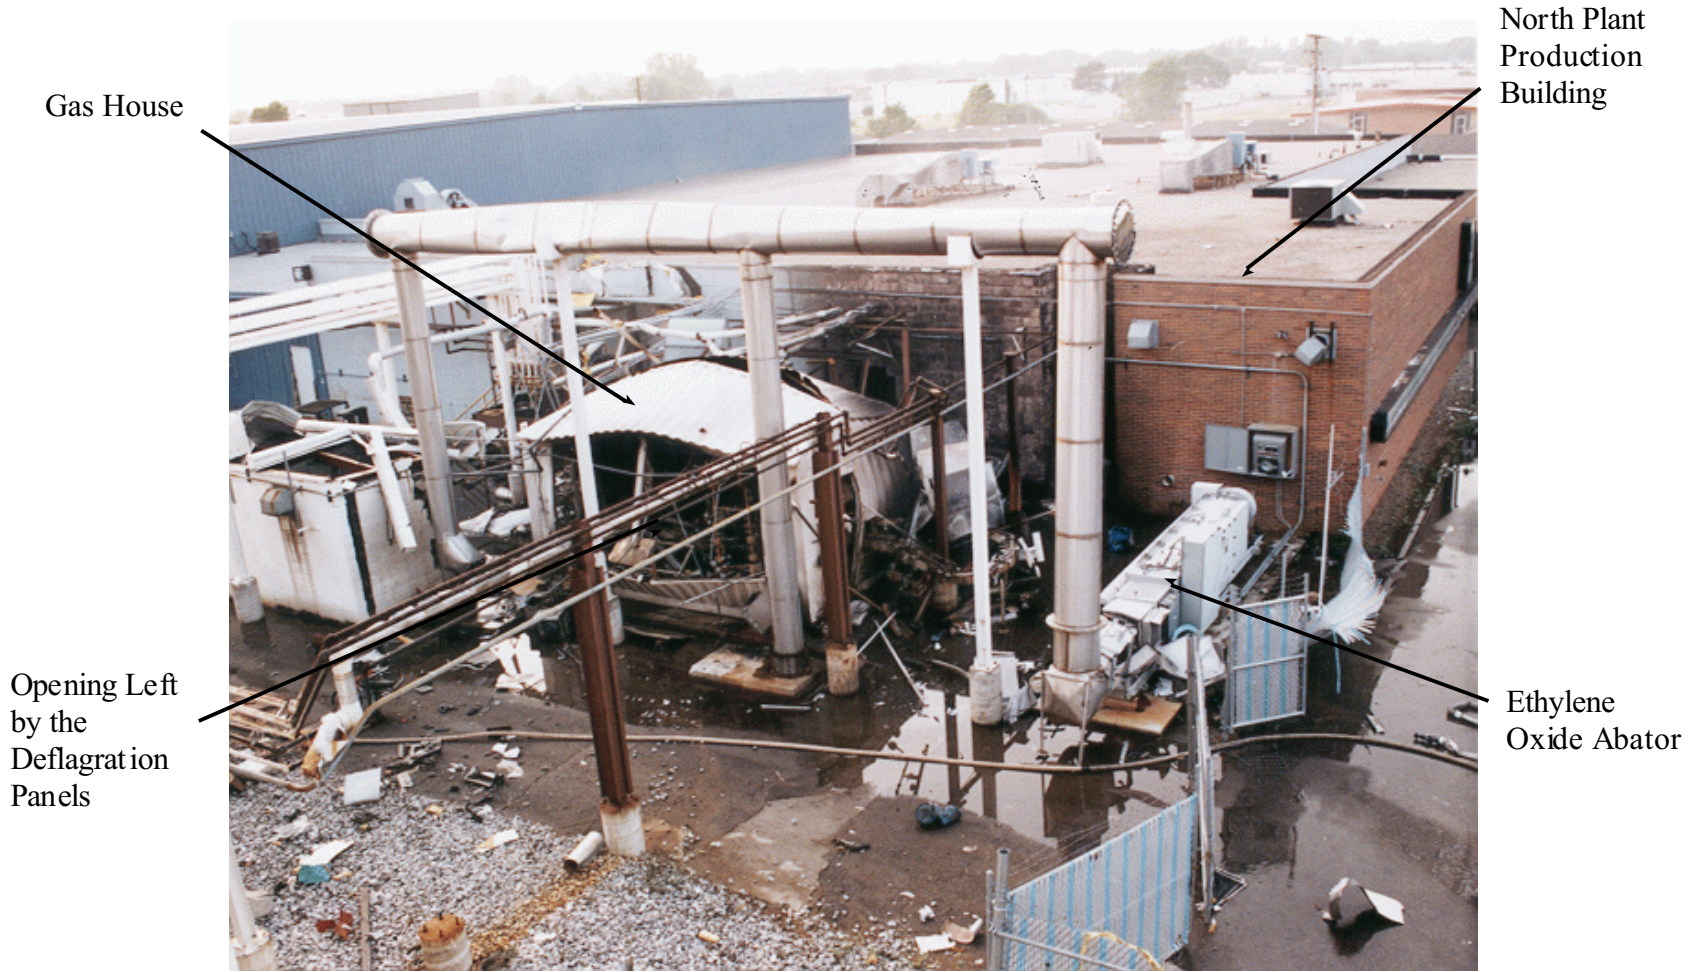
An Accra Pac employee working in the Production Building across from the Gas House was killed as a result of the explosion. When the Gas House doors were blown off, the door facing the Production Building impacted the Production Building door and caused that door and its frame to be dislodged and blown into the Production Building where it struck and killed the employee.

**A-1: The Gas House and the Production Building after the explosion and fire.**

- **Properly locate and provide sufficient barriers between units that have a potential for explosion from other processes in accordance with NFPA 30, 5-3.2.2.** Units that are recognized as hazardous with a potential for explosion should be sufficiently spaced away or provided with blast walls between units such that if an explosion occurs, employees in other locations are not harmed.

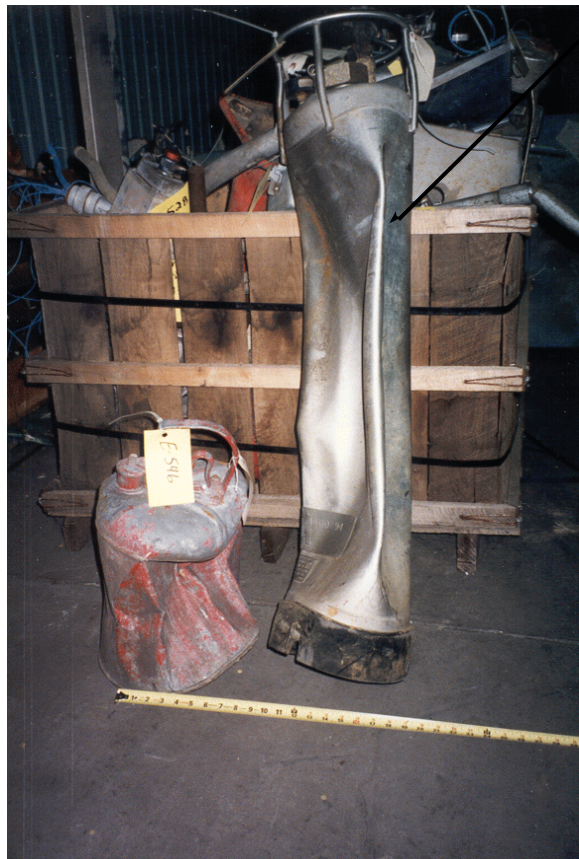
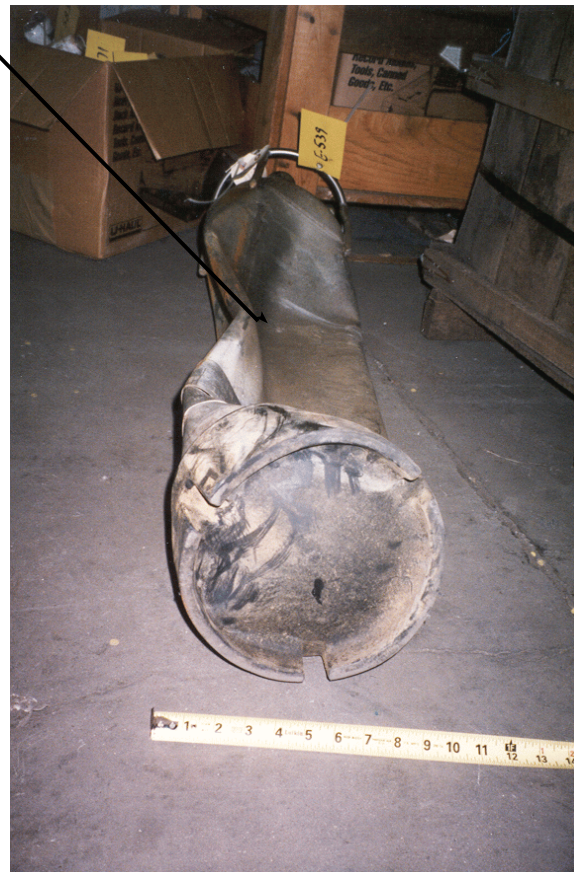
Ethylene Oxide Reclamation Tank

- The ethylene oxide reclamation tank in the Gas House was found to have been crushed by the force of the explosion. (See Appendix A-3) The tank collapsed from three sides leaving almost no void volume. Had the reclamation tank been substantially full of liquid, which is not compressible, the reclamation tank would not have become crushed in the explosion. The reclamation tank showed no signs of puncture or rupture. Thus, any release of ethylene oxide would have had to have occurred in the connectors, valves, or tubing associated with the reclamation tank.

**A-3: Side and bottom view of the ethylene oxide reclamation tank after the explosion and fire.**

- **Relocate the reclamation tank to a location outside the Gas House to reduce the amount of hazardous material inside the occupied building.** In the event of a tank leak, this would reduce the likelihood of injury to the occupant of the Gas House. Also, **develop a way to monitor the quantity of material in the reclamation tank.** This capability is necessary to avoid overfilling which can lead to an accidental release. Finally, **install a non-return check valve on the reclamation tank.** This would minimize any release should the feed line or any connectors leading to the reclamation tank fail.
