EPA/OSHA JOINT CHEMICAL ACCIDENT INVESTIGATION REPORT

**BPS, Inc.
West Helena, Arkansas**

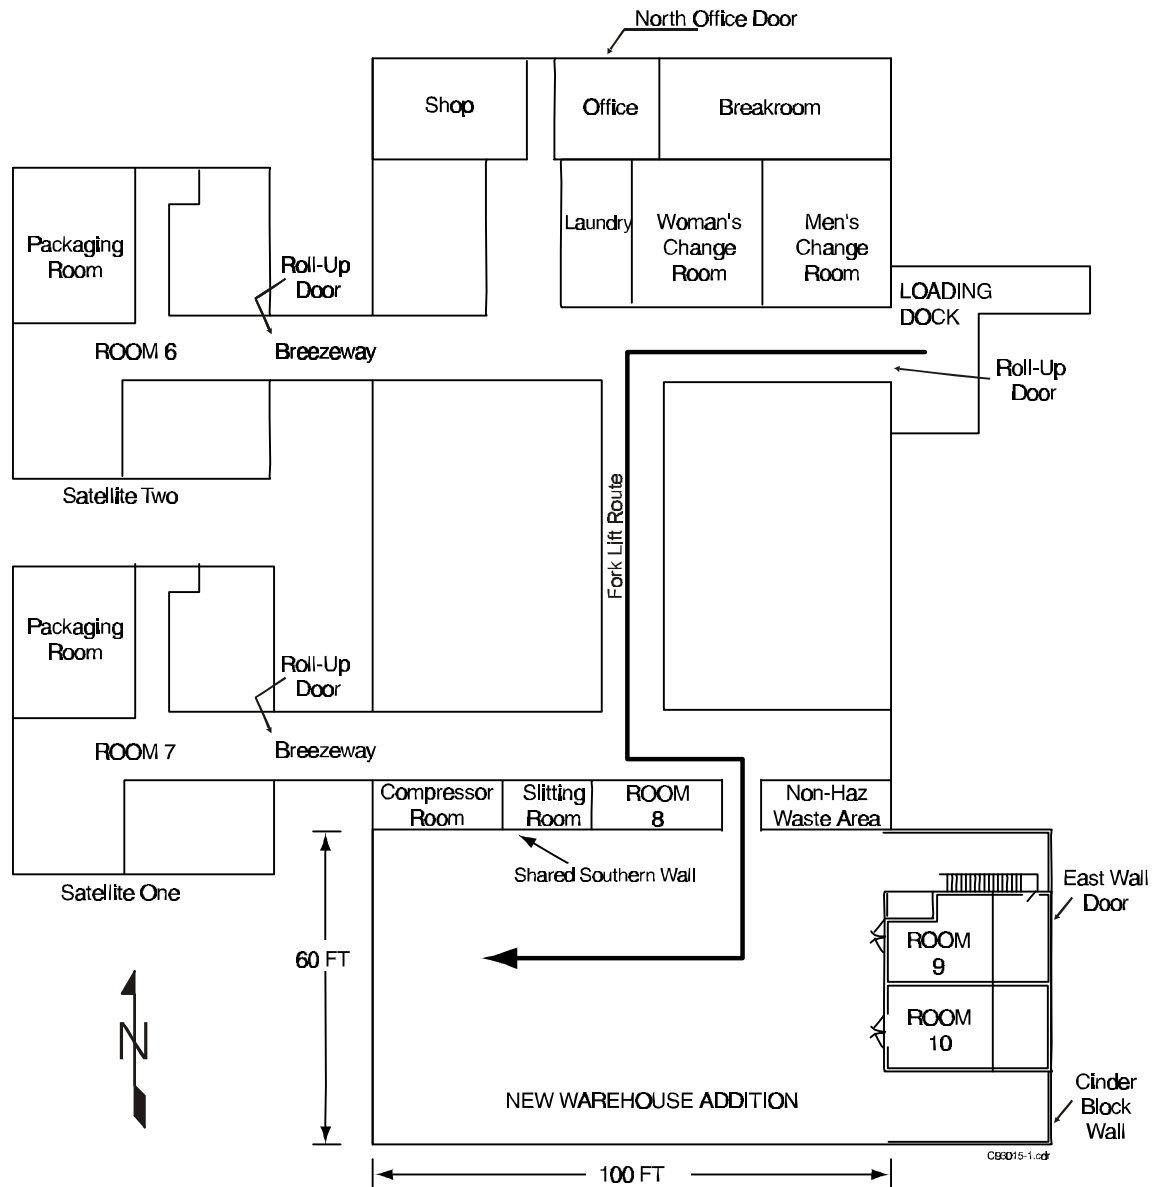
FIGURE 1: FLOOR PLAN - BPS, INC. UNIT #2

The West Helena facility employs approximately 130 workers. At the time of the incident 65 employees were on duty. The facility consists of two production buildings (referred as units One and Two), two satellite buildings, and a Agel@building. The production buildings are constructed of corrugated metal with steel reinforcement. The Unit Two building (Figure 1),

in which the incident occurred, had a 100' x 150' main area, a 16' x 34' loading dock, and two 50' x 60' satellite buildings connected to the main area by breezeways. In October 1995, a warehouse addition was added to the Unit Two building. It shared the southern wall of the original building (referred to as the new warehouse addition north wall). The addition was approximately 7800 square feet. It was also constructed of corrugated metal with the exception of the outside eastern wall. This particular area had two stories with an exterior (eastern) wall constructed of cinder blocks.

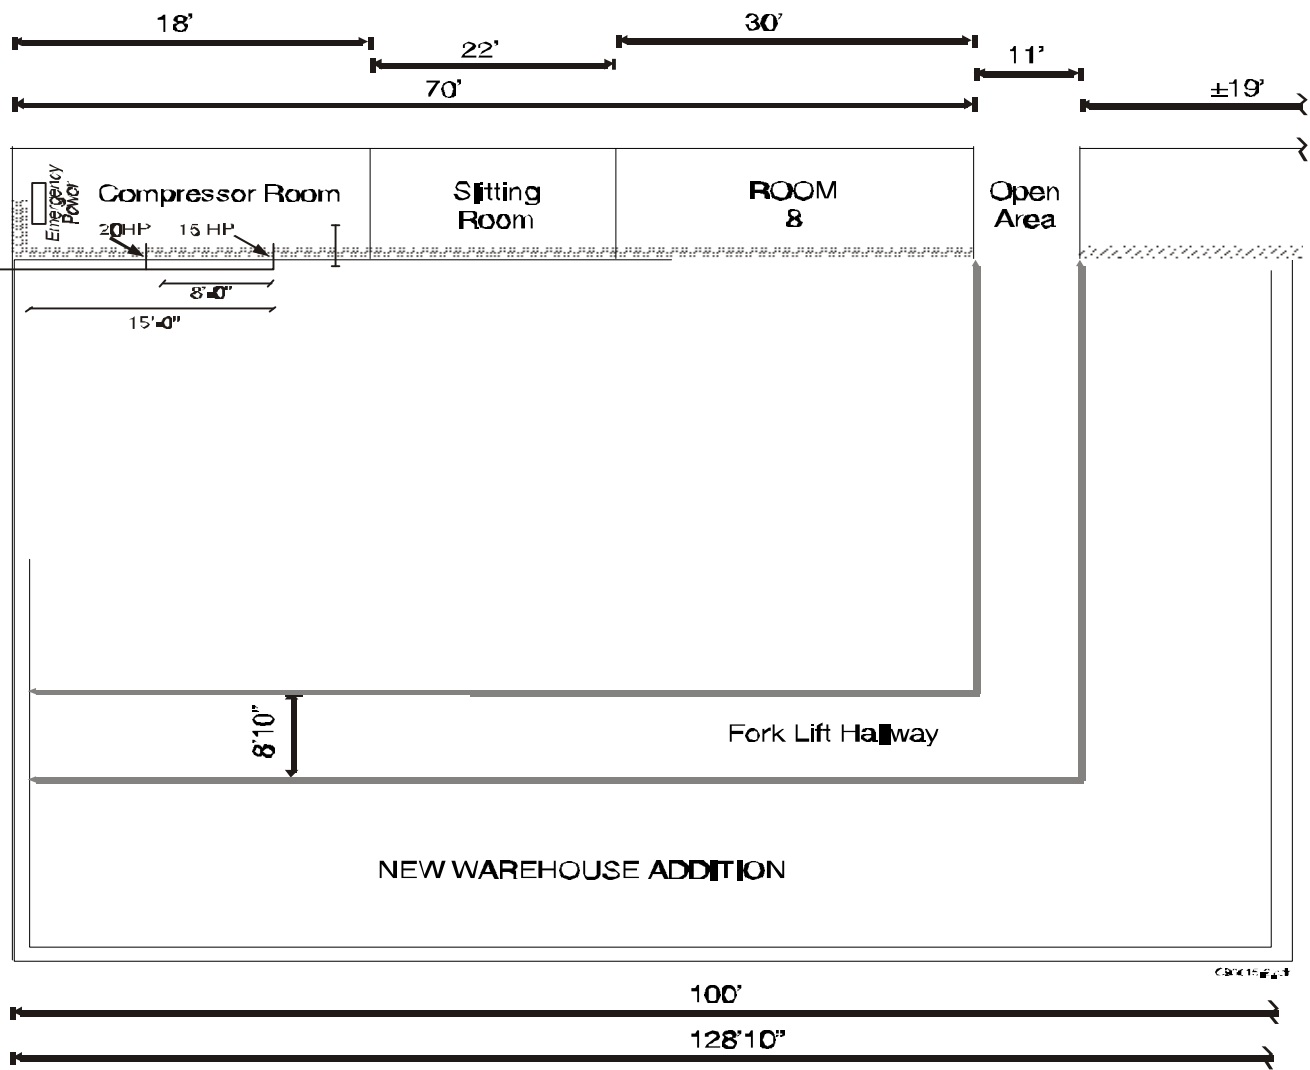
FIGURE 2: NEW WAREHOUSE ADDITION COMPRESSOR SYSTEM

Repackaging operations in the Unit Two building required the use of two reciprocating air compressors. The compressors were located in the southern portion of the original building. The compressors' discharge pipes went through the new warehouse addition's north wall into a common header pipe (Figure 2). This header pipe was fifteen feet long and 5'11" from the concrete pad floor. It ran parallel to the north wall to meet an after-cooler outside the new addition's west wall. The output from the after-cooler was piped back along the same wall 3'7" from the concrete floor carrying the cooled air back to the accumulator tanks under each compressor (Figures 3 and 4).

Two multistage reciprocating air compressors were used in the Unit Two building. As stated previously, these compressors discharged into a common header pipe that was located on the warehouse side of the wall, approximately five feet above the deck. This header was 15 feet long and led to an after-cooler outside the building. The 15-hp unit suffered substantial damage during the incident. After the explosion, this unit was found lying on its side with no lubricating oil in the crankcase. The concrete foundation by the compressor had substantial heat damage and spalling in a configuration that suggested a liquid had burned on the surface. The 20-hp unit had only moderate damage, remained in its upright position after the event, and had a substantial amount of oil in the crankcase.

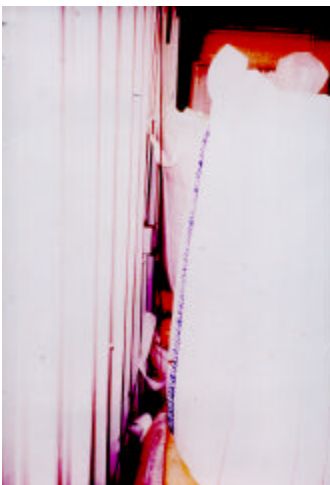
Figure 5. Supersack set-up at BPS Unit One

Shortly after the incident, BPS employees and management identified the decomposing material as an AZM supersack placed against or close to the hot compressor discharge pipe. The JCAIT confirmed that supersacks of materials were being spotted in close proximity or against walls at BPS. After the incident, JCAIT observed supersacks spotted along the wall in the Unit One warehouse. In this case, the supersacks were stacked two-high. The edge of the bottom supersack was within inches of the wall. The top supersack was listing so that it was in contact with the wall (Figure 5).

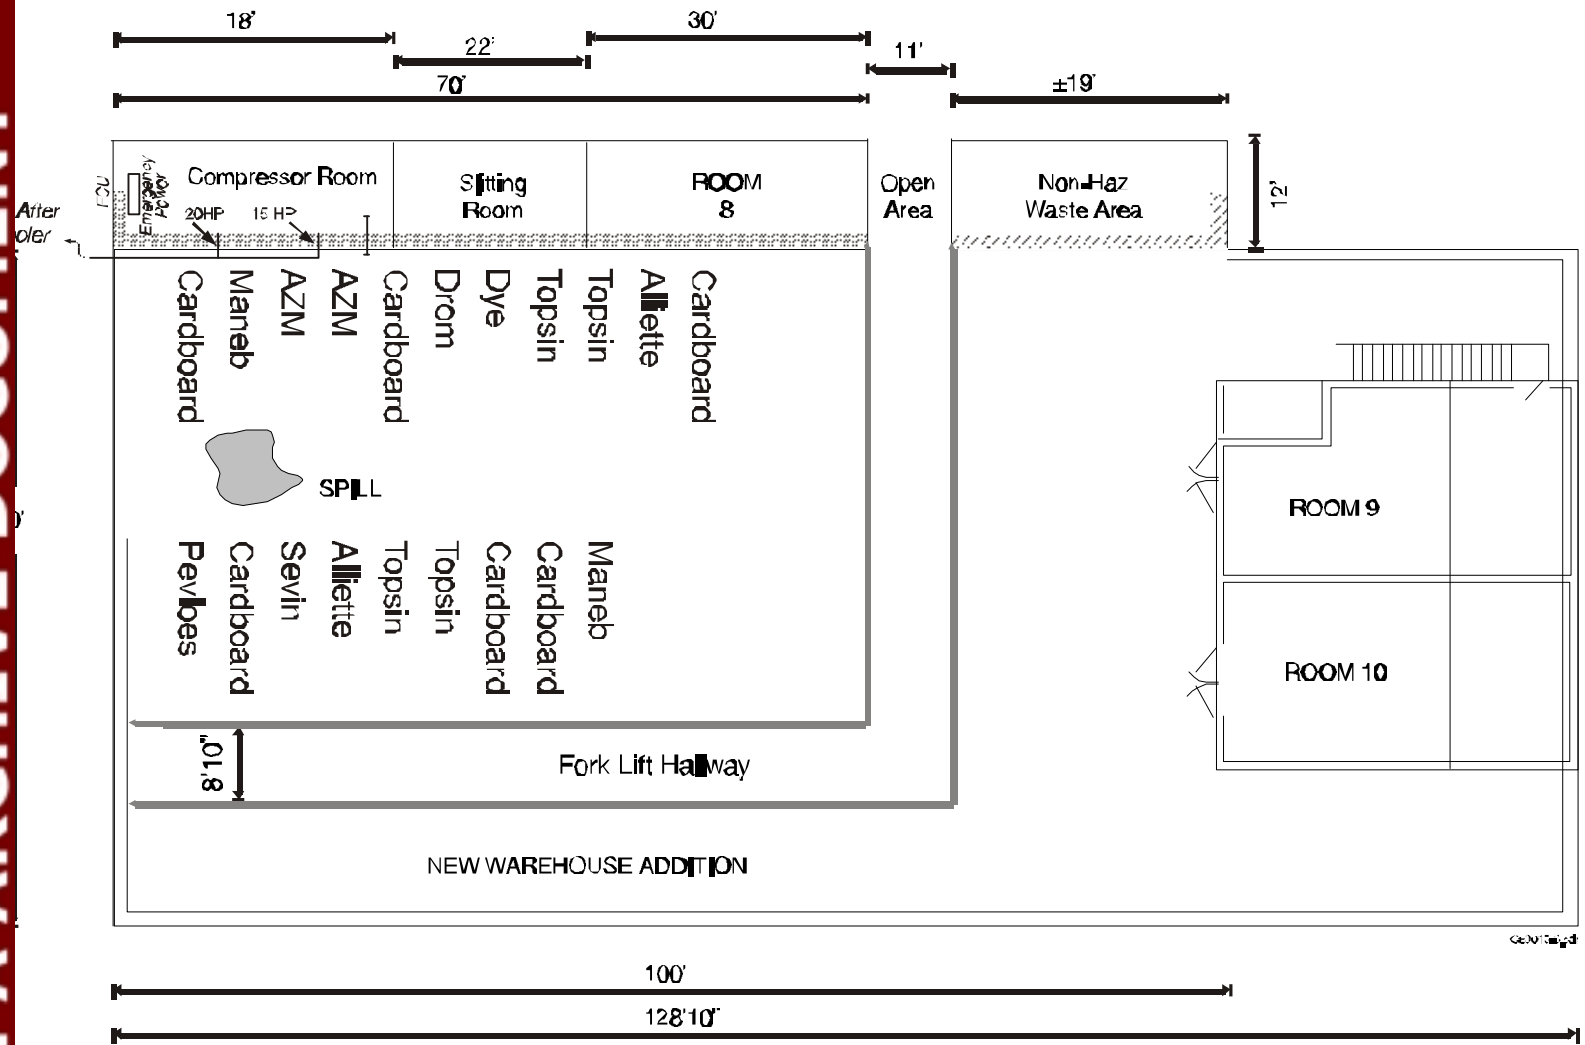
FIGURE 7: APPROXIMATE LOCATION OF CHEMICALS IN THE NEW WAREHOUSE ADDITION.

Based on witness interviews, the JCAIT identified the approximate location of the chemicals in the warehouse area (Figure 7). Even though witness accounts are somewhat conflicting regarding the quantity and approximate location of the stored chemicals, most statements agree that AZM supersacks had just been placed next to the compressor piping. Witnesses also agree that the yellow smoke or powder was coming from this location. Forklift operators recollect placing Maneb pallets by the compressor pipe in an attempt to make room for the incoming AZM. In addition to the witness statements the JCAIT:

- \$ Screened the bulk residue samples for various pesticides including AZM, Maneb, Topsin, and Sevin. Only semi-quantitative values of AZM and Maneb were reported.
- \$ Secured and analyzed the remains of the new warehouse addition ventilation fans which had visible yellow residue (Figure 8). AZM and its major decomposition products were confirmed.

The JCAIT concluded that it was highly probable that pallets of both AZM and Maneb were placed along the compressor pipe the day of the event.

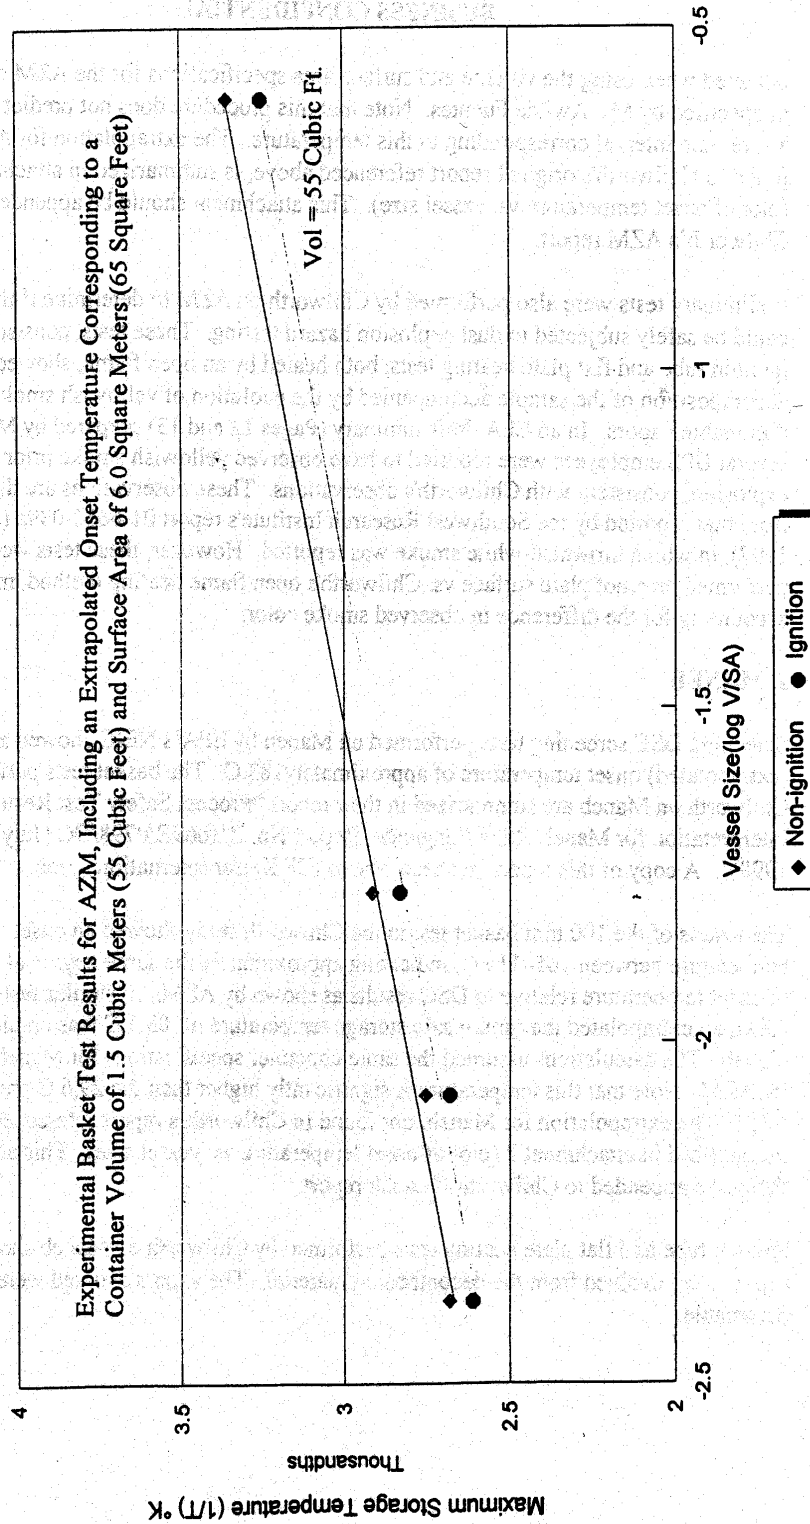
Differential Scanning Calorimetry Results
Root Cause Investigation of Explosion at Bartlo Packaging South, Inc.
NEIC Project SPOO30

- \$ A basket test to determine safe storage temperatures for bulk AZM 50W showed decomposition of the sample beginning between 158⁰-176⁰ F (70⁰-80⁰ C). The decomposition temperature corresponds to an estimated safe storage temperature of 79⁰ F (26⁰ C), using a 10% safety factor, based on volume and surface area specifications for supersacks provided by MFC. It should be noted that the test does not predict a safe time interval corresponding to this temperature.
