**Technical Report  
Marine Archaeological Documentation and Assessment**

**New Bedford Harbor Superfund Site  
Unanticipated Shipwreck Discovery  
Acushnet River  
Acushnet, Massachusetts**

September 2010

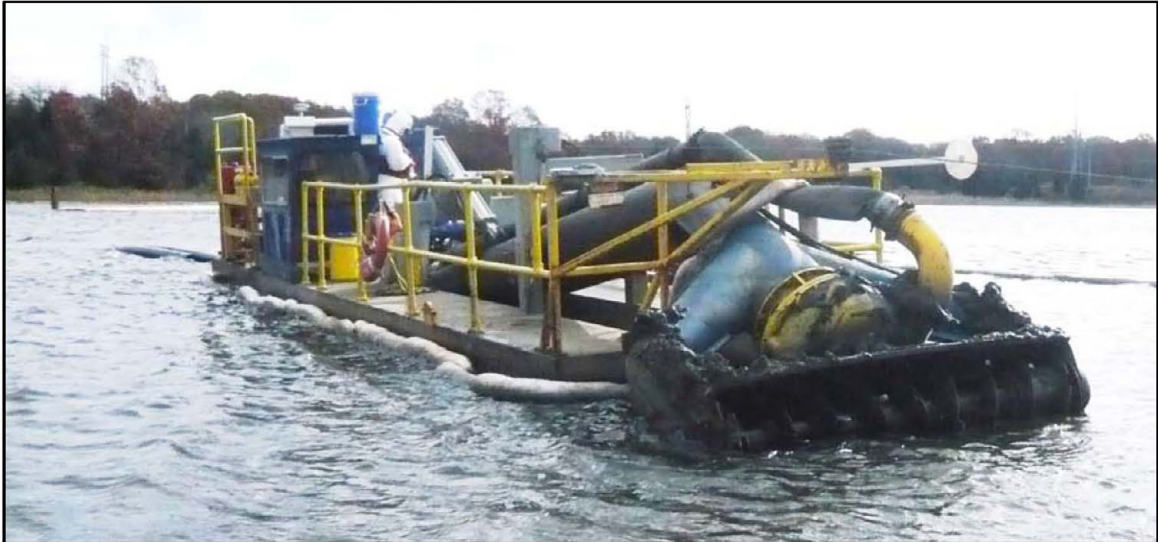
**Figure 1-3. NBHSS hazardous sediments dredging barge. Note the horizontal auger-like dredge-head at the barge's bow (photograph by David Robinson).**

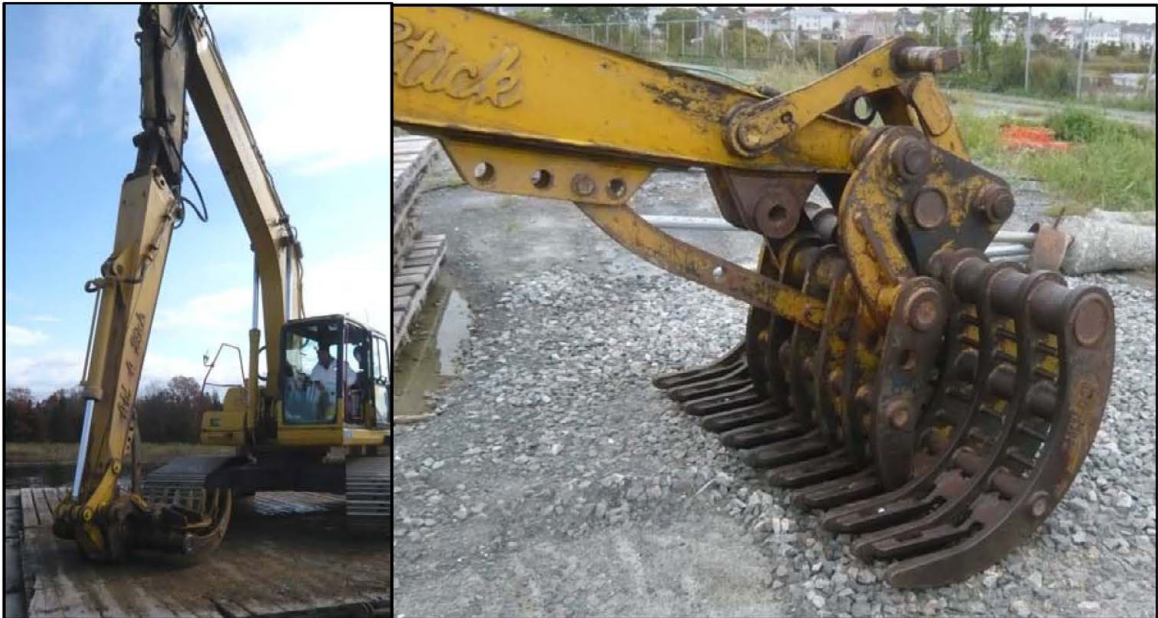
**Figure 1-4. NBHSS debris removal machine equipped with "grabber" attachment (photographs by David Robinson).**

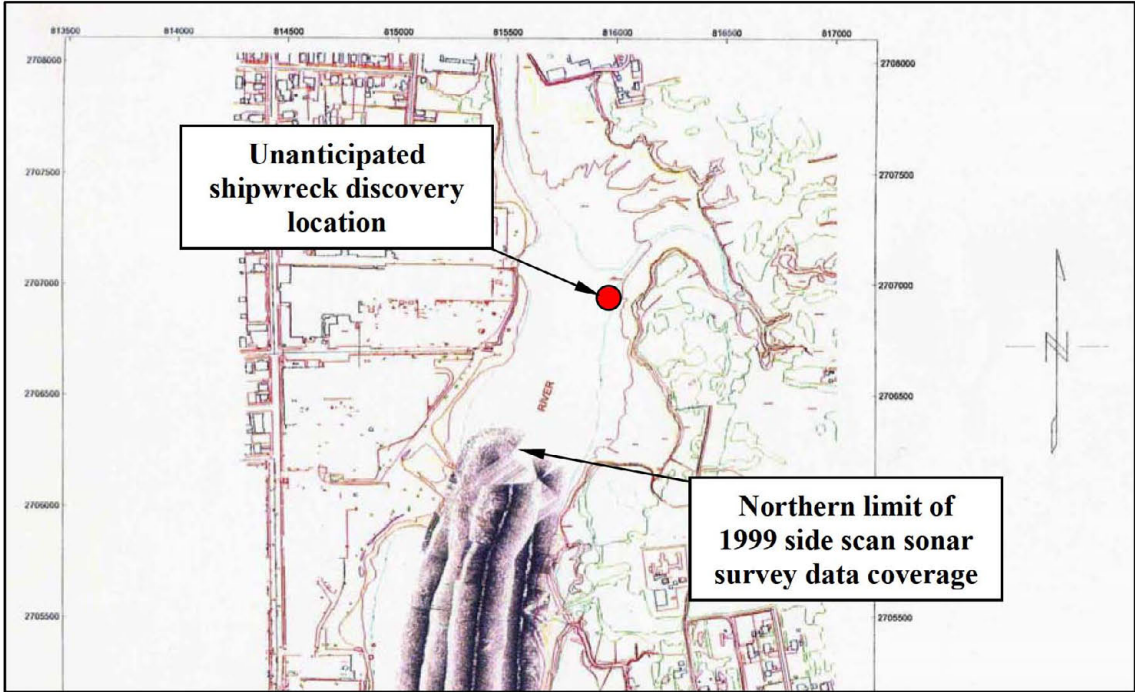
**Figure 1-6. Excerpted plot of mosaiced side scan sonar data recorded during the 1999 pre-disturbance marine archaeological survey relative to the location of the unanticipated shipwreck discovery (after Cox, Jr. 2000).**

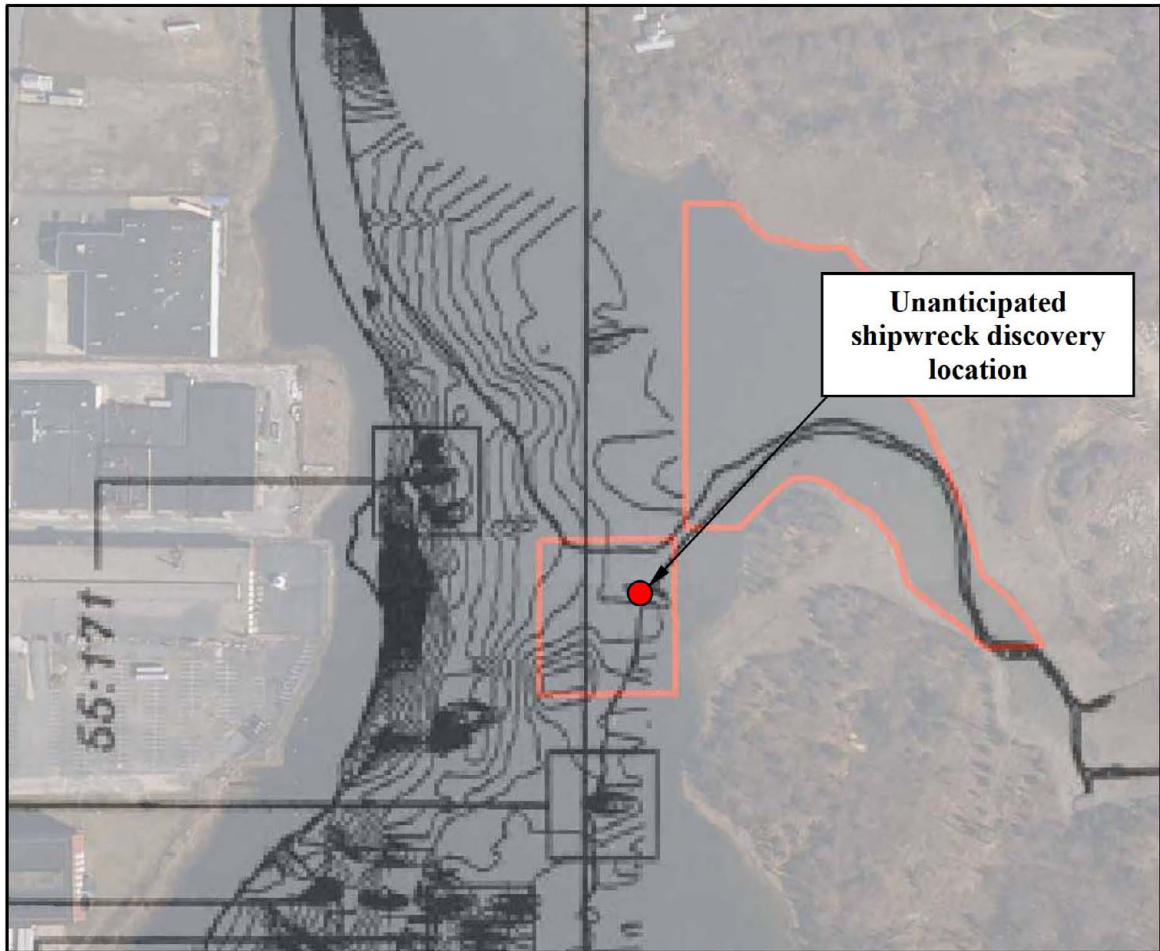
**Figure 1-7. Excerpted plot of contoured 1999 magnetometer survey data (i.e., the black contours superimposed onto the MASSGIS 2003 aerial photograph of New Bedford's Upper Harbor) relative to the location of the unanticipated shipwreck discovery and the 2009 supplemental marine archaeological remote sensing survey area (i.e., the red-lined polygons). Note the absence of any significant magnetic anomalies at the unanticipated shipwreck discovery's location (after Cox, Jr. 2000).**

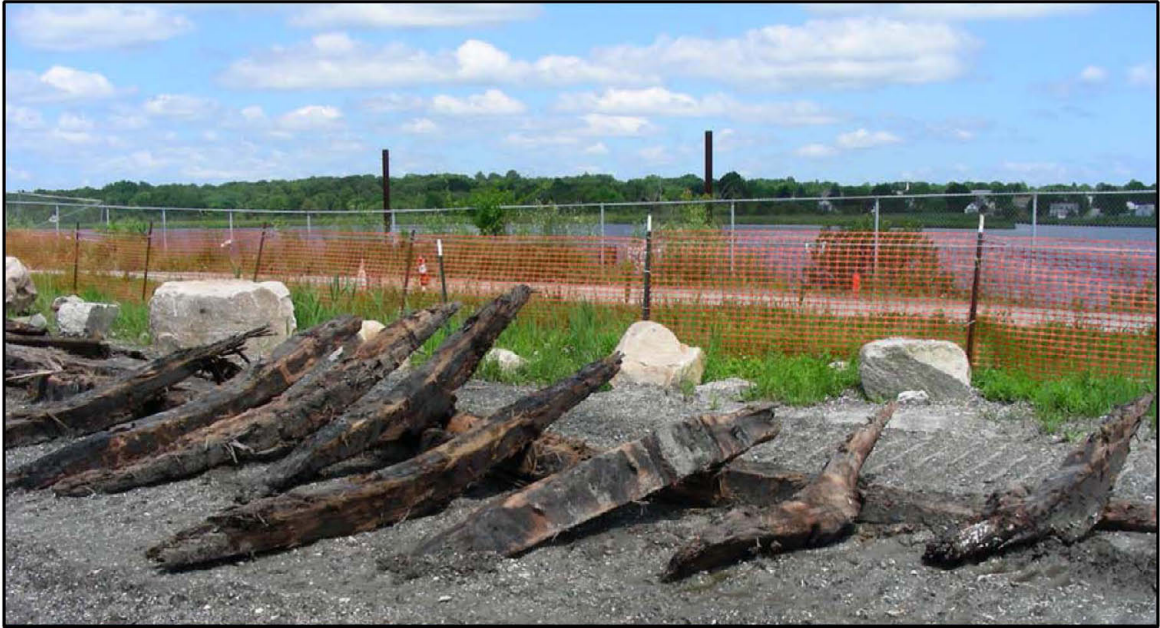
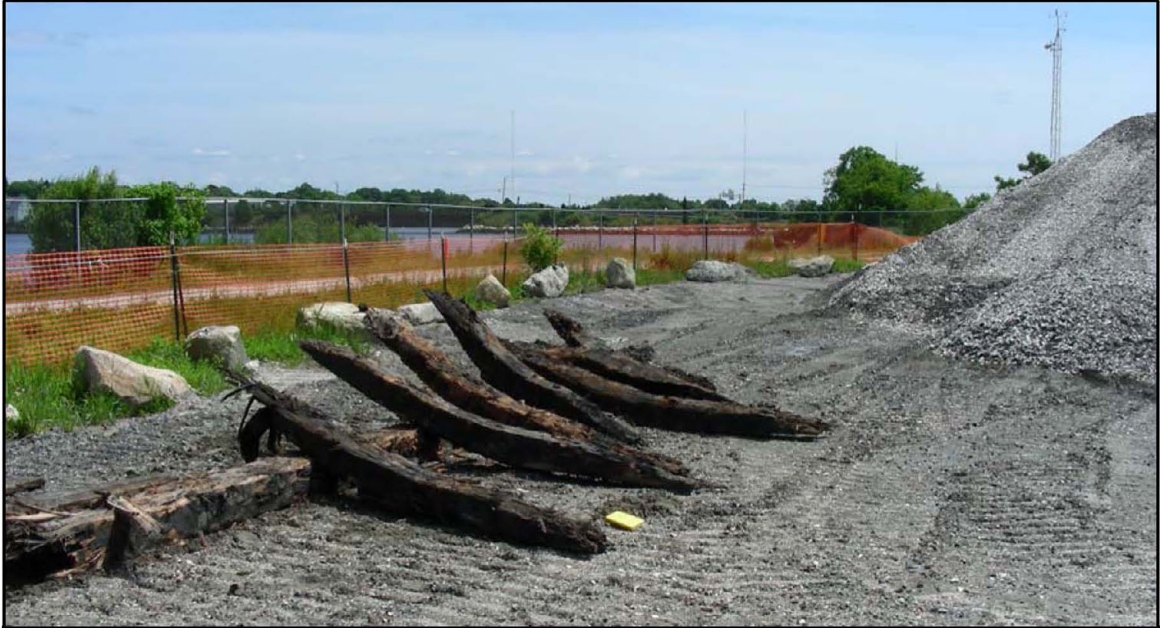
**Figure 1-8. Shipwreck timbers as they appeared shortly after their July 2009 recovery during debris removal operations (photographs by Josh Cummings, courtesy of the USACE-NED).**

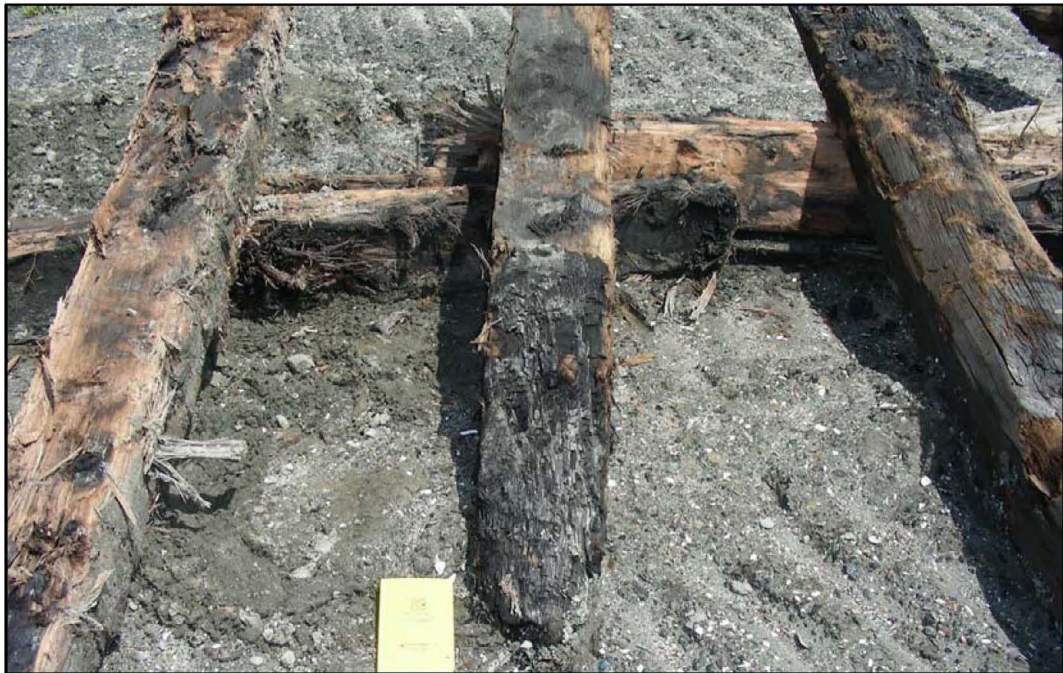
**Figure 1-12. Charring that was visible in places on the surfaces of the timbers, such as at the end of the floor timber in the middle of this photograph, indicated that the vessel was exposed to fire (photograph by Josh Cummings, courtesy of the USACE-NED).**

The condition of the wooden timbers, particularly their surfaces, was observed to be poor during the July 16 inspection. This condition was presumed to be a result of the previously waterlogged timbers' uncontrolled exposure to air and direct sunlight following their recovery. Unfortunately, this post-recovery exposure had allowed the water in the timbers to rapidly evaporate, thereby causing irreversible damage (shrinking, splitting/cracking, and checking) to the structure of the wood. In addition to this recent damage, charred areas on the ends of the floors and on the surfaces of some of the planking fragments indicated that the vessel had burned (Figure 1-12).

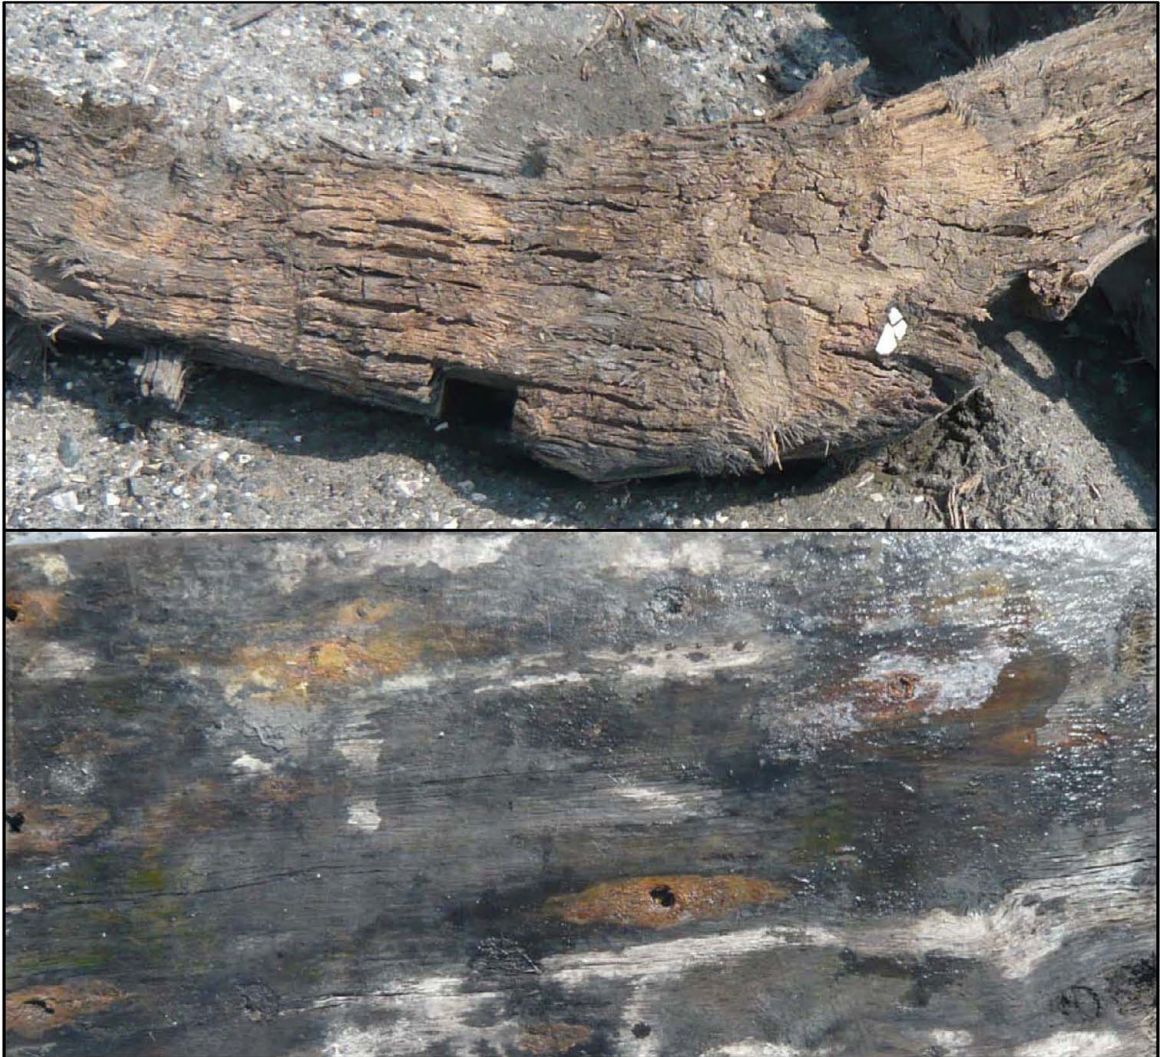
**Figure 1-13. Recovered ship timbers inspected on July 16, 2009 were in generally poor condition, their surfaces split and checked from shrinkage caused by their exposure to air (top image). Preservation of the ship's iron fasteners, even in the timbers recovered in November 2009 that were kept wet prior to their documentation, was minimal with holes and rust stains providing the primary archaeological evidence of their existence (bottom image) (photographs by David Robinson).**

The condition of the hull's iron fasteners was observed to be worse than that of the wood. In fact, the fasteners were essentially gone, as they were completely corroded with little or none of their ferrous parent metal preserved. In most cases, the only surviving evidence for their presence was the rust-stained holes left behind in the wood (Figure 1-13).

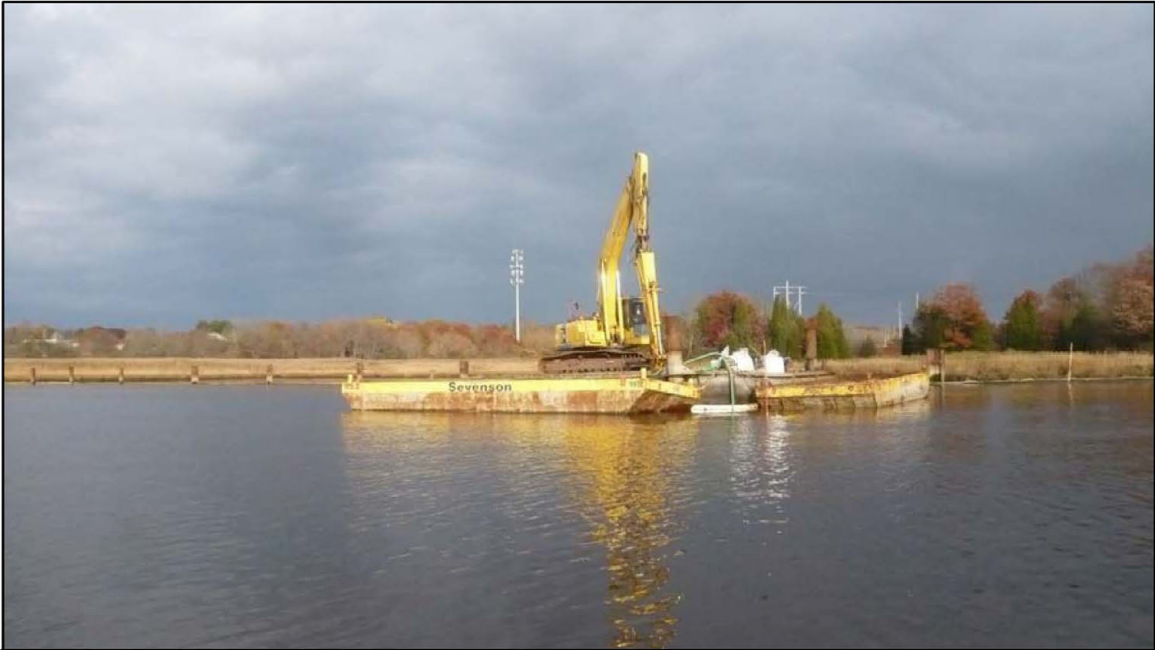
**Figure 2-1. NBHSS debris removal spud-barge with machine and hopper barges (one for the recovered timbers and the other for miscellaneous debris) positioned over the unanticipated shipwreck discovery location in November 2009 (photograph by David Robinson).**

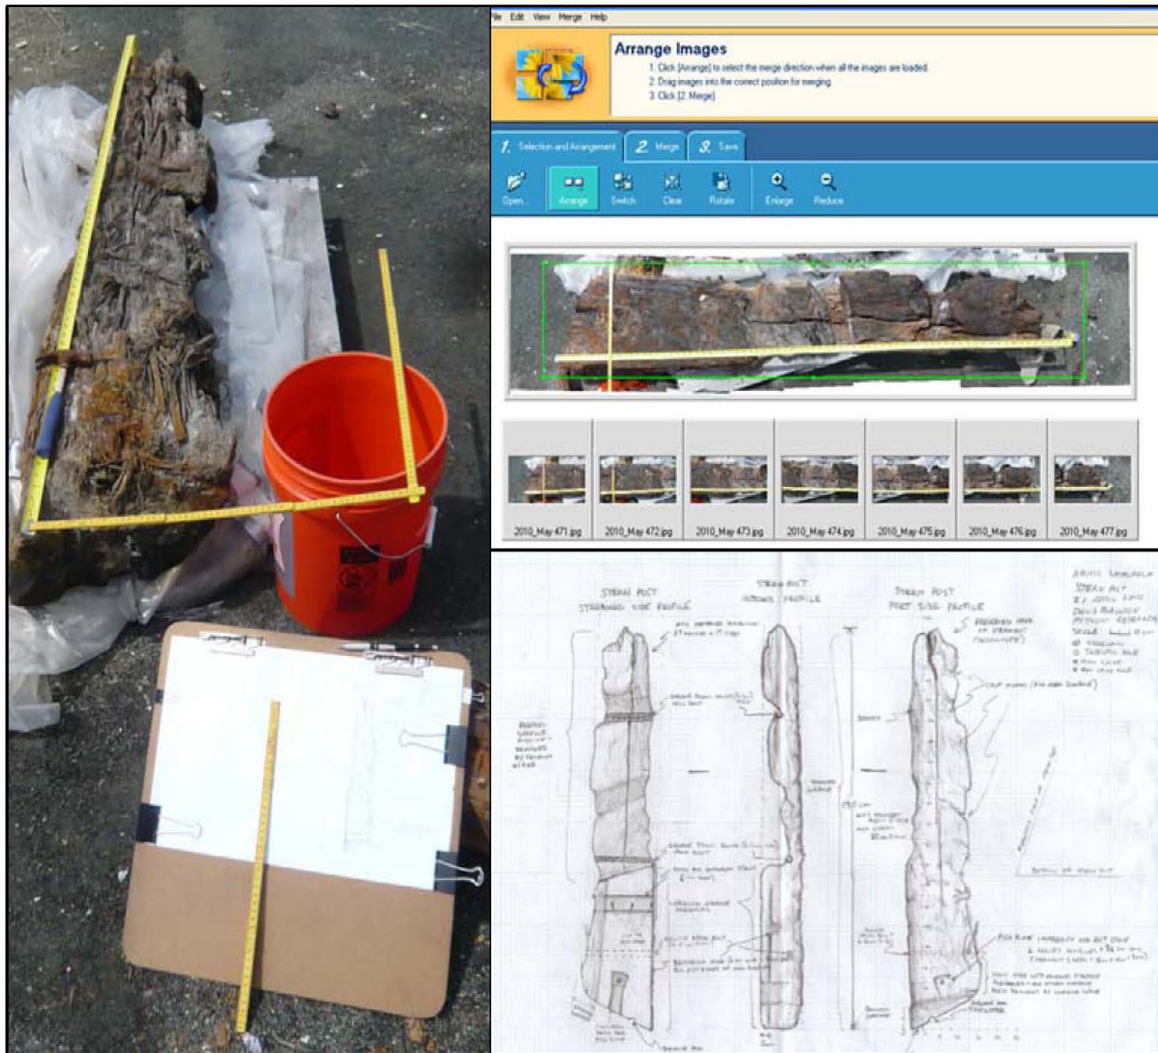
**Figure 2-5. Photographs (including photomosaics created using Cannon's PhotoStitch 3.1 computer software) and measured 2-D plan, profile, and section scale-drawings were prepared by the project archaeologist for each of the recovered timbers as part of the shipwreck's archaeological documentation process (drawings and photographs by David Robinson).**

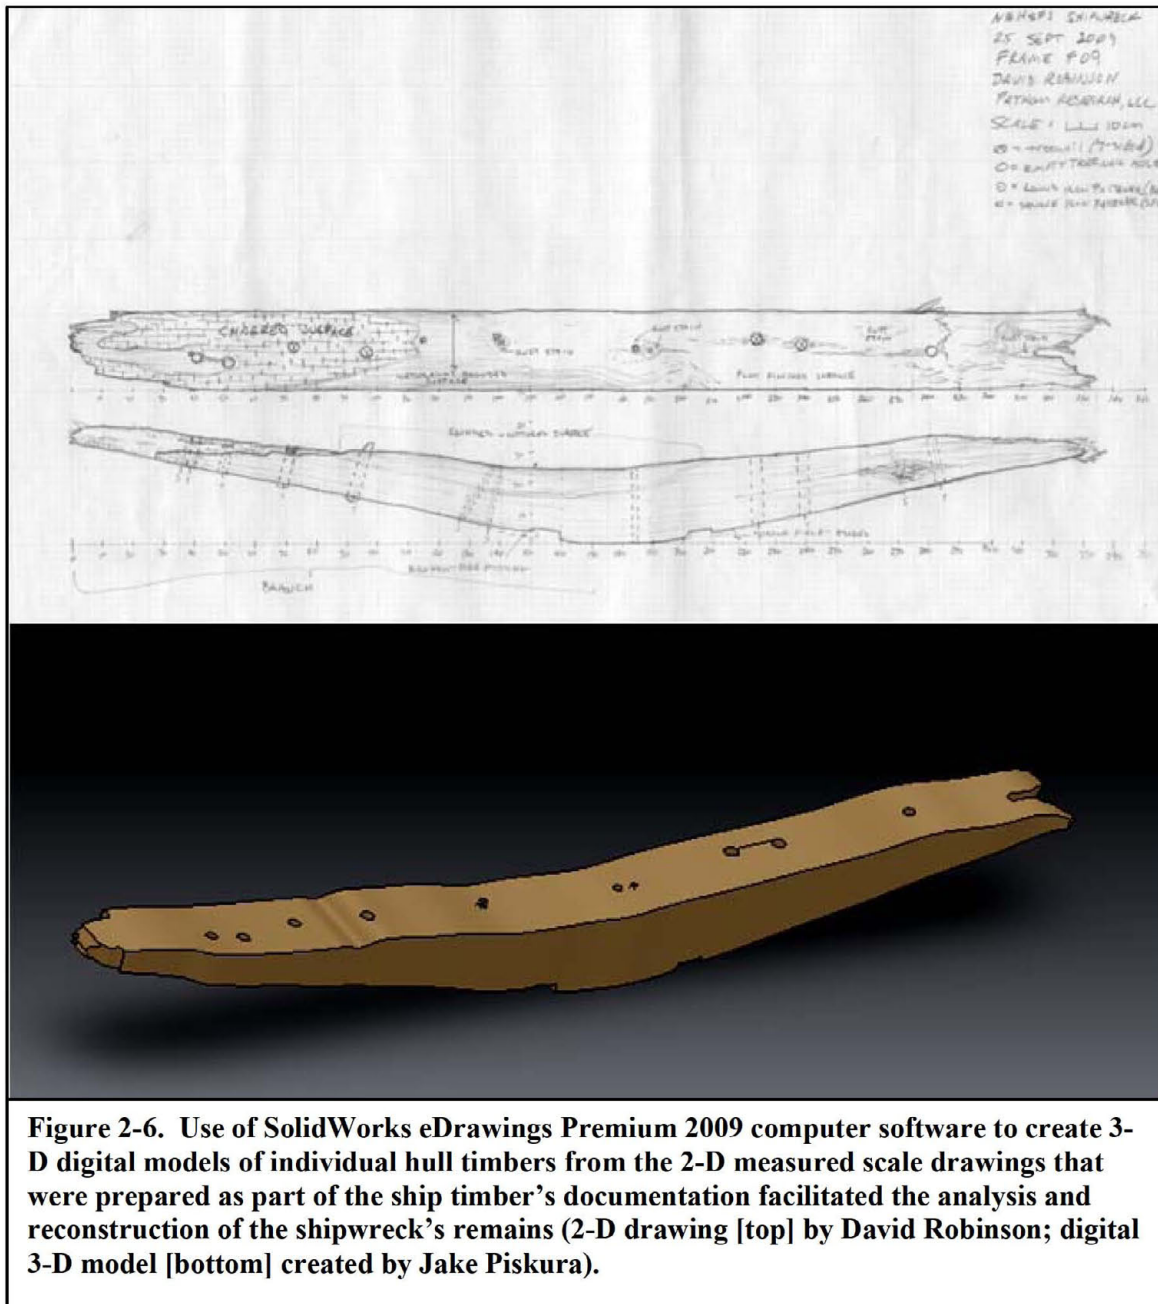
**Figure 2-6. Use of SolidWorks eDrawings Premium 2009 computer software to create 3-D digital models of individual hull timbers from the 2-D measured scale drawings that were prepared as part of the ship timber's documentation facilitated the analysis and reconstruction of the shipwreck's remains (2-D drawing [top] by David Robinson; digital 3-D model [bottom] created by Jake Piskura).**

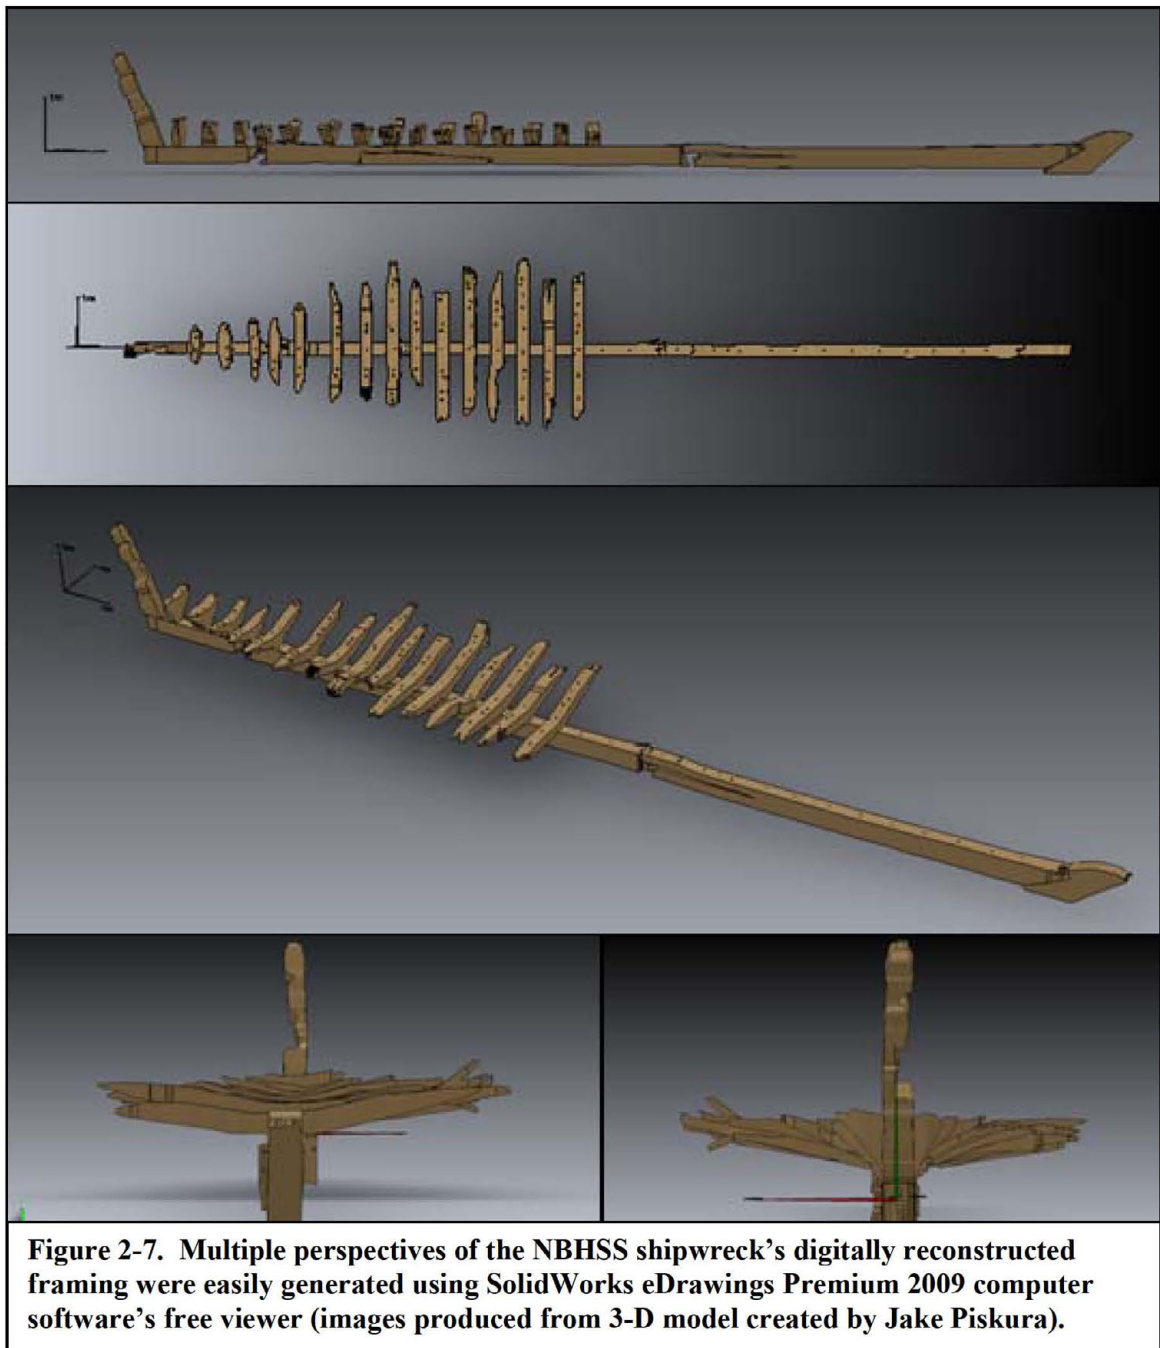
**Figure 2-7. Multiple perspectives of the NBHSS shipwreck's digitally reconstructed framing were easily generated using SolidWorks eDrawings Premium 2009 computer software's free viewer (images produced from 3-D model created by Jake Piskura).**

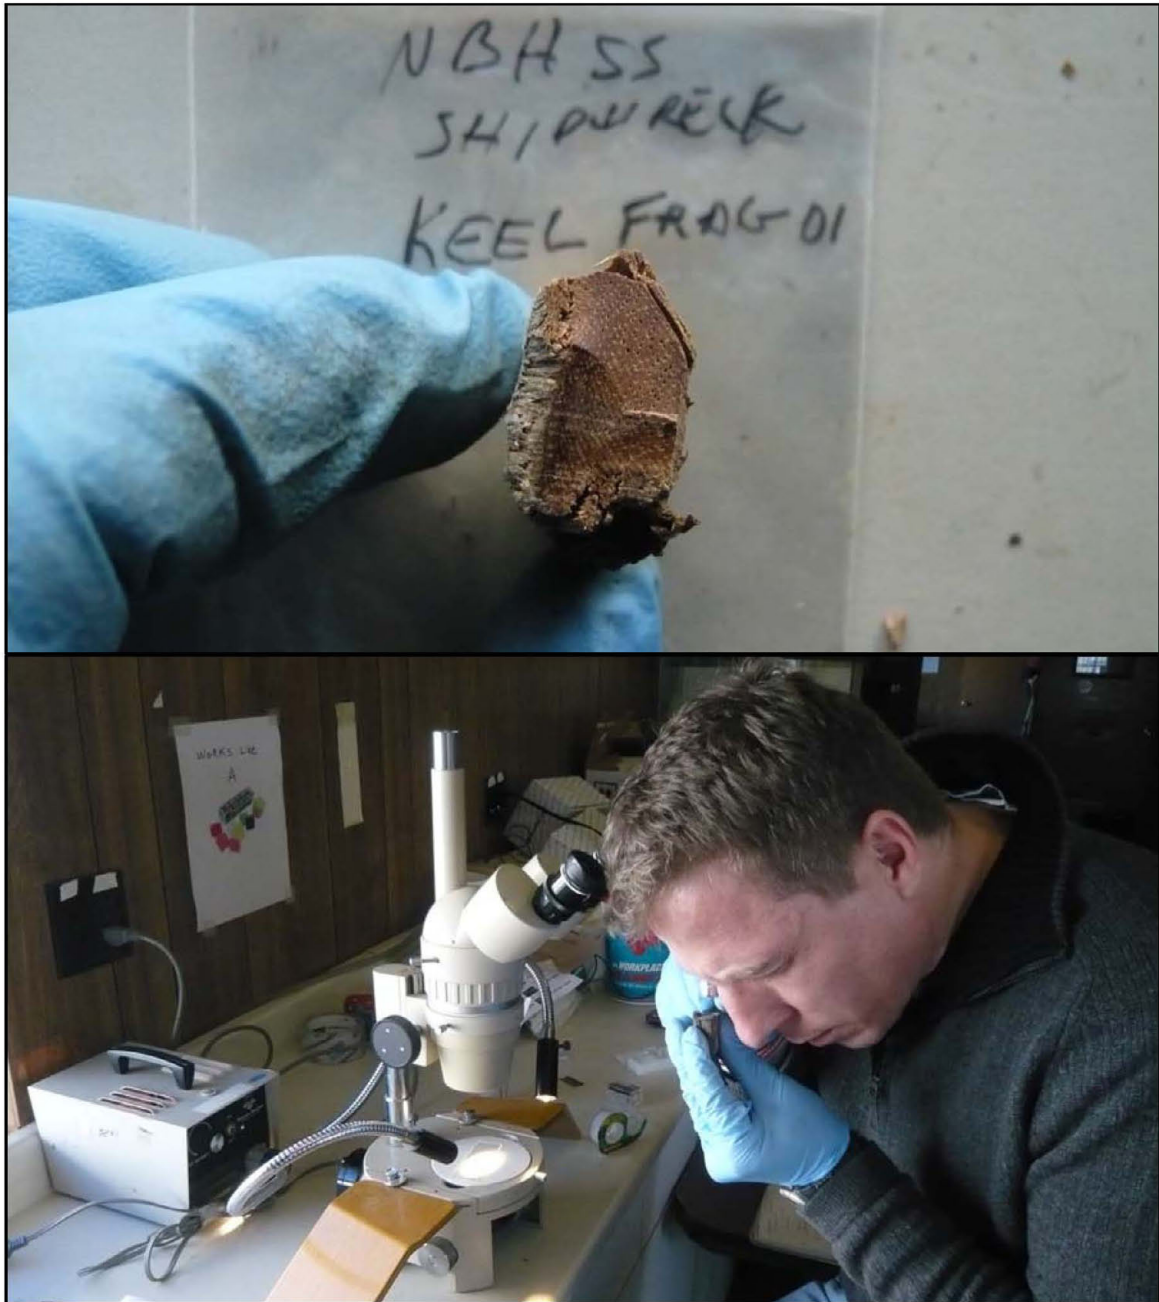
**Figure 2-8. Wood samples from a select representative sample of key structural elements of the shipwreck's hull were extracted and subjected to macro- and microscopic analyses in January 2010 by the project archaeologist and archaeological wood specialist, Dr. Brian Jordan. The purpose of this analysis was to identify the wood species used in the vessel's construction, to determine whether the wood was extracted from "old" or "new" growth forests, and to develop hypotheses regarding the general age and origin of the raw materials used in the vessel's construction (photographs by David Robinson).**

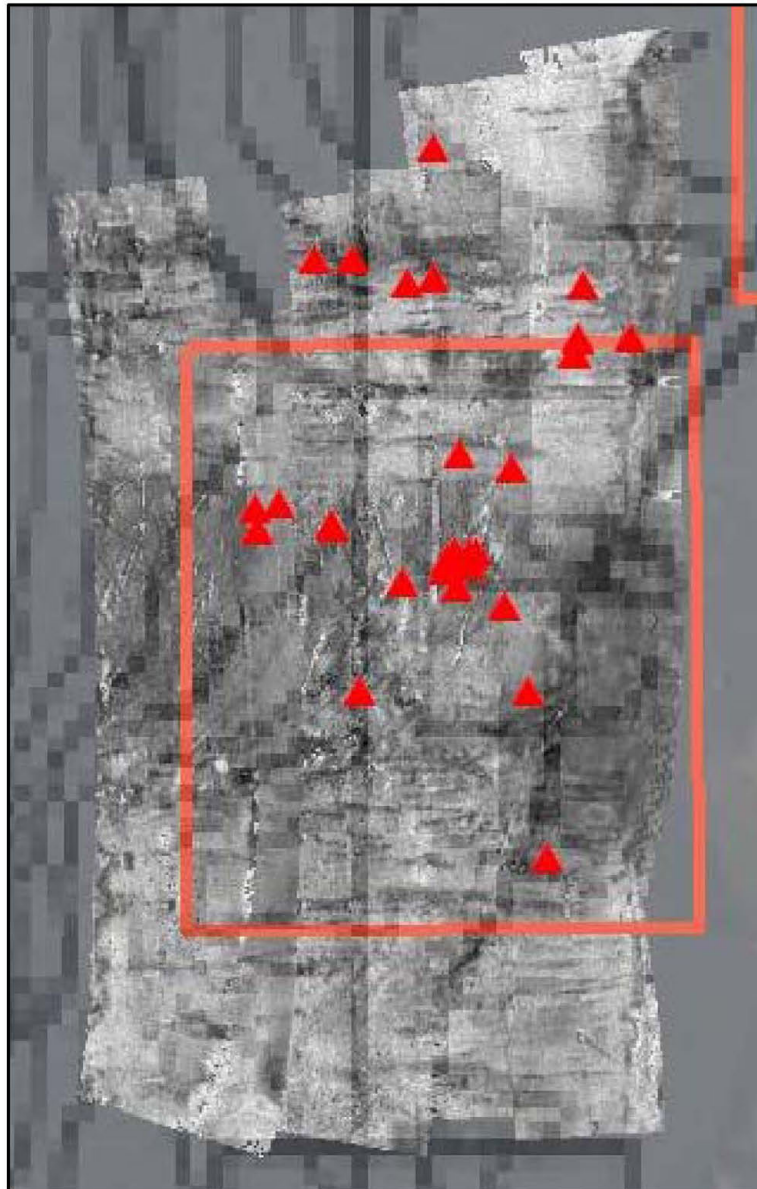
**Figure 3-1. Sidescan sonar image of plotted acoustic anomalies at the NBHSS shipwreck survey area (image courtesy of CRE).**

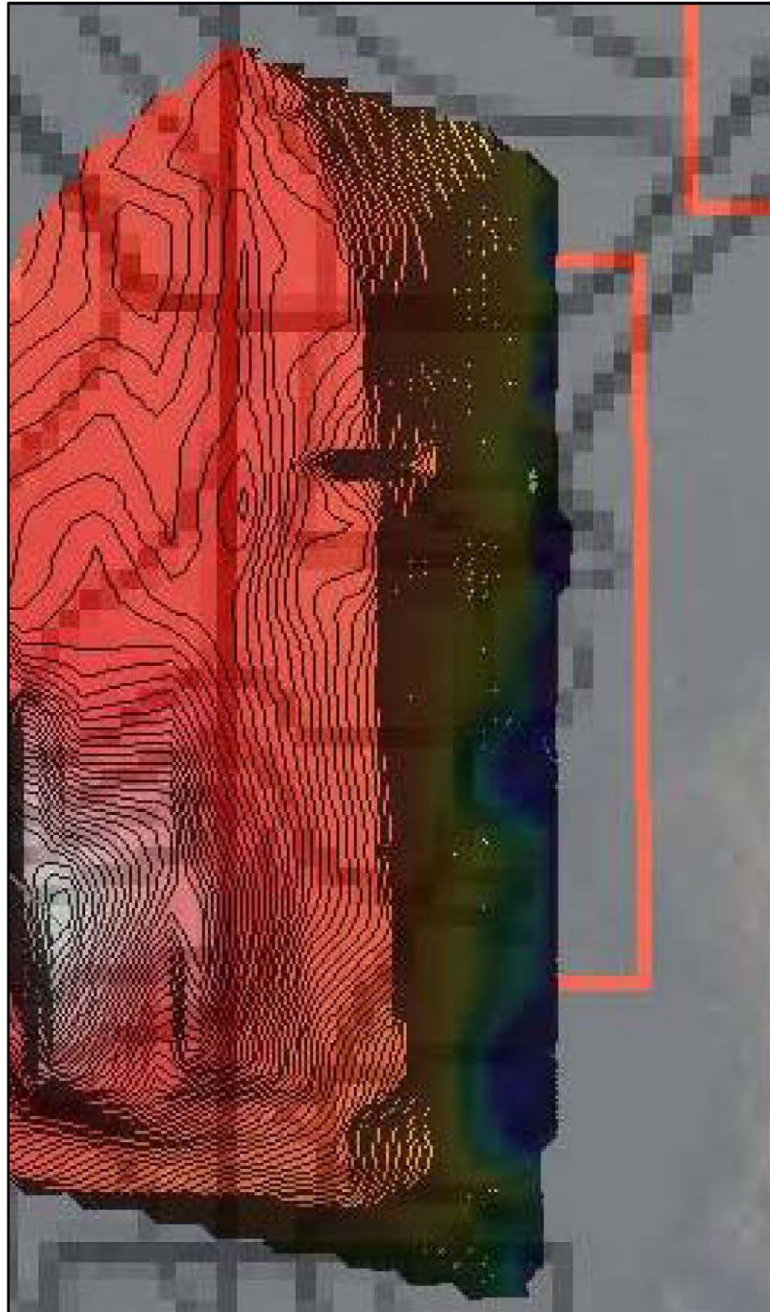
**Figure 3-2. Color-coded contour plot of magnetic data recorded during the 2009 geophysical survey of the NBHSS shipwreck study area (image courtesy of CRE).**

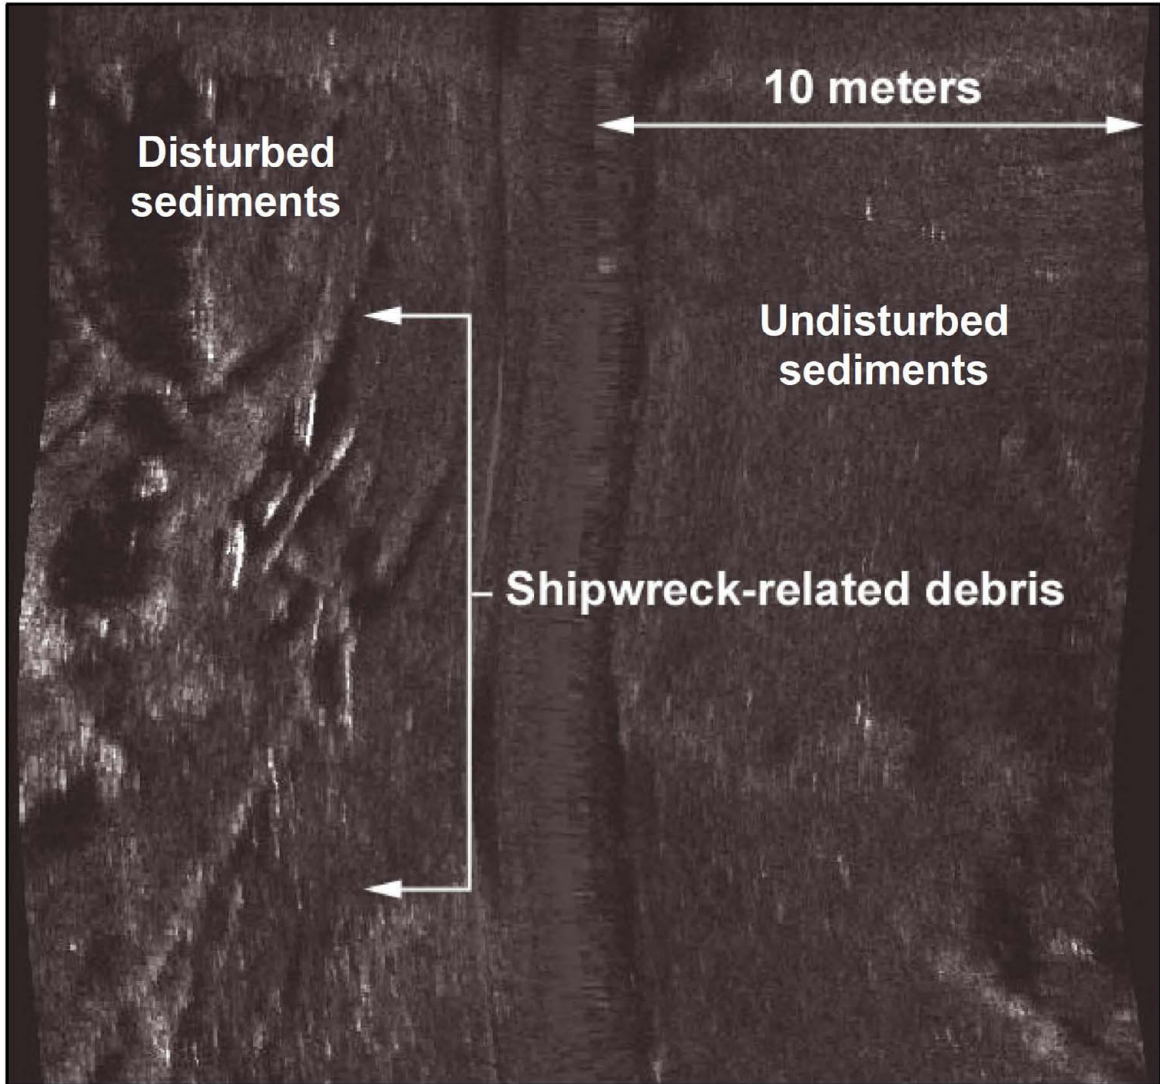
**Figure 3-3. Sidescan sonar image clearly showing disarticulated hull timbers and the scarred and disturbed nature of the sediments on the harbor floor at the NBHSS shipwreck find spot (image after CRE).**

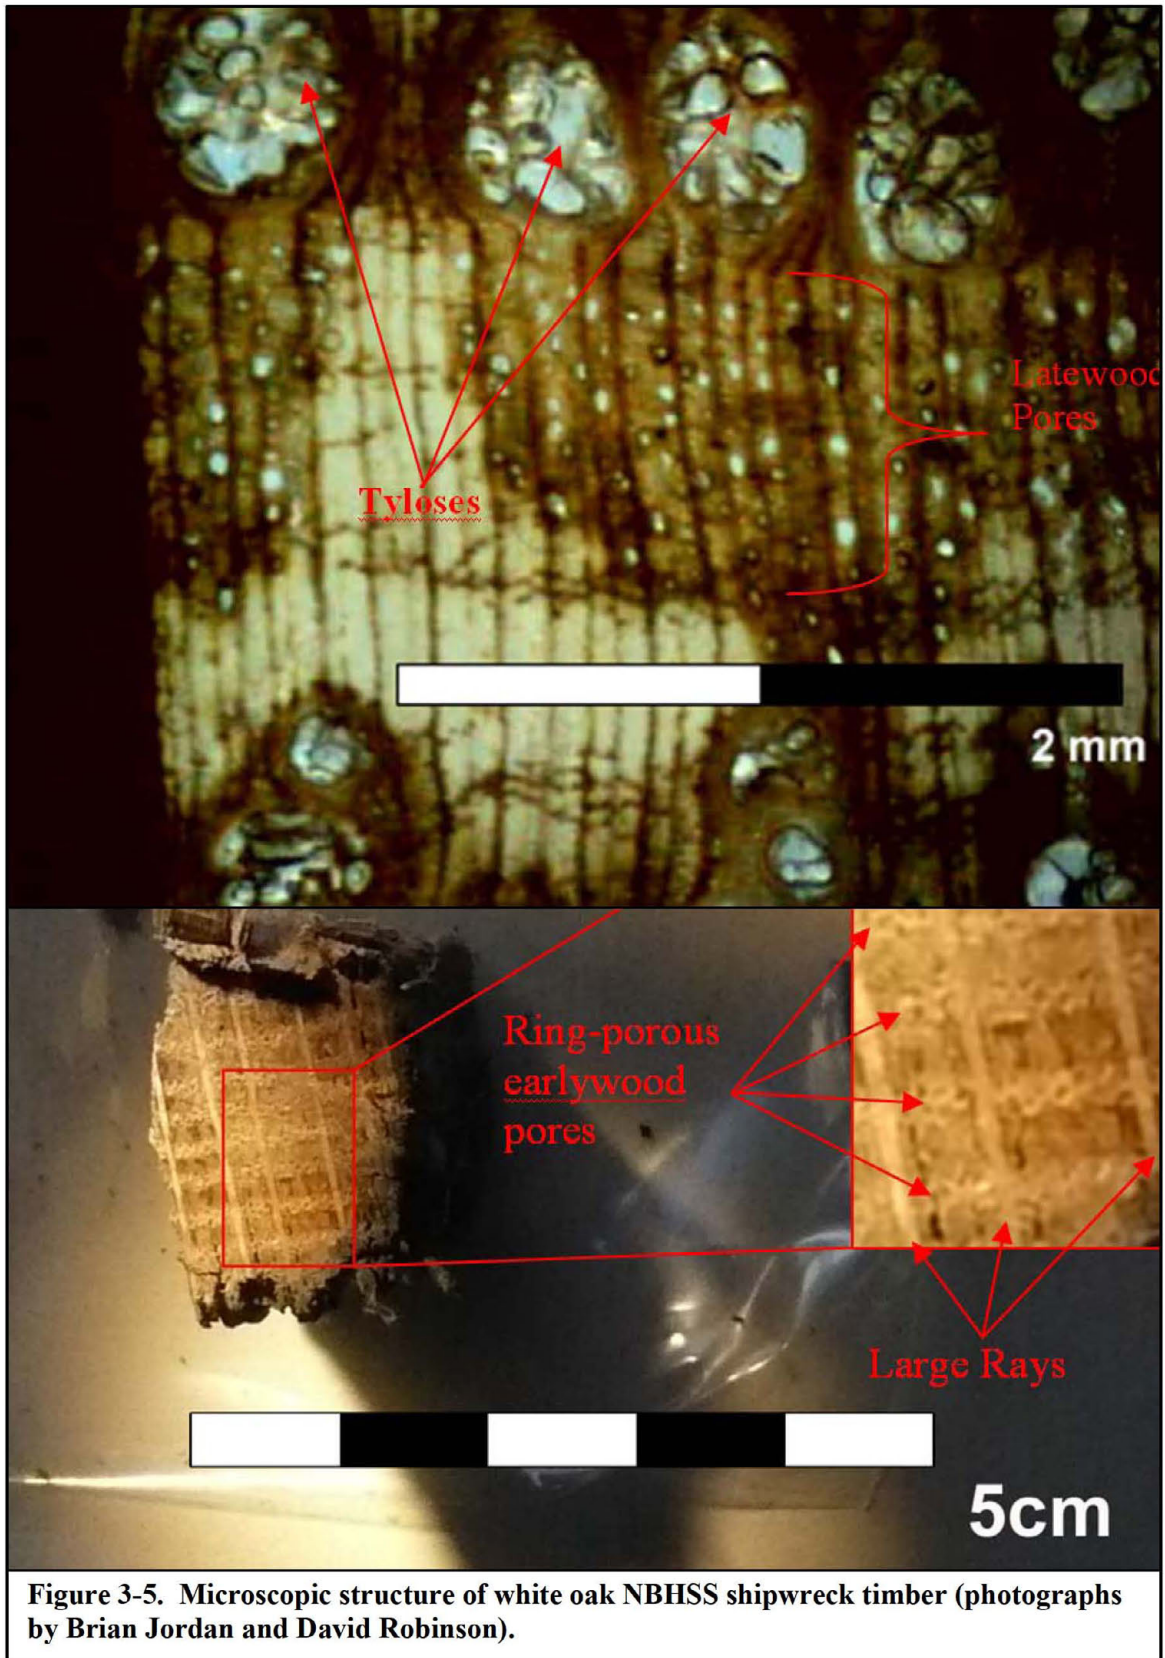
Figure 3-5. Microscopic structure of white oak NBHSS shipwreck timber (photographs by Brian Jordan and David Robinson).

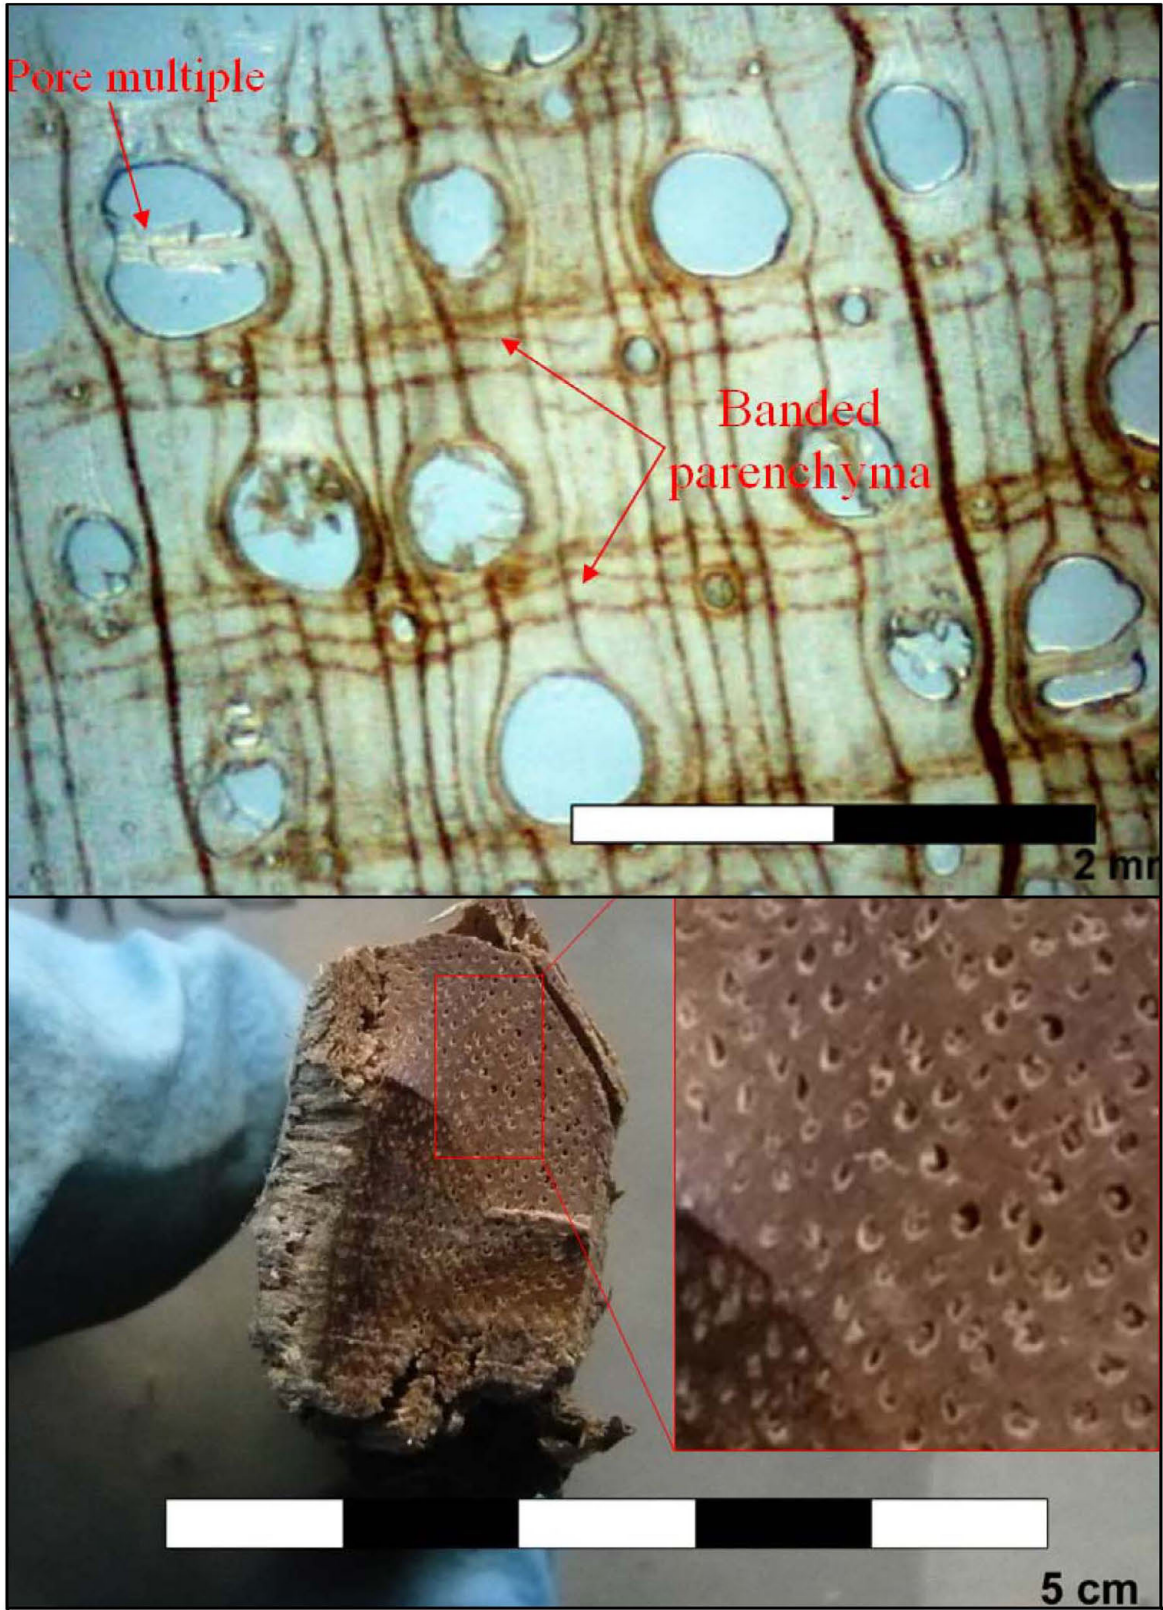
Figure 3-6. Microscopic structure of hickory sample collected from the keel of the NBHSS shipwreck (photographs by Brian Jordan and David Robinson).

The wood sample taken from the NBHSS shipwreck’s keel identified as hickory was ring-porous, but lacked the excessively large rays found in oaks. Additionally, the early-wood pores were distributed in a single row and pore multiples were present. When examining a thin section under the microscope, the presence of tyloses, combined with apotracheal banded parenchyma, led to the identification of the wood sample as hickory (Figure 3-6). Hickory can be narrowed to two sub-groups: true hickory and pecan hickory. The keel sample falls in the former sub-group based on several characteristics, most notably the absence of banded parenchyma cells in the early-wood section of true hickories. The true hickory sub-group is made up of several species, including *C. glabra* (pignut hickory), *C. laciniosa* (shellbark hickory), *C. ovata* (shagbark hickory), and *C. tomentosa* (mockernut hickory). True hickories are found today along most of the eastern half of the United States, and the wood is extremely tough, heavy, hard and strong with little to no decay resistance. Although extremely unusual in the archaeological record of eighteenth century shipwrecks, perhaps because of difficulties working with it and its limited decay resistance, hickory is among the hardest and strongest of woods native to North America. Denser, stiffer, and harder than either white oak or hard maple, hickory is commonly used where strength or shock-resistance is important. In the case of a keel, these properties would have been highly desirable.
