**Technical Report  
Marine Archaeological Documentation and Assessment**

**New Bedford Harbor Superfund Site  
Unanticipated Shipwreck Discovery  
Acushnet River  
Acushnet, Massachusetts**

September 2010

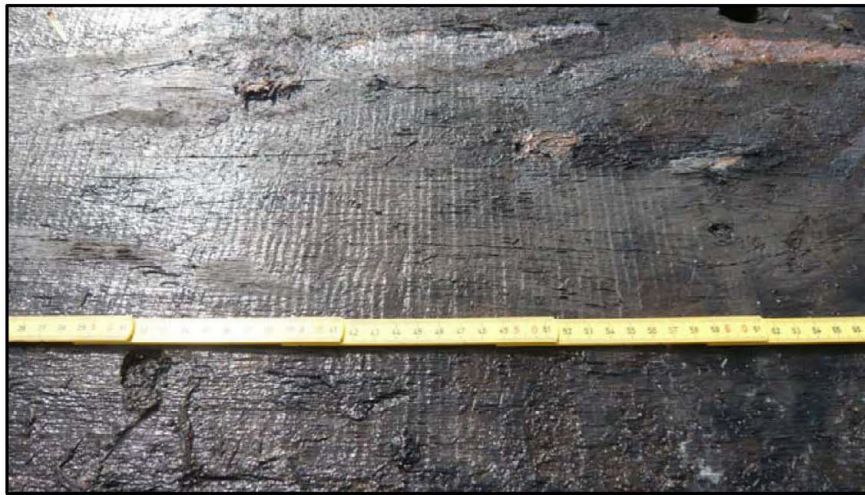
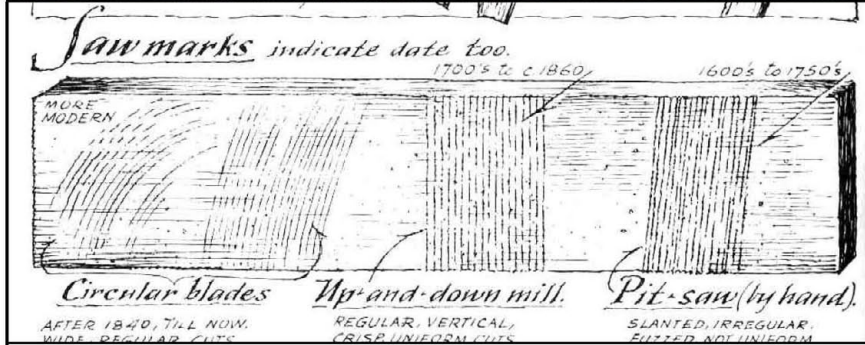
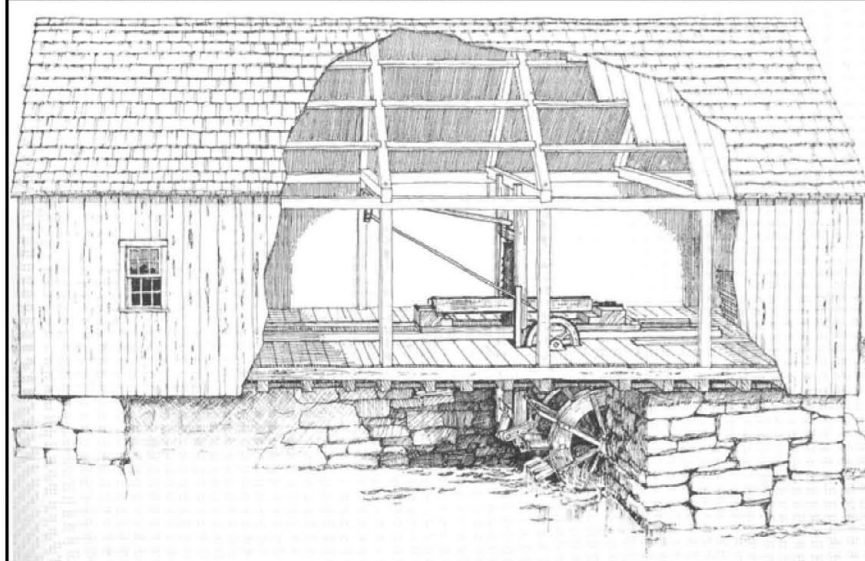
**Figure 3-7.** Clearly visible saw marks in the surface of one of the NBHSS shipwreck's hull planks produced by a water-powered, mechanized, "frame," "sash," or "up-down" saw (photograph by David Robinson; images from Sloan [1973] and Rivard [1990]).

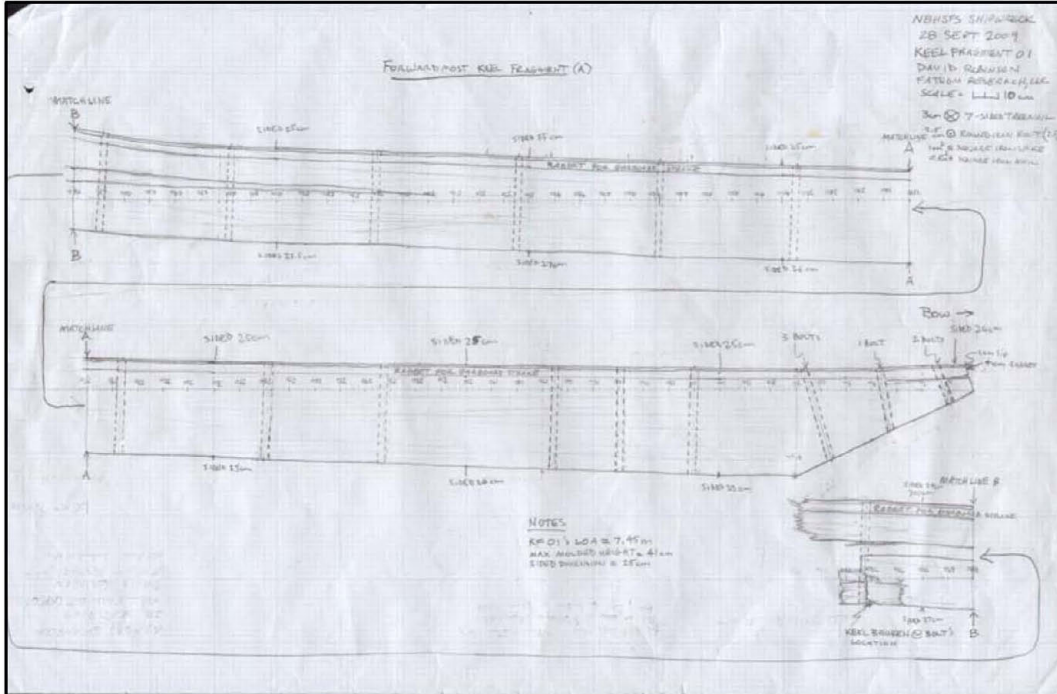
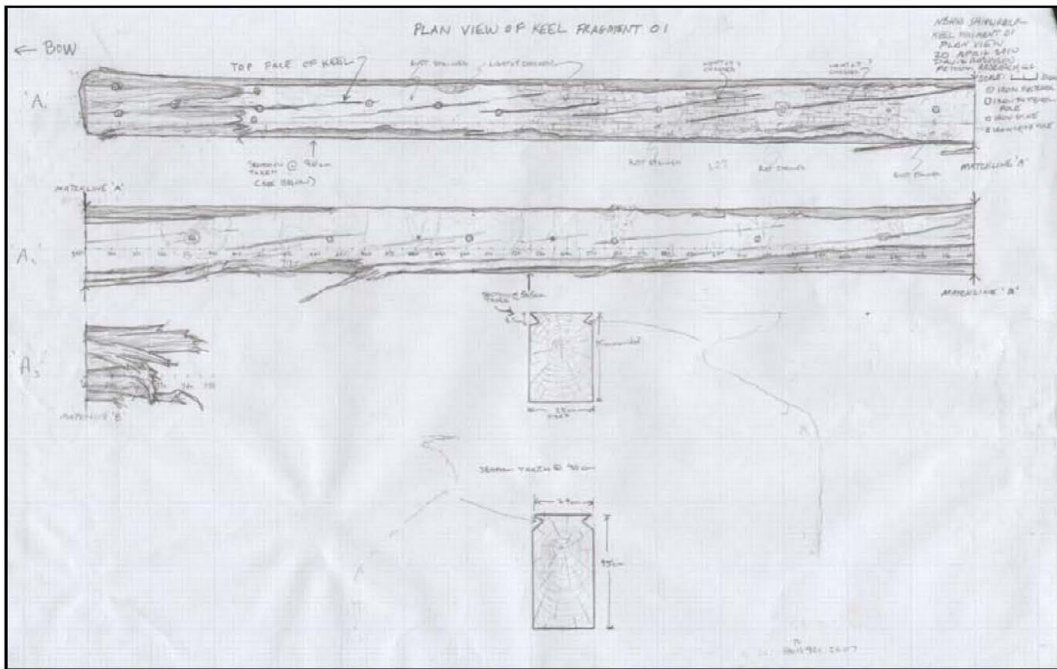
# KEEL

## Fragment A (profile [top], plan and section [bottom])

The NBHSS shipwreck's keel was broken into five separate pieces when it was recovered from the bottom of the harbor. It was originally made from two massive pieces of old growth hickory that were cut from the heartwood of a tree and flat-nibbed scarfed together about a third of the way along the hull's length from the stern. The keel measured 8.2 to 10 in (20.8 to 25.4 cm) sided (stern to bow) and 11.5 to 16 in (29.2 to 40.6 cm) molded (stern to bow), with preserved length overall of 56.6 ft (17.3 m). A "V"-shaped rabbet cut into the upper corners of the keel for the garboard strakes measured 2 in (5 cm) in width. Fastener holes and the reconstructed extension of the base of the stem 2.5 in (6 cm) below the keel's bottom provide evidence indicating the former presence of a false keel and suggest that the ship was operated in coastal shoal waters where protection of the keel from damages due to groundings was a concern. Additional fastener holes (tacks or nails) visible on the sides of the keel distributed in multiple overlapping diagonal and seemingly random patterns indicate that the keel was also sheathed in wood, which had been replaced on at least one occasion, if not more during the vessel's service life.

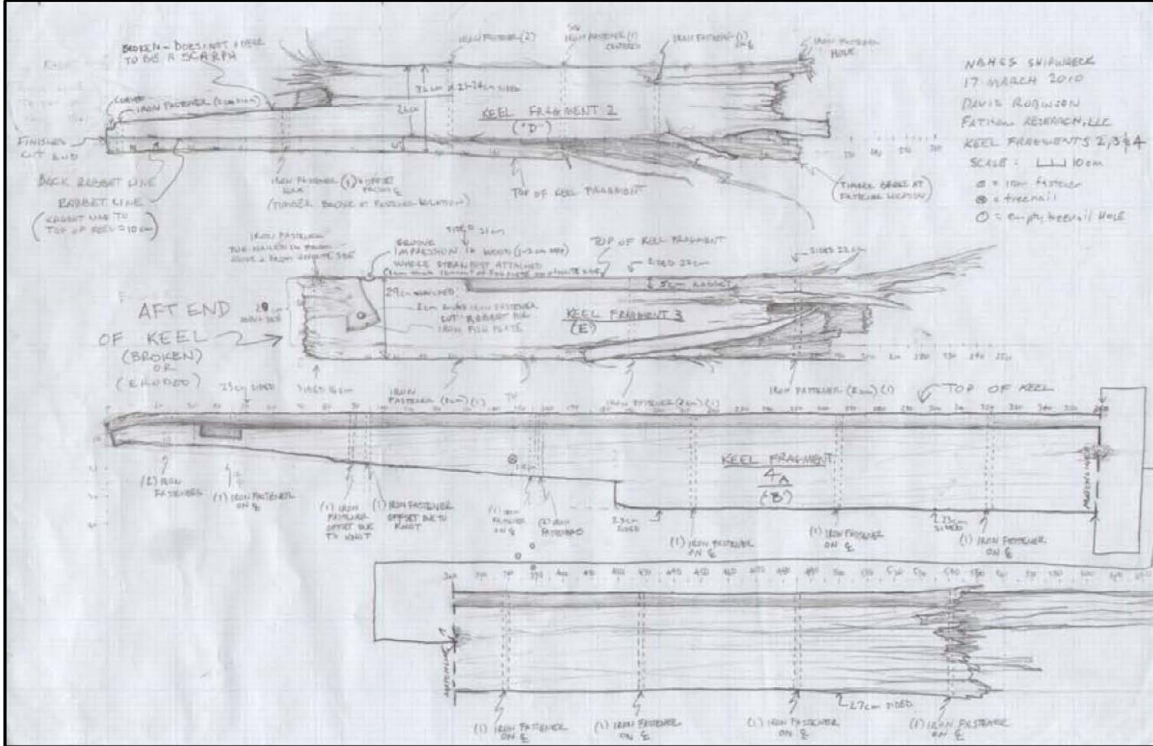
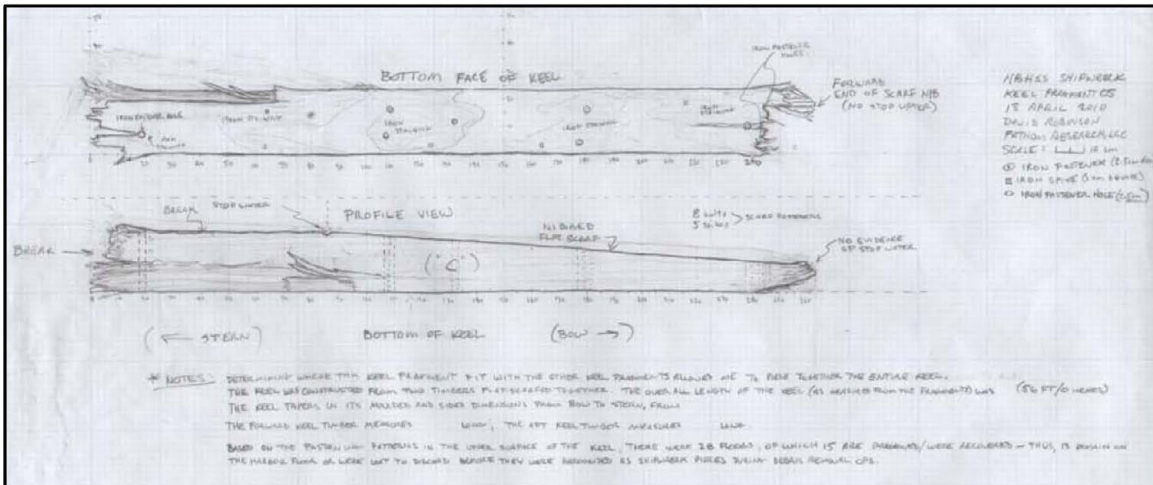
# KEEL

## Fragments B, D and E (profile)

## Fragment C (plan and profile)
