RE: Remedial Investigation Report–Revision 1 Stevens Point Former MGP, Stevens Point, Wisconsin Wisconsin Public Service Corporation

> CERCLA Docket No. V-W-06-C-847 Site Spill ID – B5CJ CERCLIS ID – WIN000509983

WPSC Stevens Point Former MGP Site Remedial Investigation Report Revision 1 May 27, 2011 Section 2 – Site Characteristics Page 12 of 64

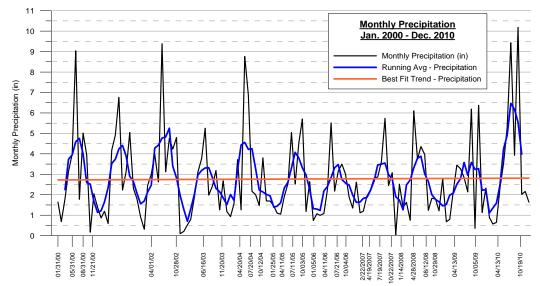
Monthly precipitation from January 1, 2000 through December 31, 2010, which generally correlates with site activities completed after soil remediation in 1998, is plotted below²

Both a running average and a regression (best fit) plot have been added to help show how precipitation totals have decreased over this period. The running average was calculated using a five-month window. This means the values from the two month prior to and the two months following the current month were used to calculate the "average" precipitation for a point in time. This removed much of the volatility from the plot due to excessively wet or dry months during any single period. The best fit plot provides an indicator of whether the overall precipitation trend is increasing or decreasing.

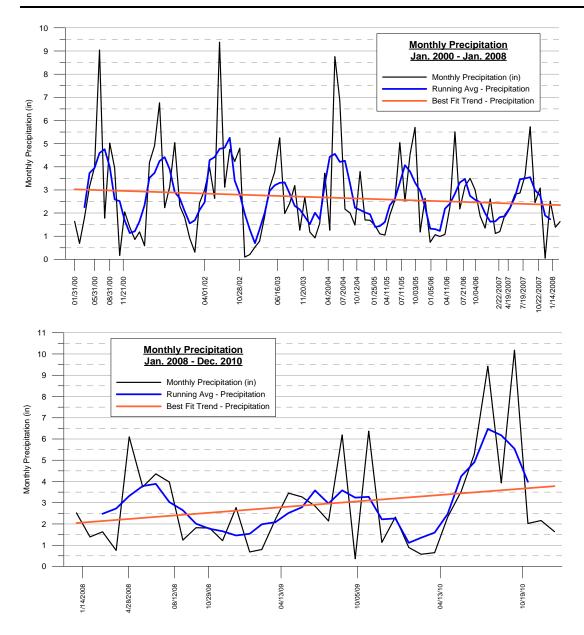
The RI originally evaluated data through January 2008, and the monthly precipitation from January 1, 2000 through January 31, 2008 was plotted (below). To evaluate overall precipitation changes between 2008 and 2010, the long term and short term plots for 2000 to 2008 and 2008 to 2010 are shown.

The significance of the 2000 to 2008 and 2008 to 2010 plots is represented by the best fit trend line. Between 2000 and 2008, overall precipitation changes from approximately 3 inches per month to an estimated 2.5 inches per month. However, between 2008 and 2010, the overall monthly precipitation value represented by the best-fit trend line changed almost two inches (from slightly more than 2 inches to just less than 4 inches) per month. These plots show the precipitation variability much better than the single plot for the period January 2000 through December 2010.

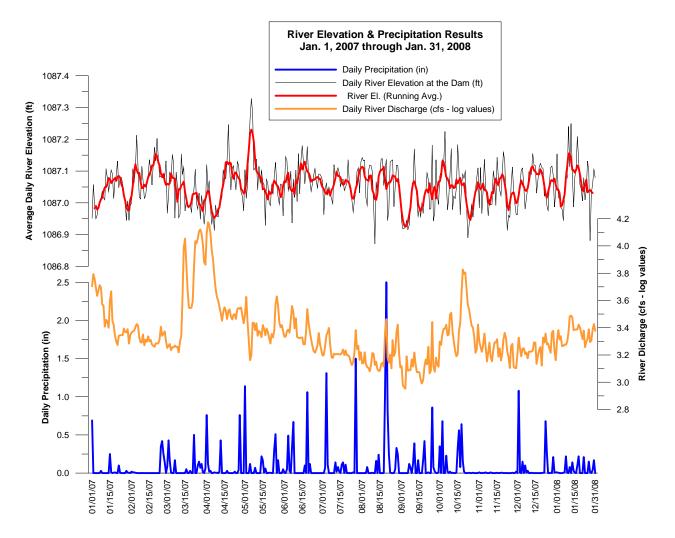
Daily precipitation, daily discharge, and daily average river elevation are plotted below. There appears to be little correlation between rainfall, river discharge, and pool elevation.

River discharge and elevation data at the dam during the RI in 2006 and 2007 was obtained from the Consolidated Water Power Company (CWPC), which operates the dam located just downstream of the site (Appendix F). Daily discharge values for 2006/2007 ranged from 897 cubic feet per second (cfs) to over 19,700 cfs. CWPC also provided hourly elevation data from January 1, 2007 through January 31, 2008 which showed the river elevation varying within a narrow range of 1086.72 and 1087.52 feet.
