Pre-Restoration Geomorphic Characteristics of Minebank Run, Baltimore County, Maryland, 2002–04

Scientific Investigations Report 2007–5127

By Edward J. Doheny¹, Roger J. Staroneck², Paul M. Mayer³, and Elise A. Striz⁴

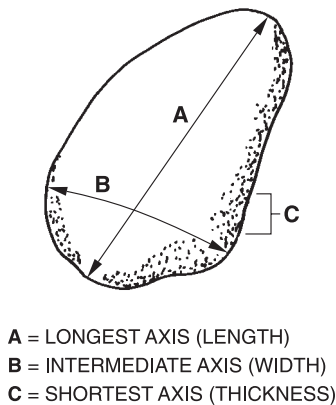
**A = LONGEST AXIS (LENGTH)
B = INTERMEDIATE AXIS (WIDTH)
C = SHORTEST AXIS (THICKNESS)**

Figure 9. Examples of longest, intermediate, and shortest axes for measuring median particle diameter of pebbles during pebble counts (modified from Harrelson and others, 1994).

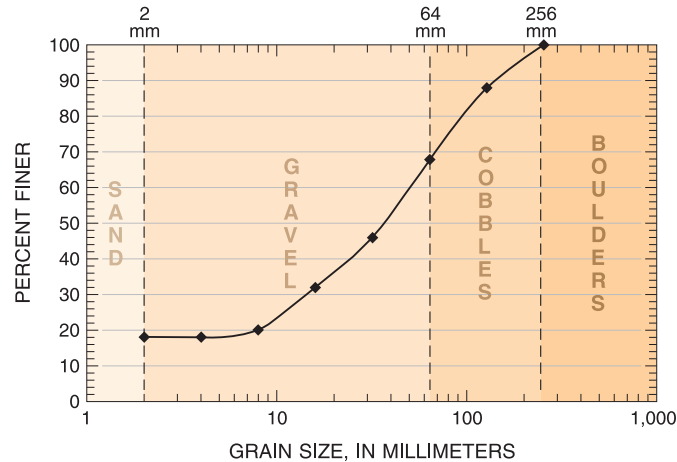
Figure 10. Plot of grain-size distribution developed from the pebble count at cross section Ff, Minebank Run study reach, June 6, 2003.

Particle description	Particle size limit (mm)	Item count	Cumulative percent finer (%)
Silt	0.062	0	0
Sand	2	18	18.0
Very fine gravel	4	0	18.0
Fine gravel	8	2	20.0
Medium gravel	16	12	32.0
Coarse gravel	32	14	46.0
Very coarse gravel	64	22	68.0
Small cobbles	128	20	88.0
Large cobbles	256	12	100.0
Small boulders	512	0	100.0
Medium boulders	1,024	0	100.0
Large boulders	2,048	0	100.0
Very large boulders	4,096	0	100.0
TOTAL	--	100	--

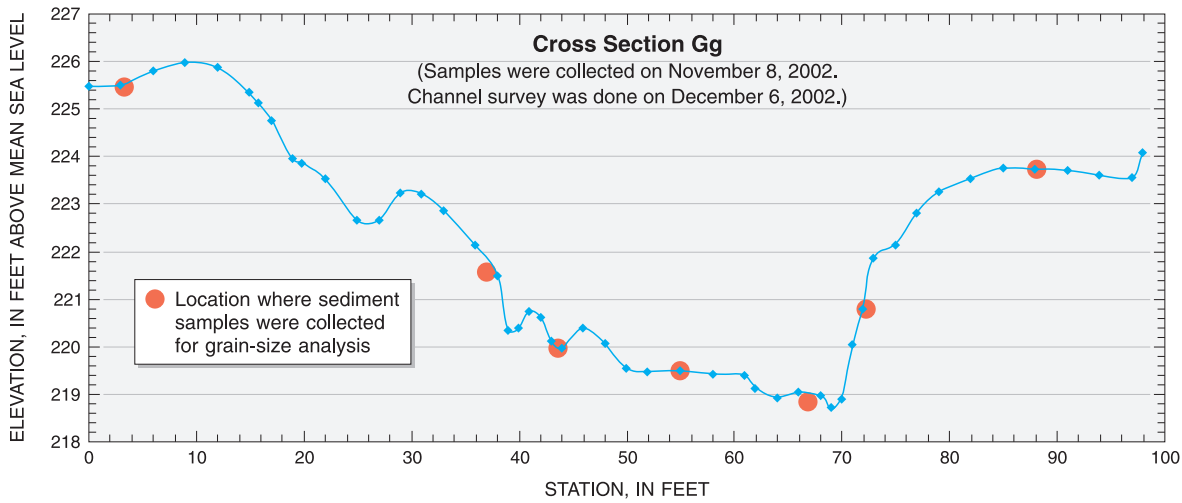
Figure 11. Example of locations within cross section Gg that were selected for sediment-sample collection, Minebank Run study reach, November 2002.

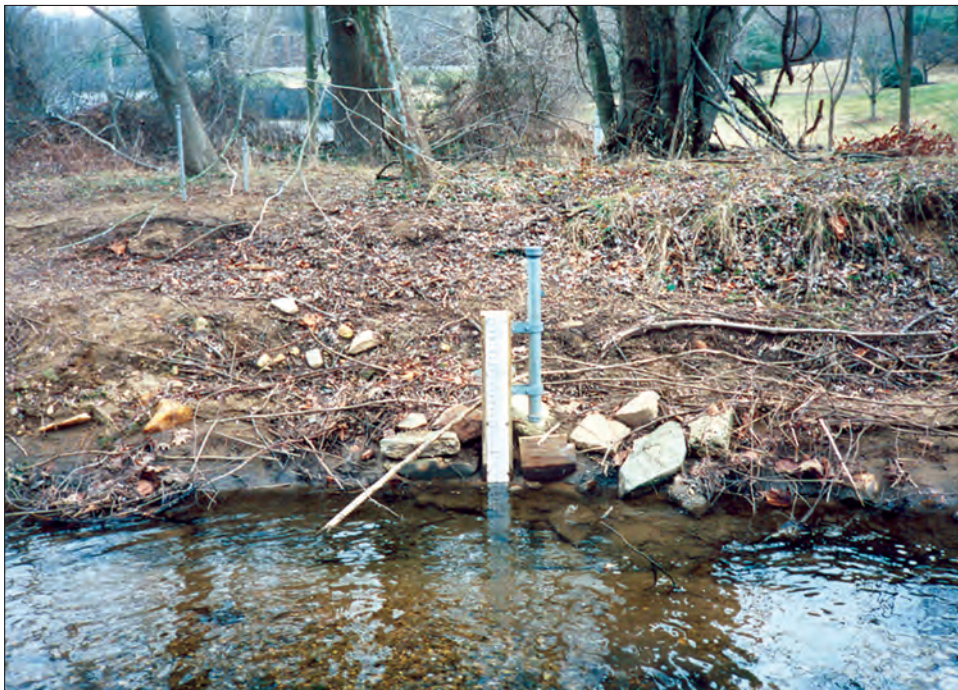
Figure 13. Crest-stage gage for obtaining high-water marks in the Minebank Run study reach. (Photograph by Edward J. Doheny, U.S. Geological Survey.)

The distance between crest-stage gages along the thalweg of the stream channel was measured so that water-surface slopes could be determined at a range of stages and discharges by use of the high-water marks. Since the reach in the vicinity of the streamflow-gaging station was the most linear section of the study reach, the streamflow-gaging station and the crest-stage gage immediately downstream of this station were predominantly used for determination of water-surface slopes. A crest-stage gage that was used for obtaining high-water marks in the Minebank Run study reach is shown in figure 13.

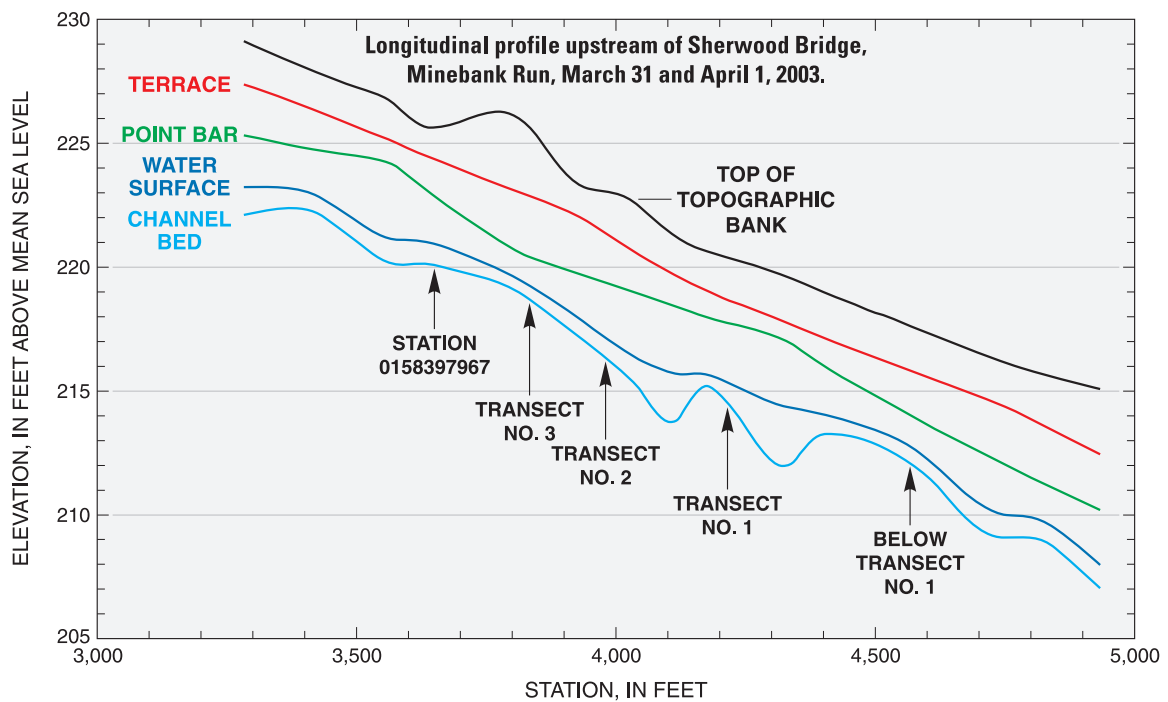
Figure 15. Longitudinal profile of channel features in the Minebank Run study reach from field survey conducted on March 31 and April 1, 2003.

A distinct and extensive series of point bar and terrace features in the main channel along the study reach is shown in figure 15. The presence of these features indicates that the channel bed has degraded over time and that the stream channel may have abandoned its flood plain at least twice due to degradation. The field evidence indicates that the stream channel may have initially degraded from the top of the topographic banks to form a new flood plain at the level of the terrace feature that was surveyed throughout the study reach. Additional degradation likely caused the stream channel to abandon this flood plain and establish an active flood plain at the approximate elevation of the top of point bar features that were surveyed throughout the study reach.

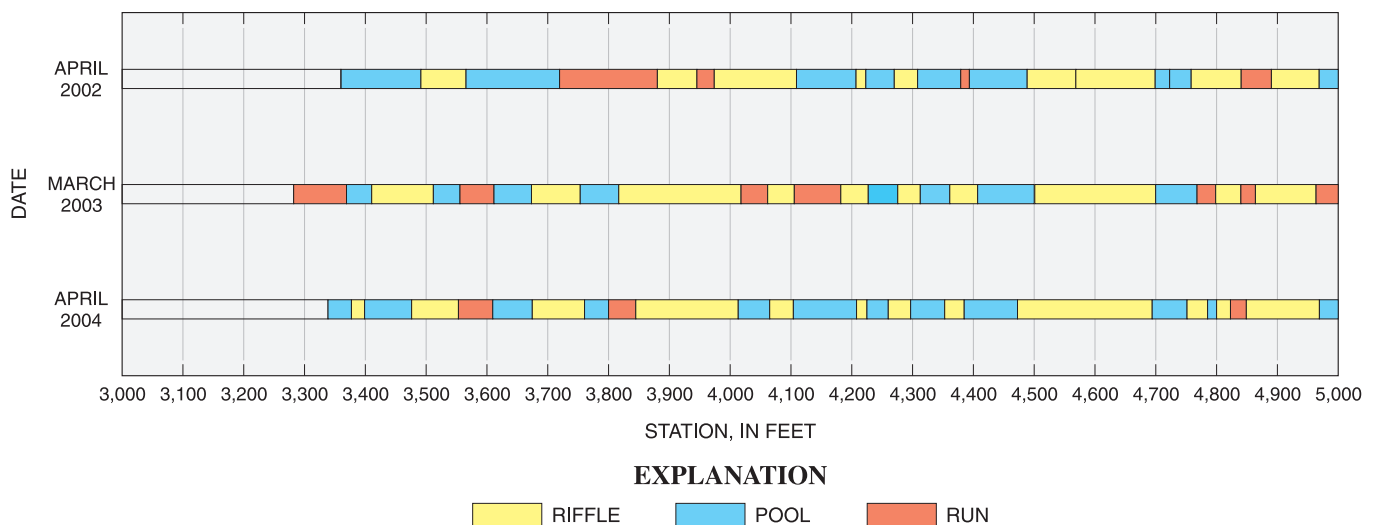
Figure 17. Comparison of riffle, pool, and run distribution in the Minebank Run study reach prior to channel restoration, 2002 through 2004.

Date of survey	Riffle (%)	Pool (%)	Run (%)
April 16, 2002	42.2	42.3	15.5
March 31–April 1, 2003	52.2	27.5	20.3
April 23, 2004	52.4	39.9	7.7

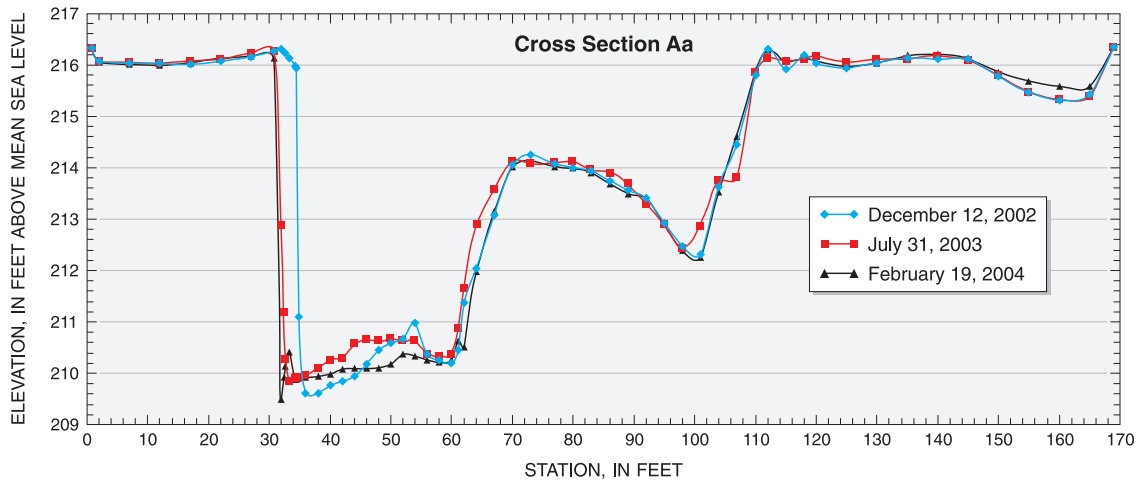
Figure 18. Pre-restoration cross-section geometry at permanent cross section Aa, December 2002 through February 2004.

Plots of the nine permanent cross sections are shown in figures 18–26. Varying degrees of aggradation and degradation of the channel bed are evident, as well as lateral erosion along the study reach. A summary of lateral erosion, maximum scour, and depths of maximum deposition that were directly measured, or reasonably approximated, based on field conditions during site visits at or near each permanent cross section in the study reach during the pre-restoration period is provided in table 7.

Net increases in cross-sectional area, channel width, and mean depth for most elevations at cross sections Aa, Dd, Ff, and Ii are indicated in table 9. These changes indicate an overall trend of bed degradation, bank instability, and channel widening over time. Cross section Aa, however, shows alternating increases and decreases in mean depth between field surveys. This indicates that, like cross section Hh, sand and gravel could be temporarily stored in this location after certain storm events despite overall degradation during the monitoring period. Considerable lateral bank erosion is also a likely factor in the increases in cross-sectional area and channel width at these locations.

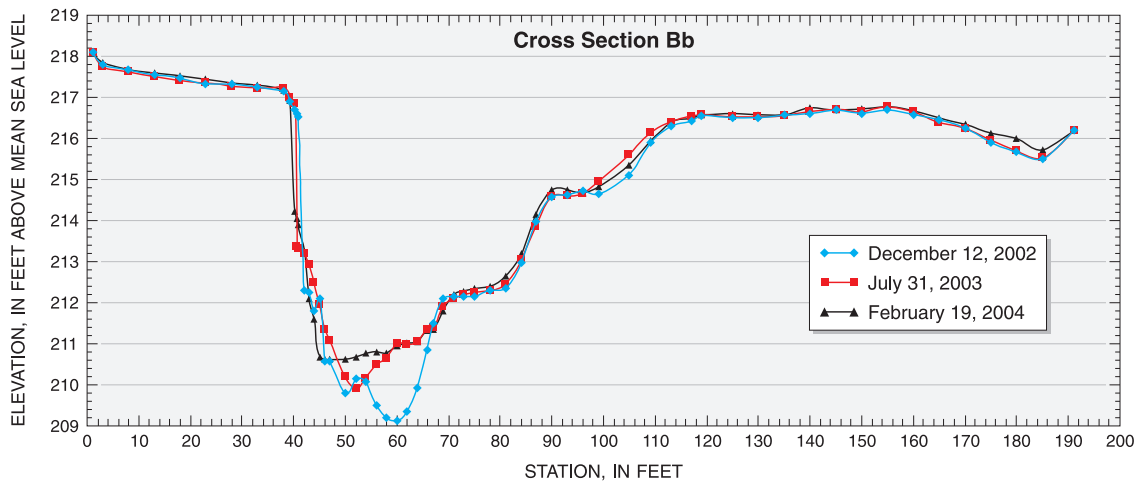
Figure 19. Pre-restoration cross-section geometry at permanent cross section Bb, December 2002 through February 2004.

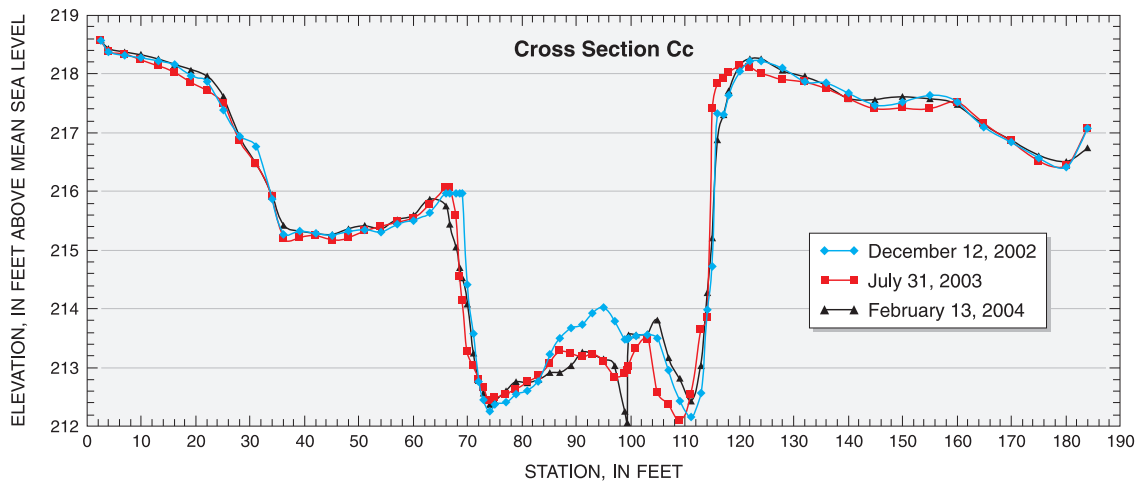
Figure 20. Pre-restoration cross-section geometry at permanent cross section Cc, December 2002 through February 2004.

Cross section Cc shows approximately the same channel-geometry characteristics that were documented at cross section Hh. The cross-sectional surveys indicate a net increase in cross-sectional area, hydraulic radius, and mean depth over time. Channel width shows a net increase at lower to mid-range elevations over time. These changes in channel width occur mainly within the active channel, due to the net effects of erosion at the base of the terrace on the left side of the channel. At most higher elevations, the channel width did not change considerably over time. The cross-section surveys also indicate alternating increases and decreases in cross-

sectional area and mean depth between field surveys. As with cross section Hh, this condition indicates temporary storage and removal of sand and gravel during storm events with net degradation of the channel bed over time.

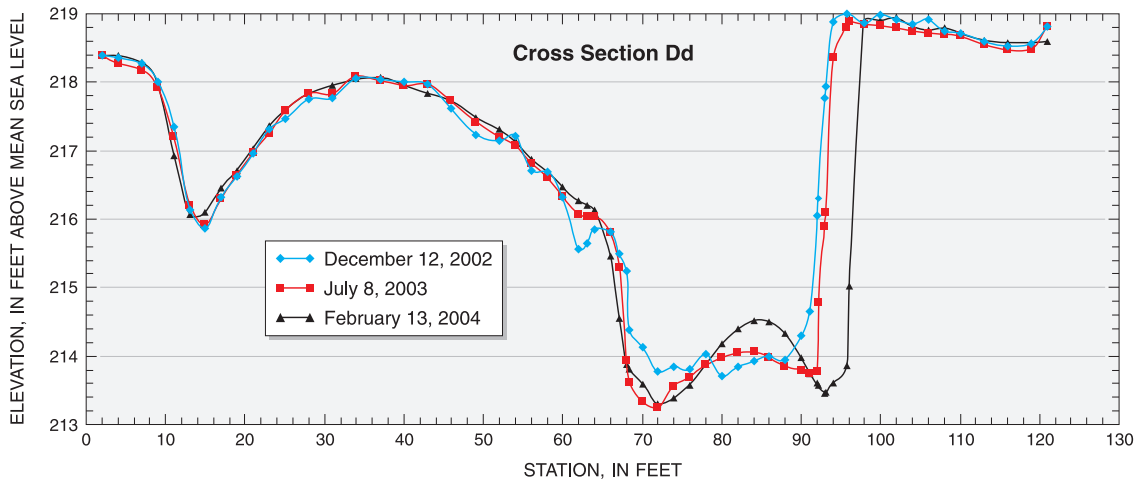
Figure 21. Pre-restoration cross-section geometry at permanent cross section Dd, December 2002 through February 2004.

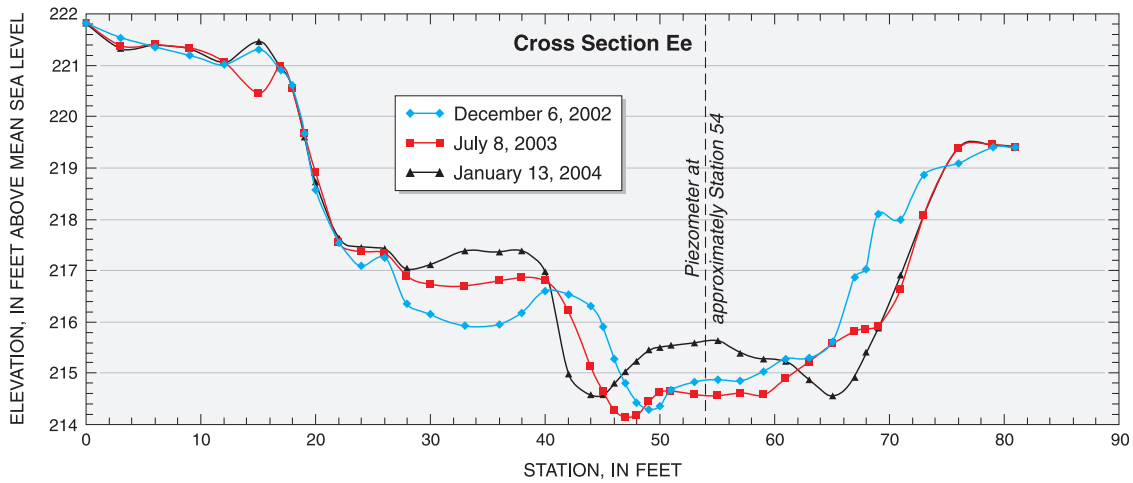
Figure 22. Pre-restoration cross-section geometry at permanent cross section Ee, December 2002 through January 2004.

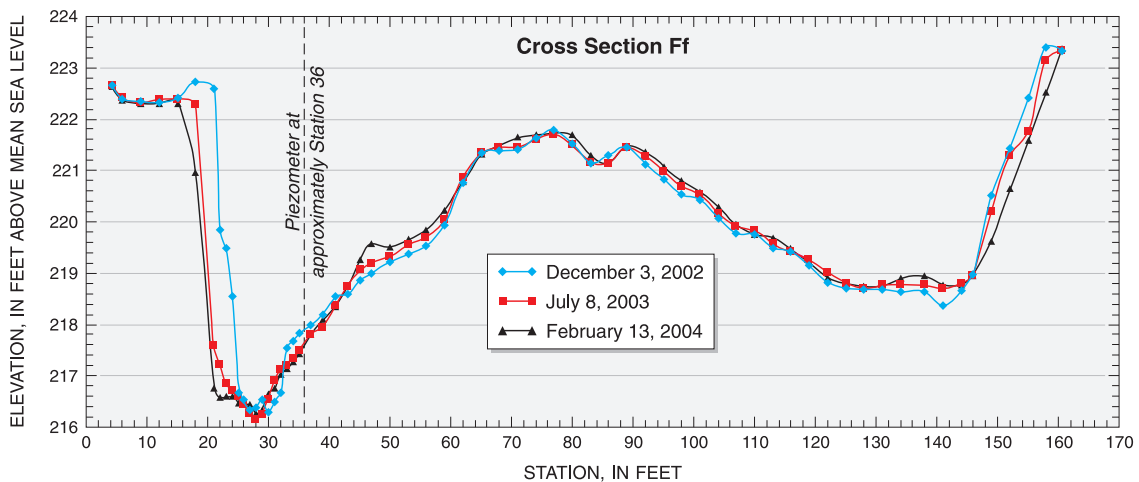
Figure 23. Pre-restoration cross-section geometry at permanent cross section Ff, December 2002 through February 2004.

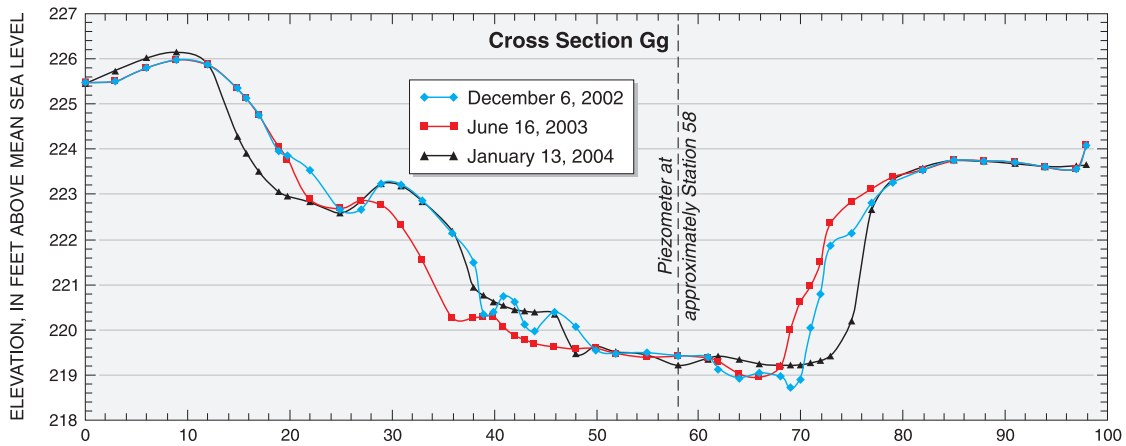
Figure 24. Pre-restoration cross-section geometry at permanent cross section Gg, December 2002 through January 2004.

Cross section Gg shows net increases in cross-sectional area and channel width over time. Mean depths show a small net decrease at lower elevations, and a net increase at higher elevations. The cross-section surveys indicate greater lateral instability of the stream channel than vertical instability in this location. Lateral migration of the right bank, and adjustment of the terrace and point bar features on the left side of the channel are the main cause of the net increases in cross-sectional area and mean depth over time.

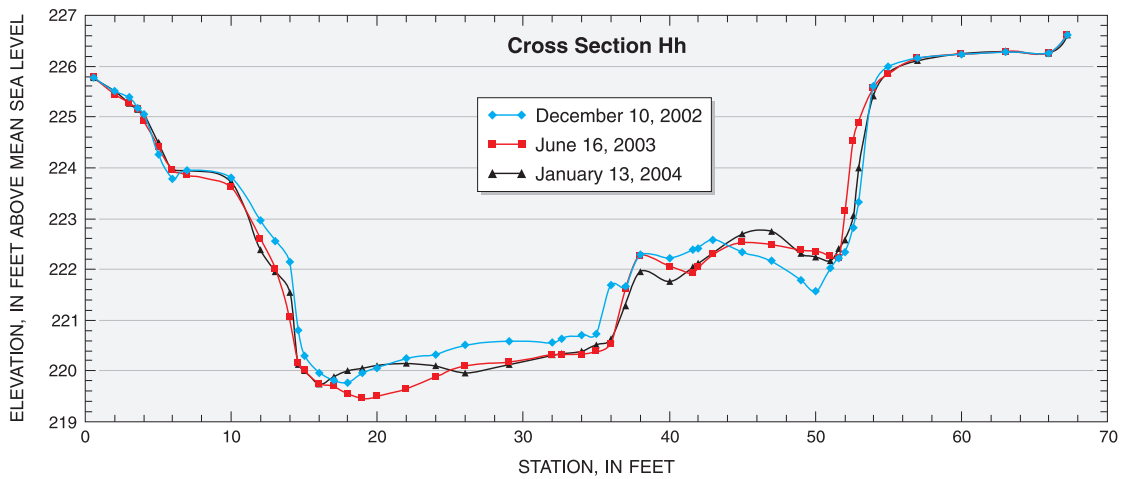
Figure 25. Pre-restoration cross-section geometry at permanent cross section Hh, December 2002 through January 2004.

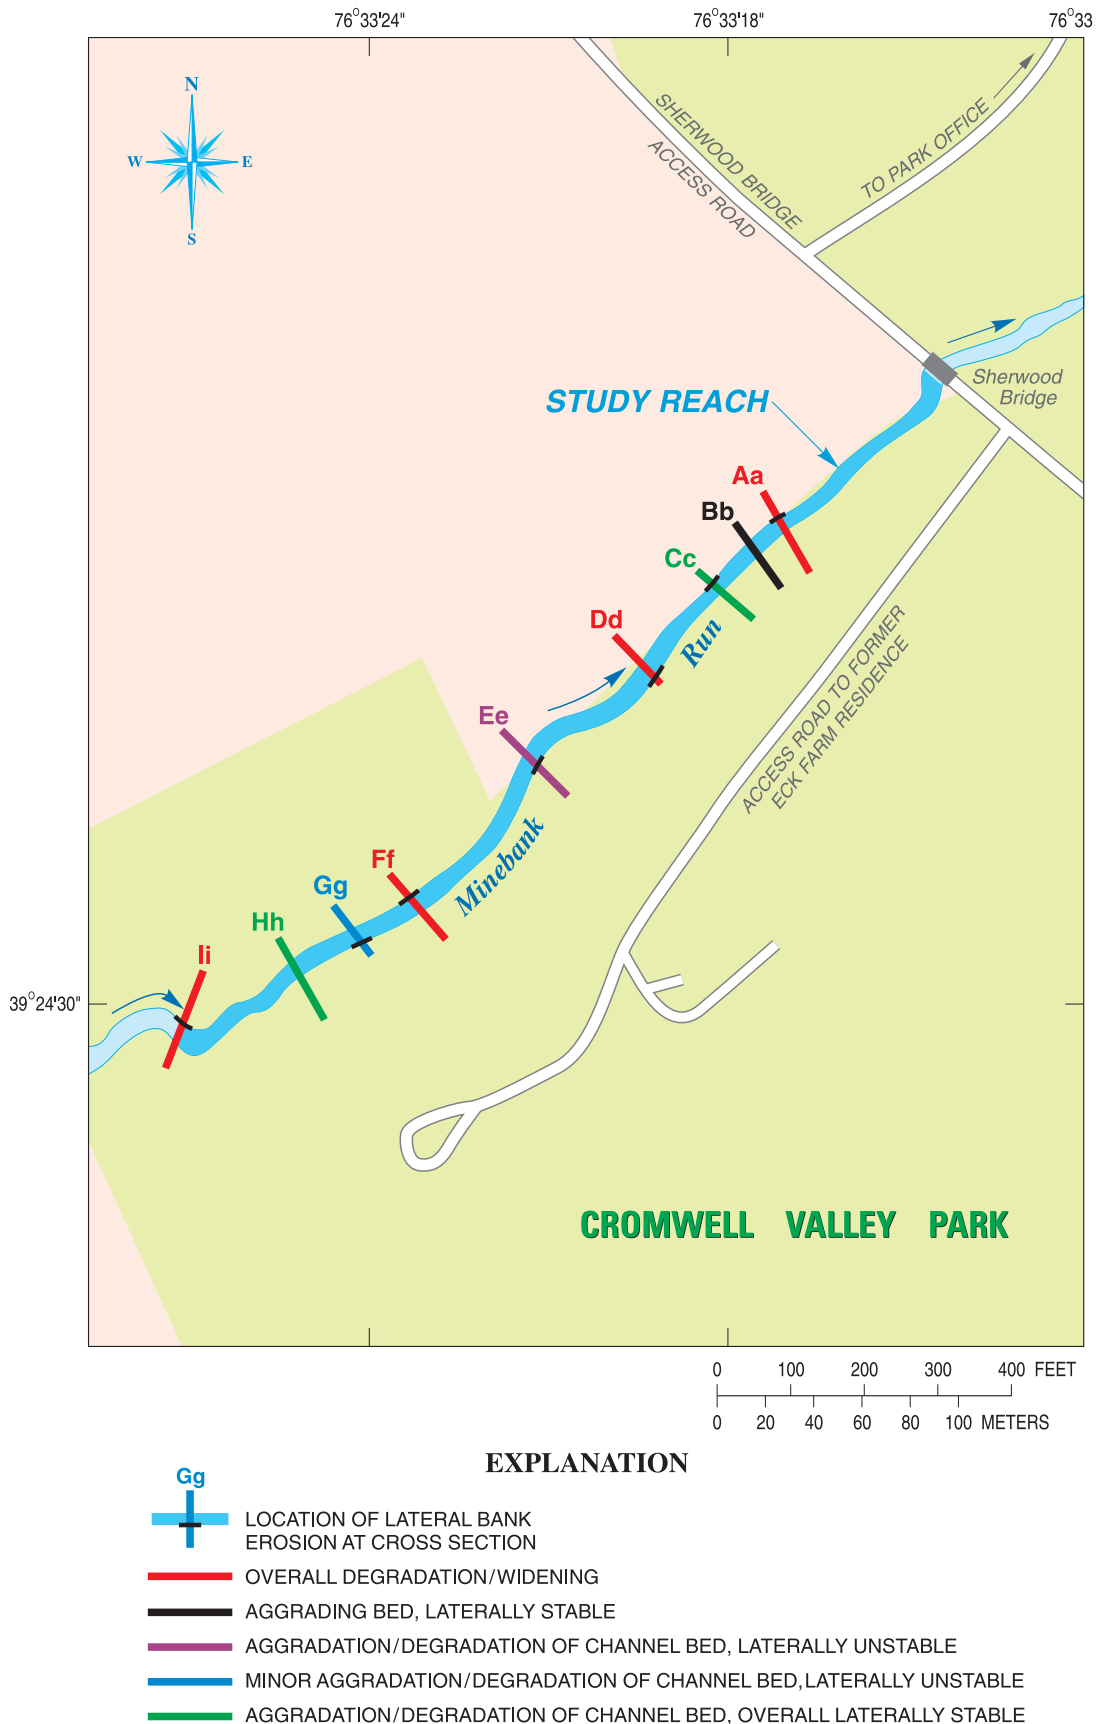
Figure 27. Summary of pre-restoration geomorphic conditions in the Minebank Run study reach, 2002 through 2004.

A summary of the pre-restoration geomorphic conditions that were interpreted from changes in the cross sections during the monitoring period is shown in figure 27. Cross sections Bb and Ee appear to be primary areas for sediment storage within the study reach. Cross section Ee appears to store large volumes of sediment for short periods of time and is vertically and laterally unstable. Cross section Bb shows net aggradation

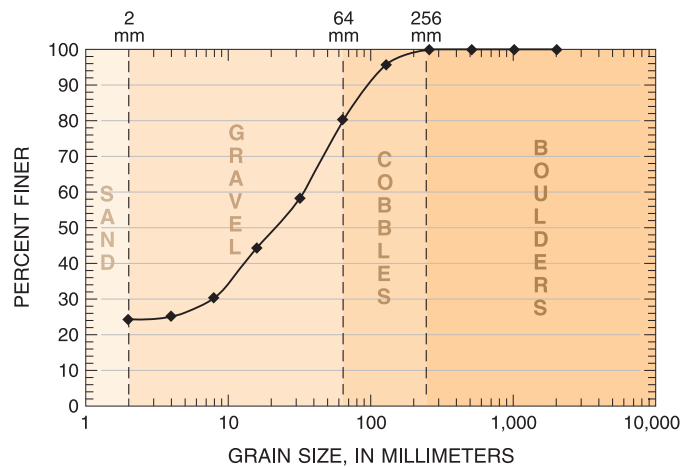
Figure 28. Composite pebble count for Minebank Run study reach above Sherwood Bridge prior to channel restoration, 2003.

Particle description	Particle size limit (mm)	Item count	Cumulative percent finer (%)
Silt	0.062	0	0
Sand	2	219	24.2
Very fine gravel	4	8	25.1
Fine gravel	8	48	30.4
Medium gravel	16	126	44.4
Coarse gravel	32	128	58.5
Very coarse gravel	64	199	80.5
Small cobbles	128	137	95.7
Large cobbles	256	38	99.9
Small boulders	512	0	99.9
Medium boulders	1,024	0	99.9
Large boulders	2,048	1	100.0
Very large boulders	4,096	0	100.0
TOTAL	--	904	--

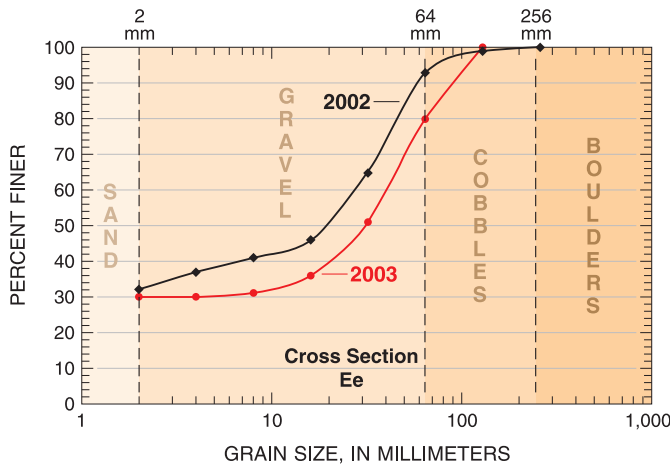
Figure 29. Comparison of particle-size distributions at cross section Ee, 2002 and 2003.

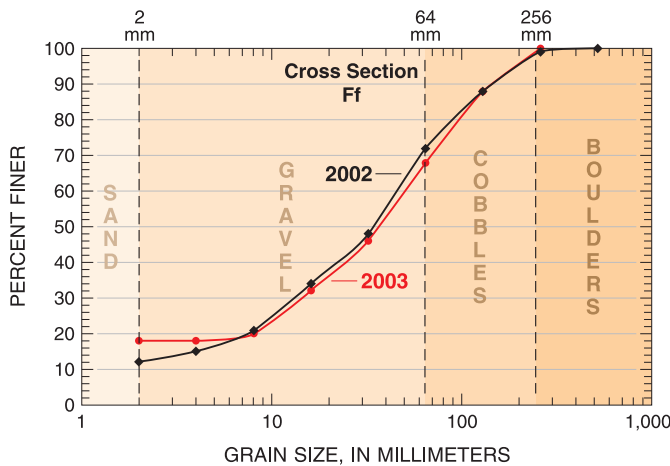
Figure 30. Comparison of particle-size distributions at cross section Ff, 2002 and 2003.

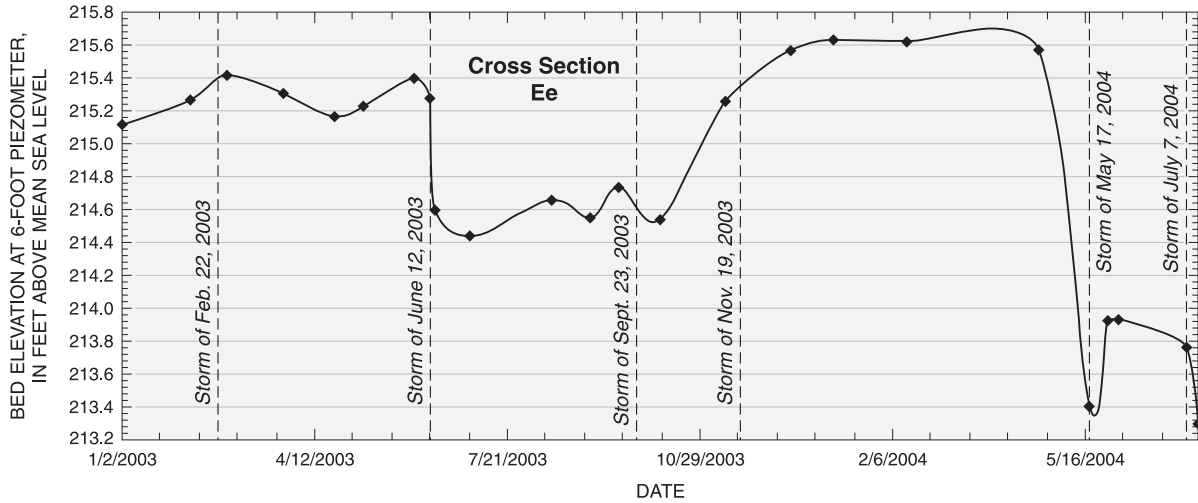
Figure 32. Net changes in bed elevation over time at cross section Ee, January 2, 2003 through July 13, 2004.

Rapid aggradation and degradation of the channel bed at cross section Ee between January 2003 and July 2004 is evident (fig. 32). Large storm events on June 12–13, 2003 caused the channel bed to degrade by nearly 1 ft in this location. From June 2003 to May 2004, the net aggradation of the channel bed in this location was nearly 1.2 ft. A large storm event on May 17, 2004 caused the channel bed to

degrade by over 2 ft in this location. The bed began to aggrade in the aftermath of this storm, but then degraded again during a large storm event on July 7, 2004. Analysis of the net changes in bed elevations indicate that (1) pulses of sediment are gradually transported into this section of the channel, and (2) the channel is undergoing alternating periods of storage and extreme erosion of sand and gravel at this location.

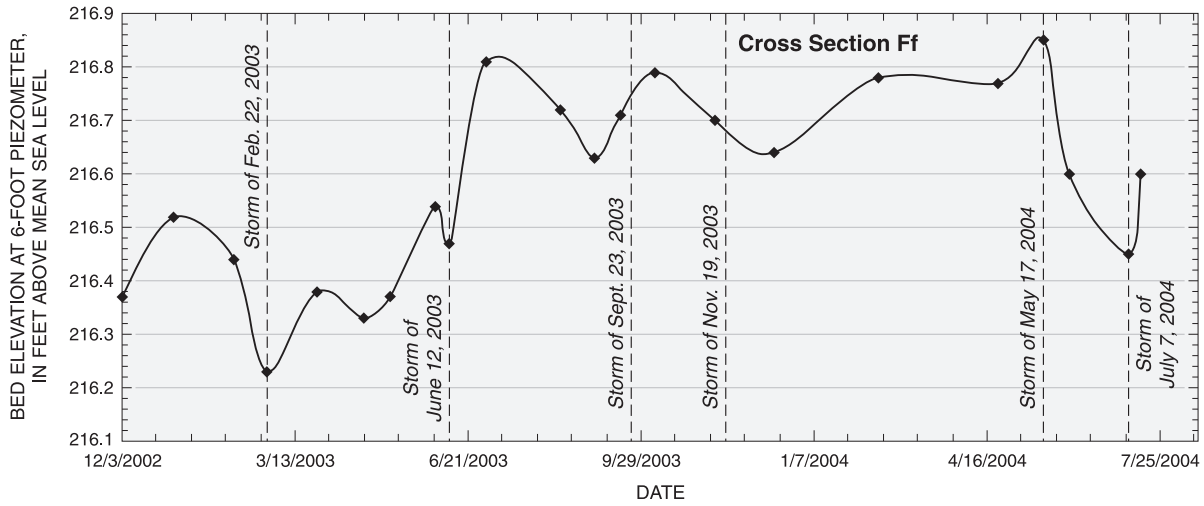
Figure 33. Net changes in bed elevation over time at cross section Ff, December 3, 2002 through July 14, 2004.

Alternating periods of aggradation and degradation of the channel bed at cross section Ff from December 2002 to July 2004 were observed (fig. 33), however, the range of net bed elevations measured during this period was approximately 0.62 ft at this location. The three storms that caused considerable degradation of the channel at cross section Ee, which is located 220 ft downstream, resulted in aggradation of the channel at cross section Ff. Overall, the channel bed showed slight aggradation during the monitoring period, with a few periods of slight degradation over time. Analysis of the net bed elevations over time indicated (1) some pulsing of sediment through the cross section, but with considerably smaller amounts of storage in this location than at cross section Ee, and (2) that channel migration could also be a contributing factor to the net aggradation observed at this location, due to considerable lateral erosion on the left bank and extension of a point bar into the channel.

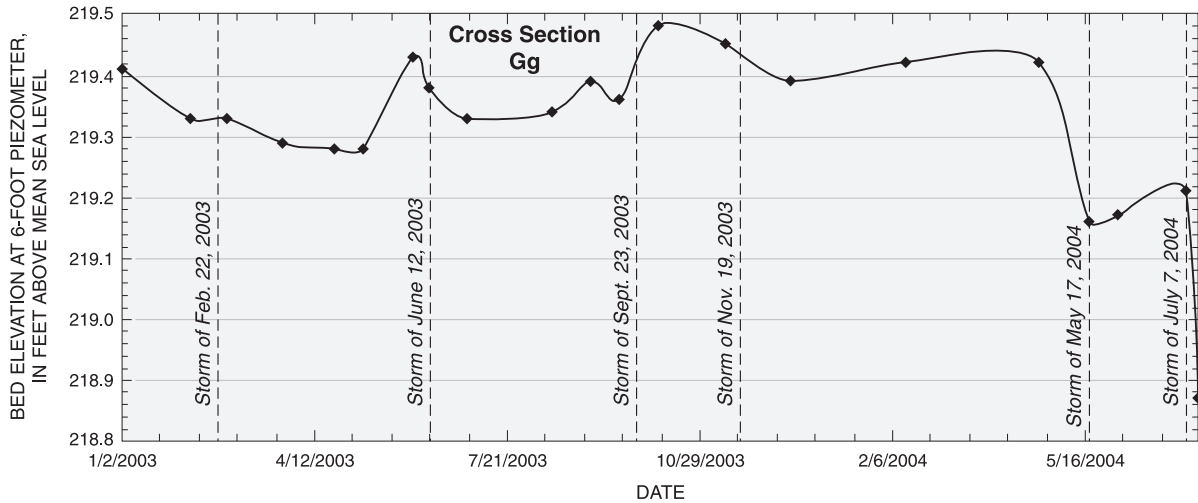
Figure 34. Net changes in bed elevation over time at cross section Gg, January 2, 2003 through July 14, 2004.

Relatively small net changes in bed elevation were observed at cross section Gg during most of the period from January 2003 to July 2004. The range of net bed elevations measured during this period was approximately 0.61 ft at cross section Gg, however, the range was only about 0.20 ft from January 2003 to April 2004. The storm of May 17, 2004 caused the channel bed to degrade by 0.26 ft, and the storm of July 7, 2004 caused the channel bed to degrade by an additional 0.34 ft. Analysis of the net bed elevations over time indicated that (1) the channel cross section was relatively stable with some pulsing of sediment through the cross section, but with considerably smaller amounts of storage in this location than at either cross section Ee or Ff, and (2) the channel bed became increasingly unstable during the last 3 months of the monitoring period from May to July 2004.

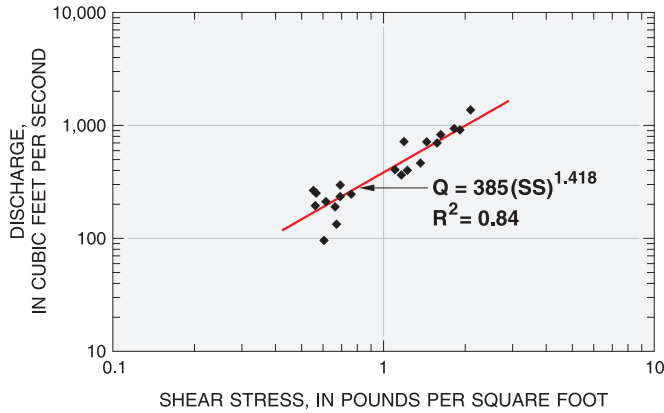
Figure 36. Boundary shear stress versus peak discharge in the Minebank Run study reach, November 2001 through September 2004.

The computed boundary shear stress values were plotted against the peak discharge for each storm (fig. 36) and against corresponding mean velocity (fig. 37). Simple linear regression was used to determine logarithmic relations for both boundary shear stress versus peak discharge and boundary shear stress versus mean velocity. The following equations

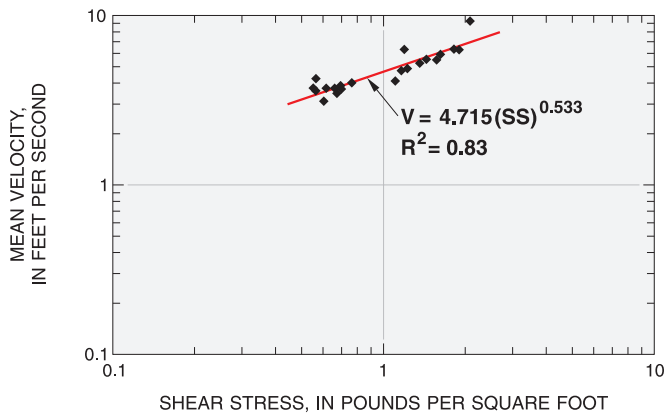
Figure 37. Boundary shear stress versus mean velocity at the peak discharge during storm events in the Minebank Run study reach, November 2001 through September 2004.
